DEPARTMENT OF THE AIR FORCE

1155 TECHNICAL OPERATIONS SQUADRON (AFTAC) MCCLELLAN AIR FORCE BASE CALIFORNIA 95652

NRC Inspection - License No. 04-09951-03

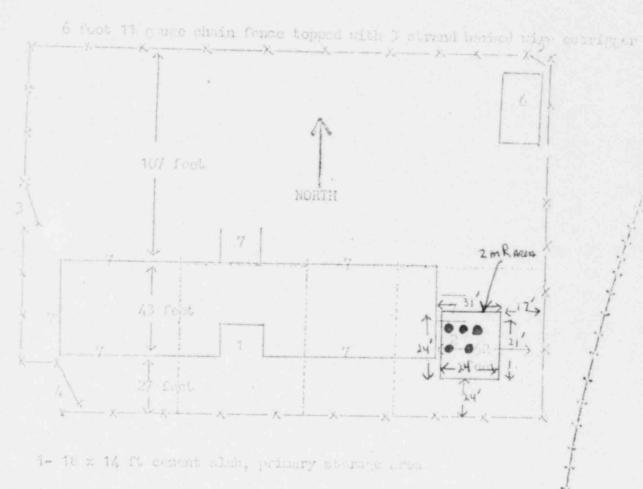
2. Sketch of RTG Storage Area

- b. Mr. Skov also mentioned that the survey should have included a sketch of the area of the RTG placement. This was accomplished.
- c. Copies of the corrected survey of leak tests and a sketch of the RTG storage area are attached.
