Atomic Energy
of Canada Limited

- 10 CFR 21 NOTIFICATION -
REPORTED INCIDENTS OF CERTAIN AECL-CP
TELETHERAPY UNITS

MEDICAL DEVICE RECALL ACTION
AECL-CP WARNING NOTICE WN-81-1

DIGITAL TREATMENT TIMER G7200 INSPECTION

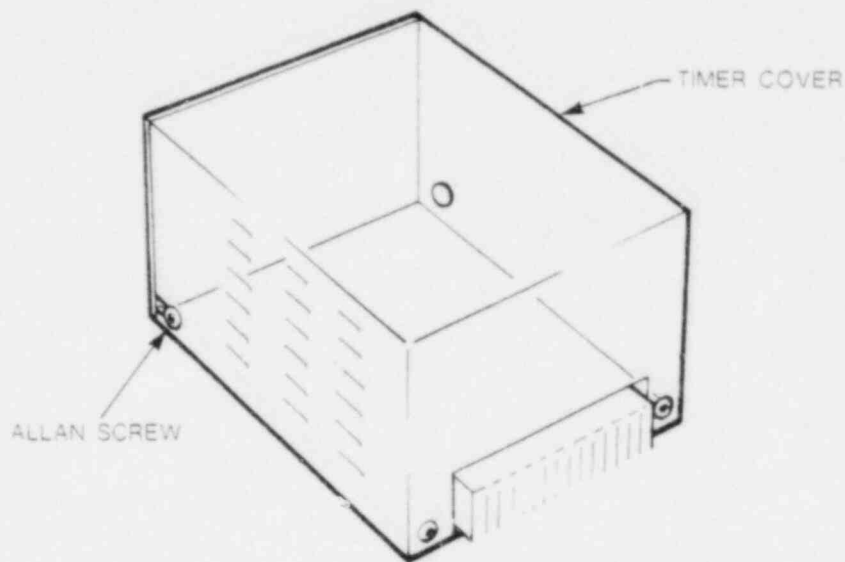
Fig. 3. Location of the Four Screws Retaining the Time Cover

IF THE PCB IS NOT CORRECTLY INSTALLED, THE TIMER MAY NOT OPERATE PROPERLY AND UNWANTED RADIATION MAY BE DELIVERED TO PERSONNEL.

- (ii) On the Theratron 60, 80 and 780 and on the Eldorado 6, 8, and 78 console, affix the warning label (provided) to the exterior rear surface of the console. The new nameplate label, Model G7200, is not required.
5. Using the Allan key provided, remove and discard the four screws which retain the timer cover. Remove and discard the timer cover; DO NOT REINSTALL. See Fig. 3.
6. Ensure that the battery printed circuit board (PCB) is correctly installed; it must be fully inserted into its socket. The top of the PCB must be level with or below the top of its guide rails when properly installed.
