LICENSEE EVENT REPORT (LER)

LaSalle County Station Unit 1

Title (4) Inadvertent Primary Containment Isolation Actuation Due to Inadequate

Logic Setup During Modification Installation

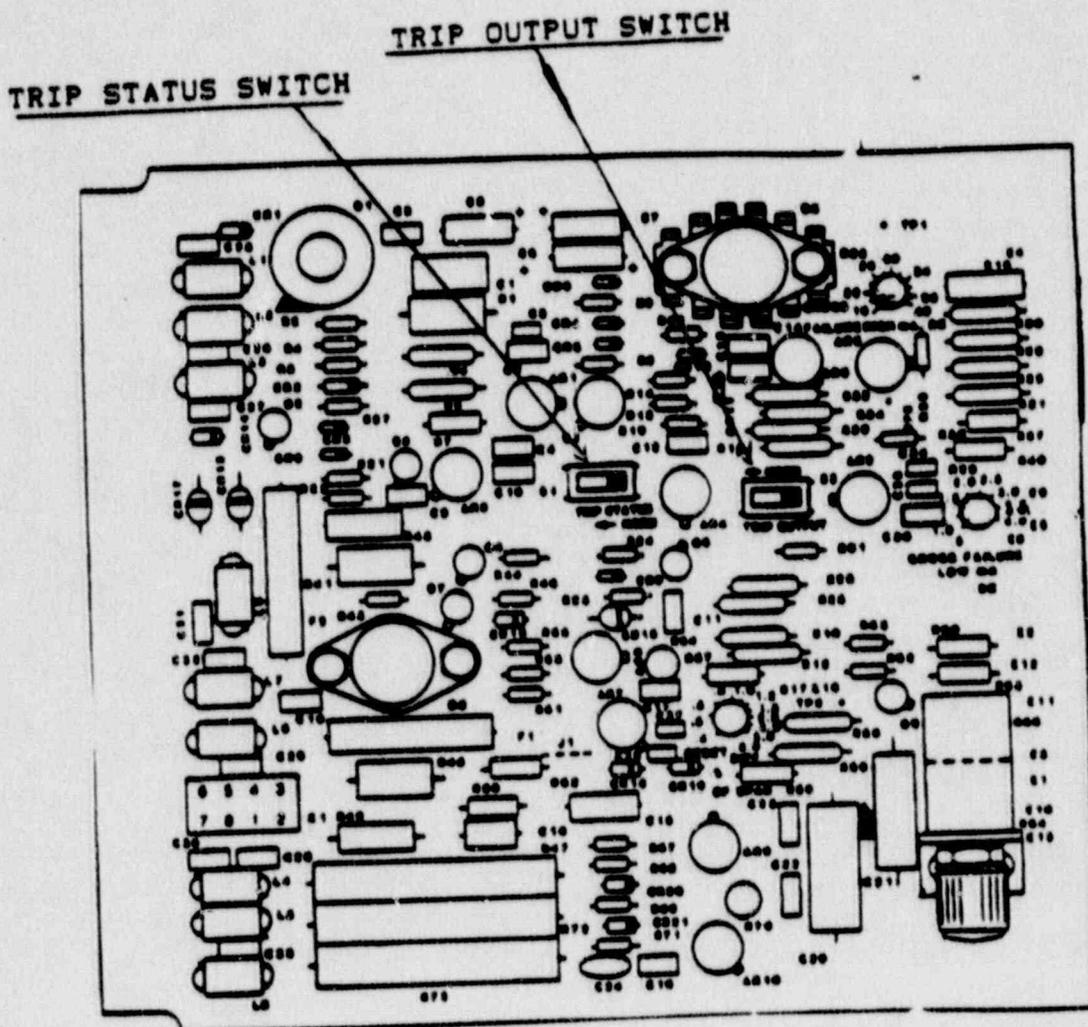
The Operating personnel completed clearing the outages for the Static-O-Ring reactor level switch replacement without any further problems. Once the inspection of all the relays associated with the RPS and PCIS logic was completed and the outage was completely cleared, the Operating personnel attempted to reset the PCIS logic; no change in relay status was observed. The Shift Engineer (SE, licensed Senior Reactor Operator) instructed the Operating personnel to prepare and hang another outage to defeat the PCIS Groups 2, 3, 4 and 5 isolation logic from initiating due to troubleshooting the reactor level 2 logic. The Instrument Maintenance personnel were then requested to troubleshoot reactor level 2 and 3 Rosemount trip units to determine why the Operator was unable to reset the logic. After performing a calibration and inspection of the master and slave trip units it was discovered that the Trip Status switch S1 and Trip Output switch S2 located on the printed circuit board for these trip units were in the wrong position. (See attached diagram.) The Trip Status switch S1 was found in the "normal" position (should have been in the reverse position) and the Trip Output switch S2 was found in the "reverse" position (should have been in the normal position).

The Trip Output switch in the "normal" position, controls the contact in the logic for the Master or Slave trip unit which opens to de-energize the RPS or PCIS relay that will initiate a scram or isolation. The Trip Status switch in the "reverse" position, controls the trip indicating LED located on the master or slave trip unit which should energize to indicate a trip during a trip condition. The Trip Output and Trip Status switches operate independently of each other, therefore the Trip Status light (LED, Light Emitting Diode) may not be lit when the Trip Output relay is in the trip condition. The setting of the Trip Output and Trip Status switches are all a function of whether the system is energized to initiate or de-energize to initiate. The normal configuration is set to de-energize to initiate.

The root cause of this event was that the modification was installed with the Master and Slave trip unit Trip Output or Status switches improperly set. No written instructions were provided in the modification package on how to set the switches. This caused the person in charge of the work to authorize restoring the level instrumentation to service in an abnormal condition. This allowed the level indicating meters on the Master Trip units to indicate upscale with the trip contacts open in the tripped condition with no trip indicating light illuminated on either the Master or Slave trip units. When the Master and Slave trip units were inspected prior to clearing the outage no trip lamps were illuminated. The jumpers were removed across the open contacts while clearing the outage resulting in de-energizing trip logic relays for reactor level 2 and 3 RPS and PCIS logic. This caused PCIS Group 2, 6 and 7 isolations to occur.

Drawing of the printed circuit board for a typical Master or Slave trip unit showing the "Trip Status" and "Trip Output" switches.

The Trip Output and Status switches were repositioned and calibrations completed in accordance with LIS-MS-107A/B and LIS-MB-101A/B without any further problems.

The Instrument Maintenance Department was requested to troubleshoot and calibrate the Rosemount reactor level instrumentation in accordance with LIS-MS-107A/B and LIS-NB-101A/B. During the performance of the calibration the Instrument Maintenance personnel determined the problem was the 1B21-N703A/B/C/D Master and 1B21-N704B/C Slave trip unit Trip Output and Status switches being in the wrong position. The Trip Output and Status switches for each of the trip units were repositioned and the calibration was completed without any further event.

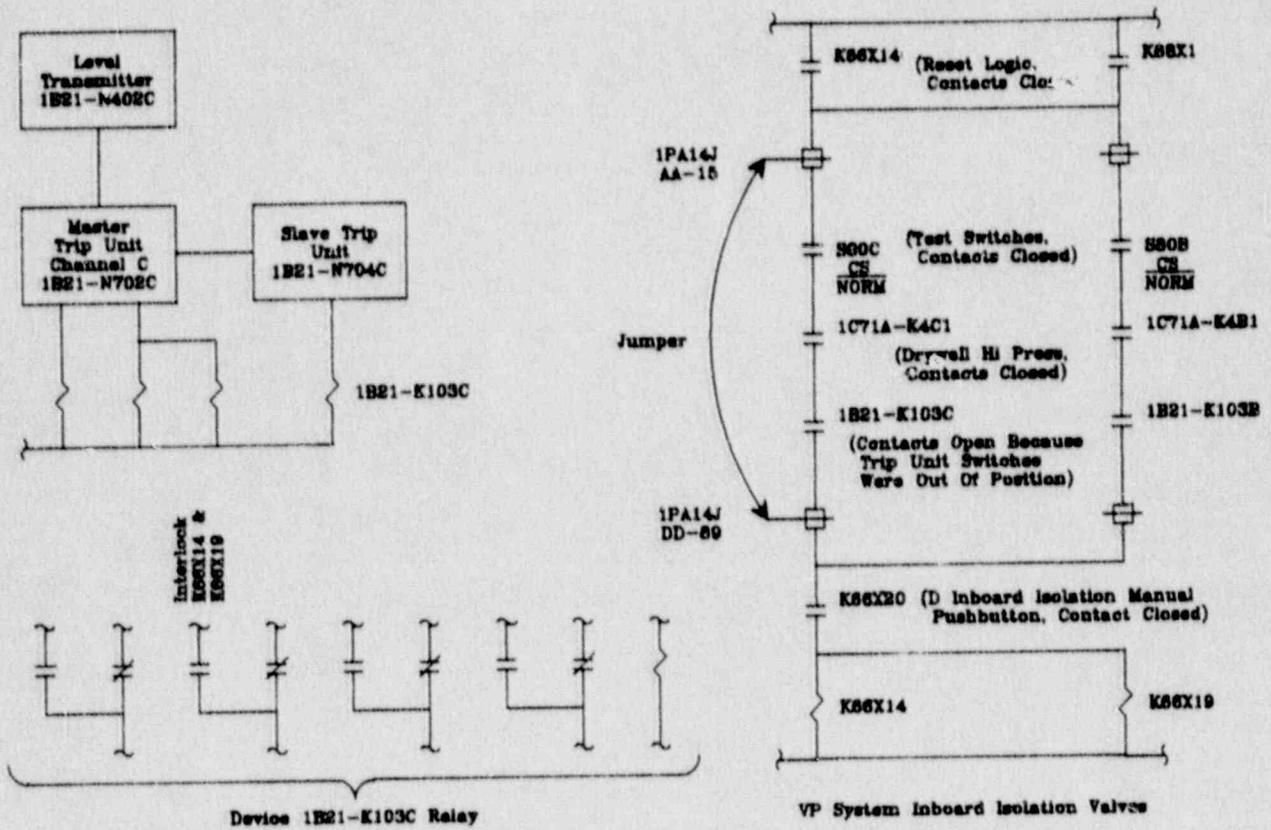
master trip unit.) were not completely calibrated, it was not identified that the slave trip units were in the tripped condition when the jumper was removed. (See attached diagram.) Upon further investigation the master trip units associated with reactor level 3 trips were also found in the trip condition. This prevented resetting the logic, alarms and resulted in the operation of valves associated with the RPS and PCIS logic.

Simplified Schematic Diagram of the Channel C Level 2 Logic
