TENNESSEE VALLEY AUTHORITY

TENNESSEE VALLEY AUTHORITY - SEQUOYAH NUCLEAR PLANT UNIT 1 - DOCKET NO.
50-327 - FACILITY OPERATING LICENSE DPR-77 - LICENSEE EVENT REPORT (LER)
50-327/89026

LICENSEE EVENT REPORT (LER)

TITLE (4) Entry into LCO 3.0.3 as a result of more than one RPI per bank being inoperable because of a lack of preventive maintenance to CRDM cooling system dampers.

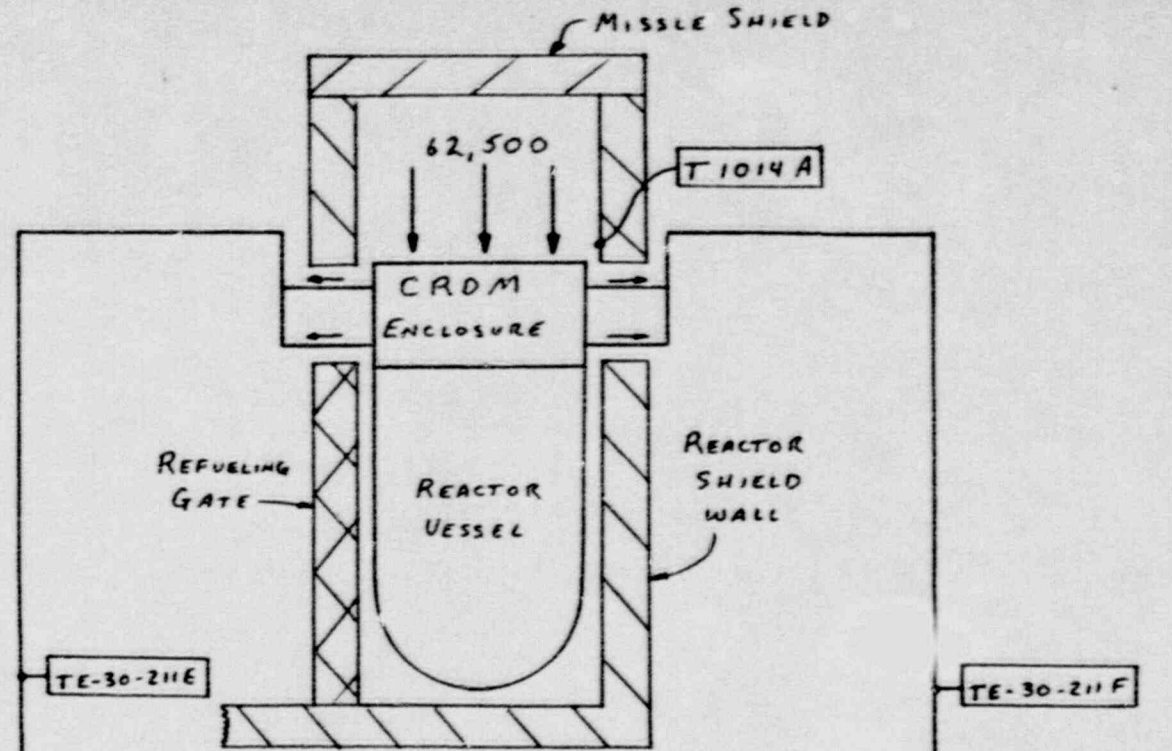
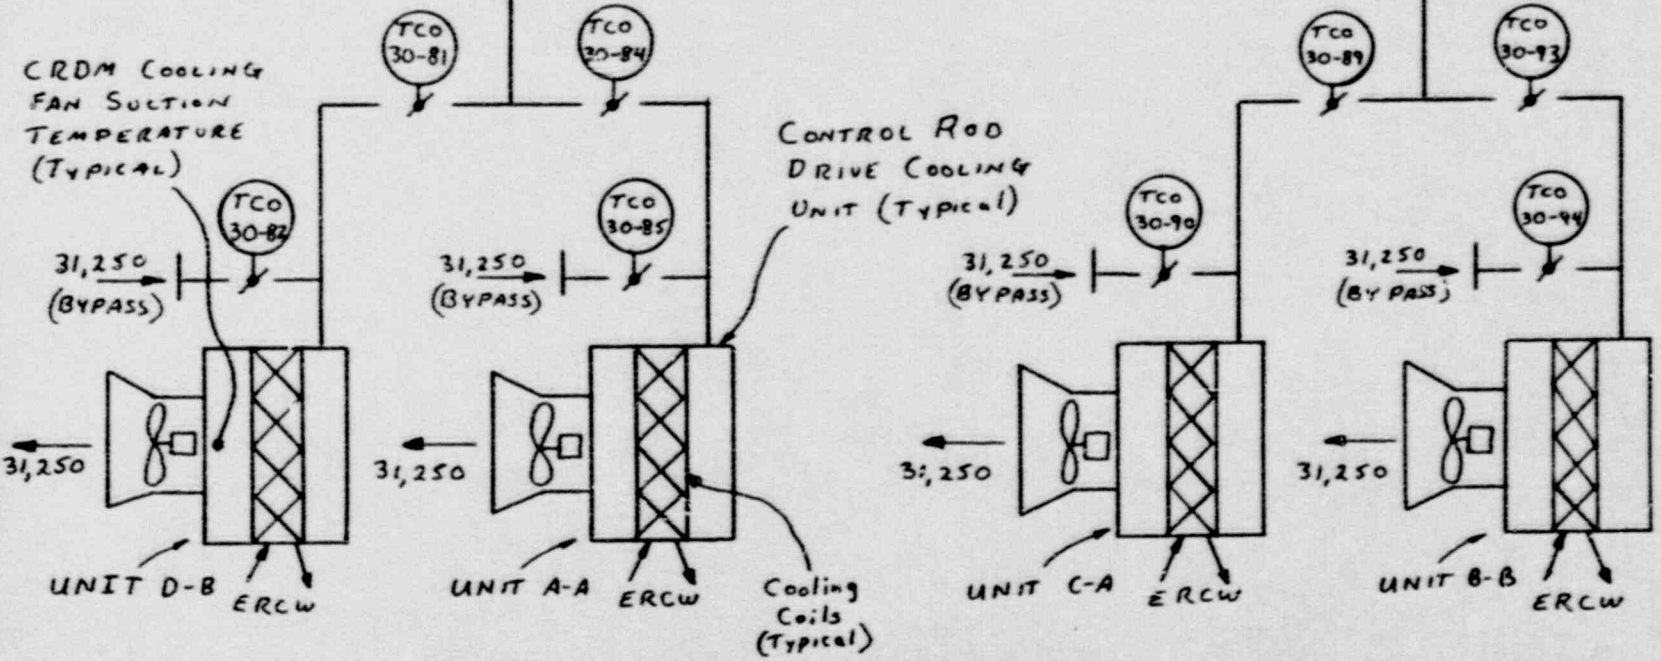
CRDM COOLING SYSTEM

Earlier in the same day, the A-A and B-B control rod drive mechanism (CRDM) cooling fans (EIIS Code CD) were in service with suction aligned to the CRDM enclosure. (See attached simplified sketch.) Preparations were being made to perform Surveillance Instruction (SI) 266.1.2, "18-Month Circuit Breaker Inspection (Westinghouse Type DS 480V)," to test Breaker SQN-1-BCTB-030-0092-B, which supplies power to the B-B CRDM cooler fan. At 2055, the unit operator (UO) swapped from the A-A and B-B CRDM cooling fans to the C-A and D-B fans, aligning their suction to the CRDM enclosure.

The root cause of this event is believed to have been a lack of preventive maintenance (PM) on the CRDM cooling system dampers. Alignment of the CRDM cooling system to the C-A and D-B cooling fans failed to provide adequate cooling to the CRDM enclosure. The suspected reason for the inadequate cooling is a damper malfunction that aligned the cooling fan suction to bypass rather than to the CRDM enclosure. (See attached simplified sketch.) This reason is suspected because of previous problems with the dampers. In September 1988, the cognizant system engineer inspected the CRDM cooling system and identified a number of problems. Work requests were initiated to correct the problems, and the problems were subsequently fixed. However, because the dampers in the system are not covered by a PM program, it is suspected that they may have again experienced a malfunction. Because these components are not accessible at power, verification of a malfunction will have to await the next outage.

Two contributing causes of this event have also been identified. The first is equipment deficiencies that interfered with the verification of proper CRDM cooling system performance by operators following the swapover to the C-A and D-B cooling fans. The most useful temperature indication available to the operators following swapover would have been the CRDM enclosure exit temperatures measured by TE-30-211E and TE-30-211F, shown on the attached simplified sketch. However, the main control room display for these temperatures, the Morgan-1 recorder (TR-56-1), was inoperable at the time of this event. The temperature indication that was available to the operators in the main control room was the P-250 Computer Point T1014A. However, this computer point was vaguely labeled as containment air temperature opposite from the refueling gate, which reduced its usefulness to the operators. The second contributing cause of this event is a lack of guidance for the operators on indicators to monitor while swapping CRDM cooling fans in System Operating Instruction (SOI) 30.3, "Containment Upper and Lower Cooling, Heating and Ventilation". The UO used the CRDM cooling fan suction temperatures following swapover to verify system performance. These temperatures are measured between the essential raw cooling water coolers and the fan intake and are, therefore, not indicative of CRDM enclosure air temperatures.

As immediate corrective action, the RPIs were adjusted to within the required 12 step tolerance. Work requests have been initiated to investigate and repair as necessary any malfunction of the CRDM cooling system dampers or fans during the next scheduled outage for each unit.

As corrective action to prevent recurrence, the Technical Support group will initiate actions by January 2, 1990, to place the appropriate CRDM cooling system components (such as the dampers) in a PM system. In addition, by December 15, 1989, the Technical Support group will determine a more appropriate description for computer point T1014A and initiate actions to revise its P-250 listing. A section will also be added to SOI-30.3 by February 1, 1990, to provide better guidance for the operators when swapping the fans for CRDM enclosure cooling.
