AEOD TECHNICAL REVIEW REPORT

UNITS: Beaver Valley 2 DOCKET NO.: 5000412 LICENSEE: Duquesne Light Co. NSSS/AE: Westinghouse/Sargent and Lundy TR REPORT NO.: AE0D/1926 DATE: December 29, 1989 EVALUATOR/CONTACT: F. M. MANNING

SUBJECT: EVALUATION OF TWO BEAVER VALLEY 2 NUCLEAR PLANT EQUIPMENT DEGRADATION EVENTS FOR THEIR COMBINED SIGNIFICANCE

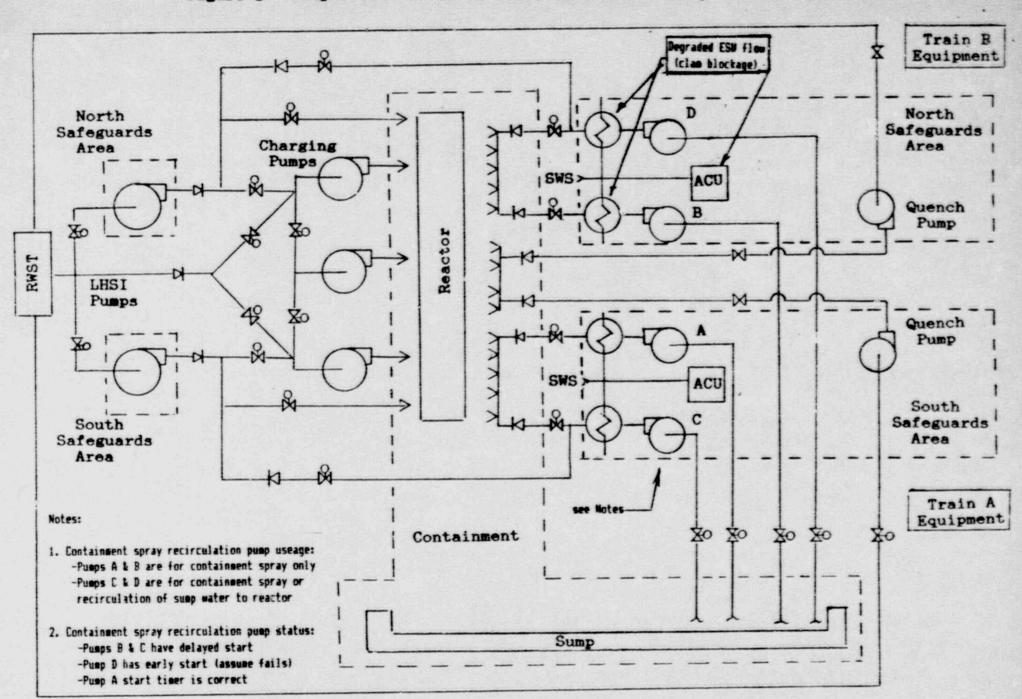
Figure 1 - Simplified sketch of Selected Beaver Valley 2 ESF systems

The first LER concerns reduction of the emergency service water (ESW) flow through the heat exchangers of train B of the containment recirculation spray system (Figure 1). The ESW flow reduction was caused by partial blockage of the heat exchangers due to Asiatic clams. The Beaver Valley 2 plant design provides dual function use of the recirculation spray pump trains. Given a loss of coolant accident (LOCA), the containment recirculation system pumps are used for both reactor inventory makeup, and for containment heat removal. The reduced ESW flow could affect the performance of both functions given an accident. The second LER evaluated in this report concerns incorrect operation of the containment recirculation pump start timers. These described problems would degrade the redundancy of the systems available to respond to and mitigate a LOCA.

The first LER describes a degradation found during refueling outage tests of the Train B recirculation spray system. The degradation involved partial blockage of ESW heat exchangers in the B train due to ingress and growth of Asiatic clams. The clams restricted the ESW cooling water flow through the tube side of the heat exchangers for recirculation pump B and D (see attached simplified sketch).

The corrective actions taken by the licensee appear to have been adequate. These actions included replacing or readjusting recirculation pump start timers as needed, and increasing the monitoring and preventative maintenance on the affected heat exchangers. No further action by AEOD other than monitoring these types of events is required.
