UNITED STATES
 NUCLEAR REGULATORY COMMISSION
 REGION II
 101 MARIETTA STREET, N.W.
 ATLANTA, GEORGIA 30323

Report No.: 50-395/89-22

Facility Name: V. C. Summer

Inspection Conducted: November 1 - 30, 1989

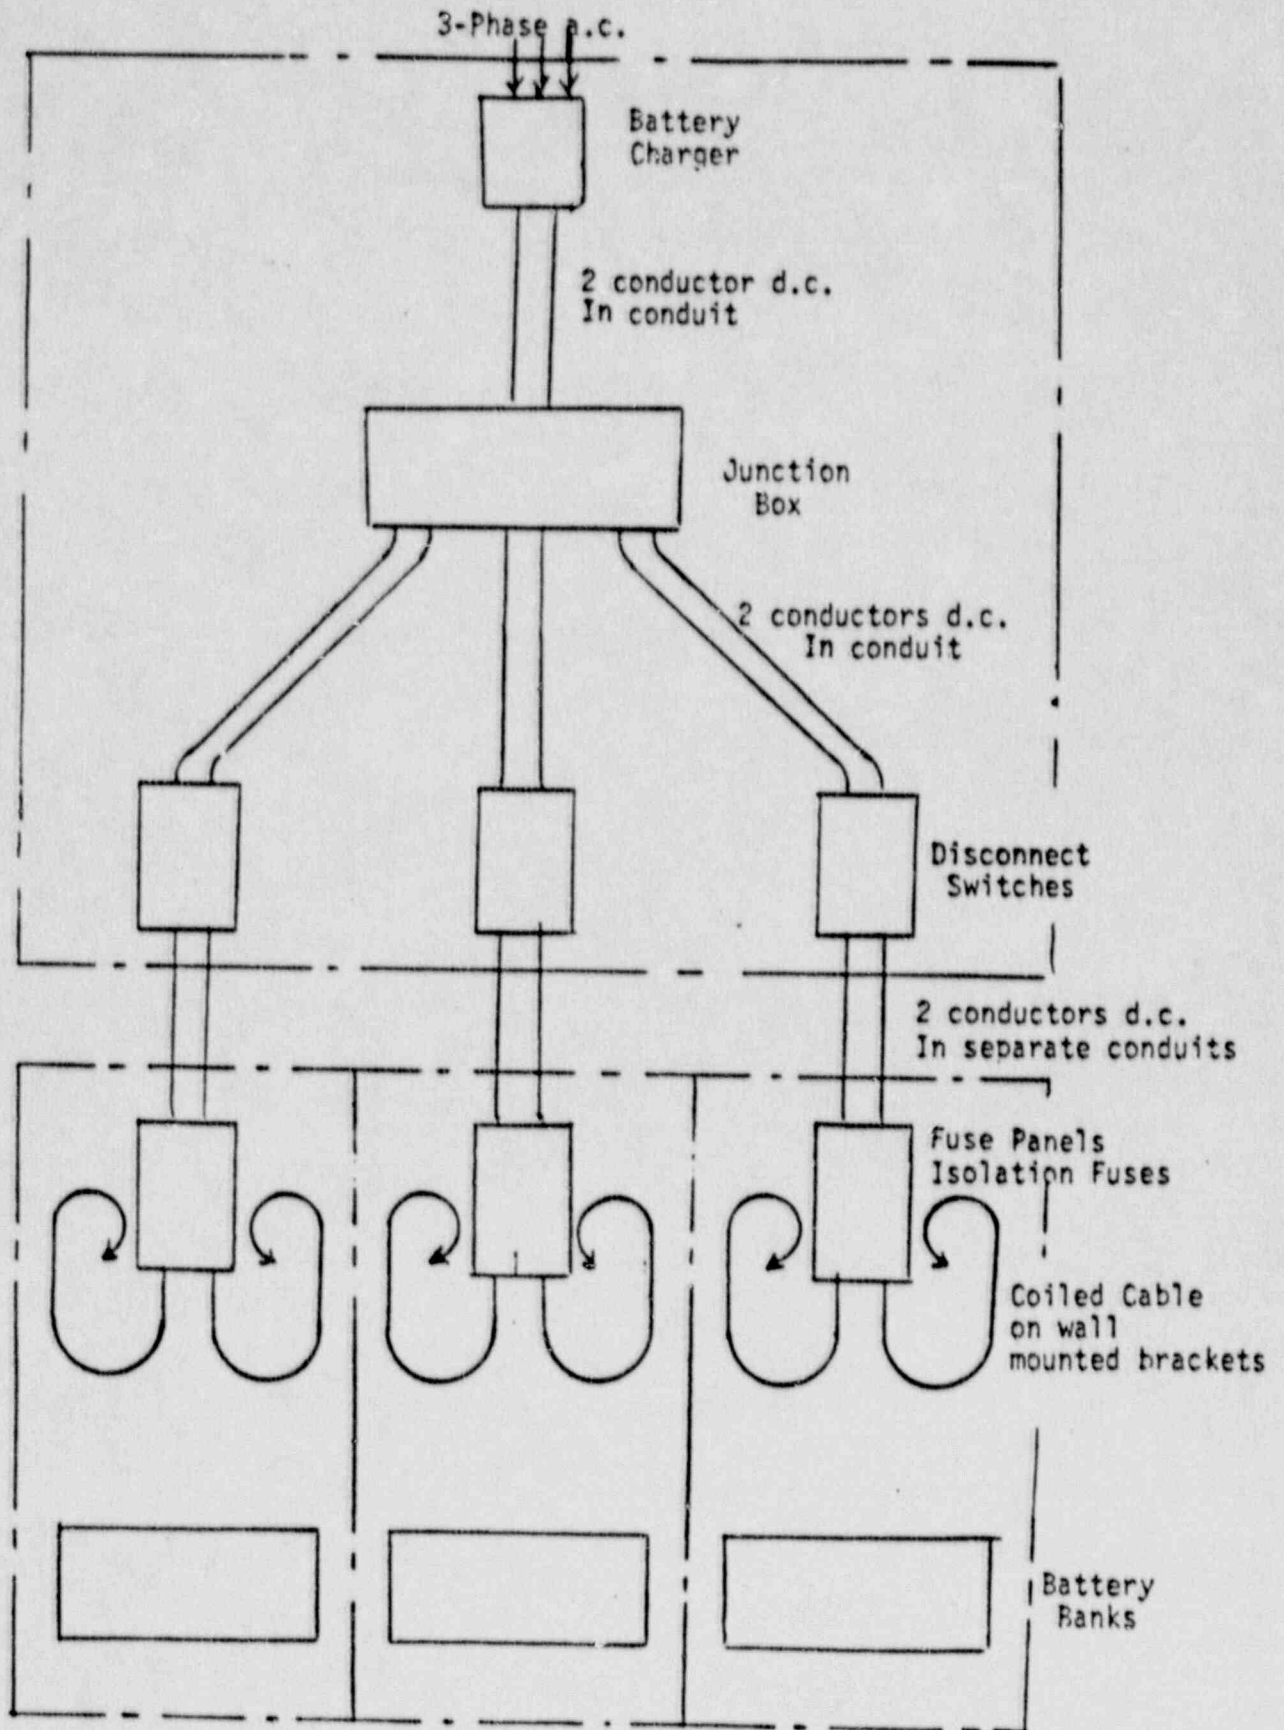
ATTACHMENT B

A simplified electrical diagram of the modification is shown on attachment B. The single cell battery charger and the 3 disconnect switches, one for each of three batteries, are located in a separate room. The three fuse panels are wall mounted in their respective battery rooms. The single cell battery charger stand, terminal box, disconnect switches, fuse panels, fuses, and cable racks are

seismically mounted. The three disconnect switches are padlocked and controlled administratively to prevent more than one being closed at a time. Only two of the three batteries are safety related.
