U. S. NUCLEAR REGULATORY COMMISSION
REGION I

Report No. 50-320/89-13

Facility Name: Three Mile Island Unit 2

Inspection Summary: Inspection on November 30, 1989 and December 15, 1989
(Report No. 50-320/89-13)

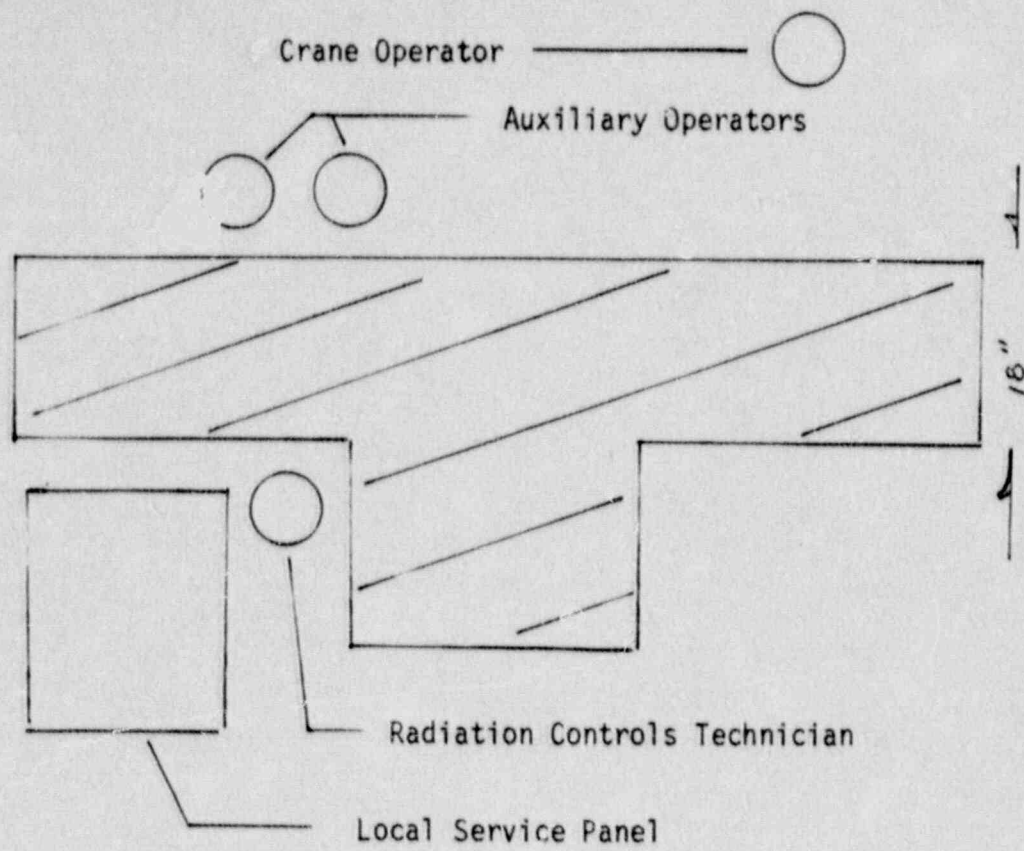
allows operators standing on the platform access to the reactor vessel. Figure 1 depicts the arrangement of the "T" slot and the approximate positions of the individuals involved during the incident. There is a rail that borders the "T" slot of approximately three feet in height. The rail's sides are covered with a shield for radiation protection purposes. Off to one side of the "T" slot is an area designated as the "local service panel", essentially a table, which is used by the radiation controls technicians in handling materials removed from the vessel.

Figure 1 depicts the approximate location of the two auxiliary operators, the crane operator and the radiological controls technician when the incident occurred. The auxiliary operators' job was to pull up the Peters tool from the vessel in order to retrieve the reusable end-plug. As they pulled it up out of the water in the "T" slot through the area of the rails they wiped it down with a clean cloth, while at the same time the RCT surveyed the pole. When the object at the end of the tool got to the height of the rails where it could be grabbed, the RCT surveyed it to determine if the dose rates on it were low enough to remove it from the vessel. The RCT did not give the auxiliary operators an indication that there were any unusual dose rates associated with the end-plug.
