SUBJECT: Arkansas Nuclear One - Unit 1
Docket No. 50-313
License No. DPR-51
Licensee Event Report No. 50-313/89-040-00

LICENSEE EVENT REPORT (LER)

TITLE (4) Two Emergency Diesel Generator Actuations Due to Loss of Power to a 480V Engineered Safeguards Bus
Caused By Personnel Error

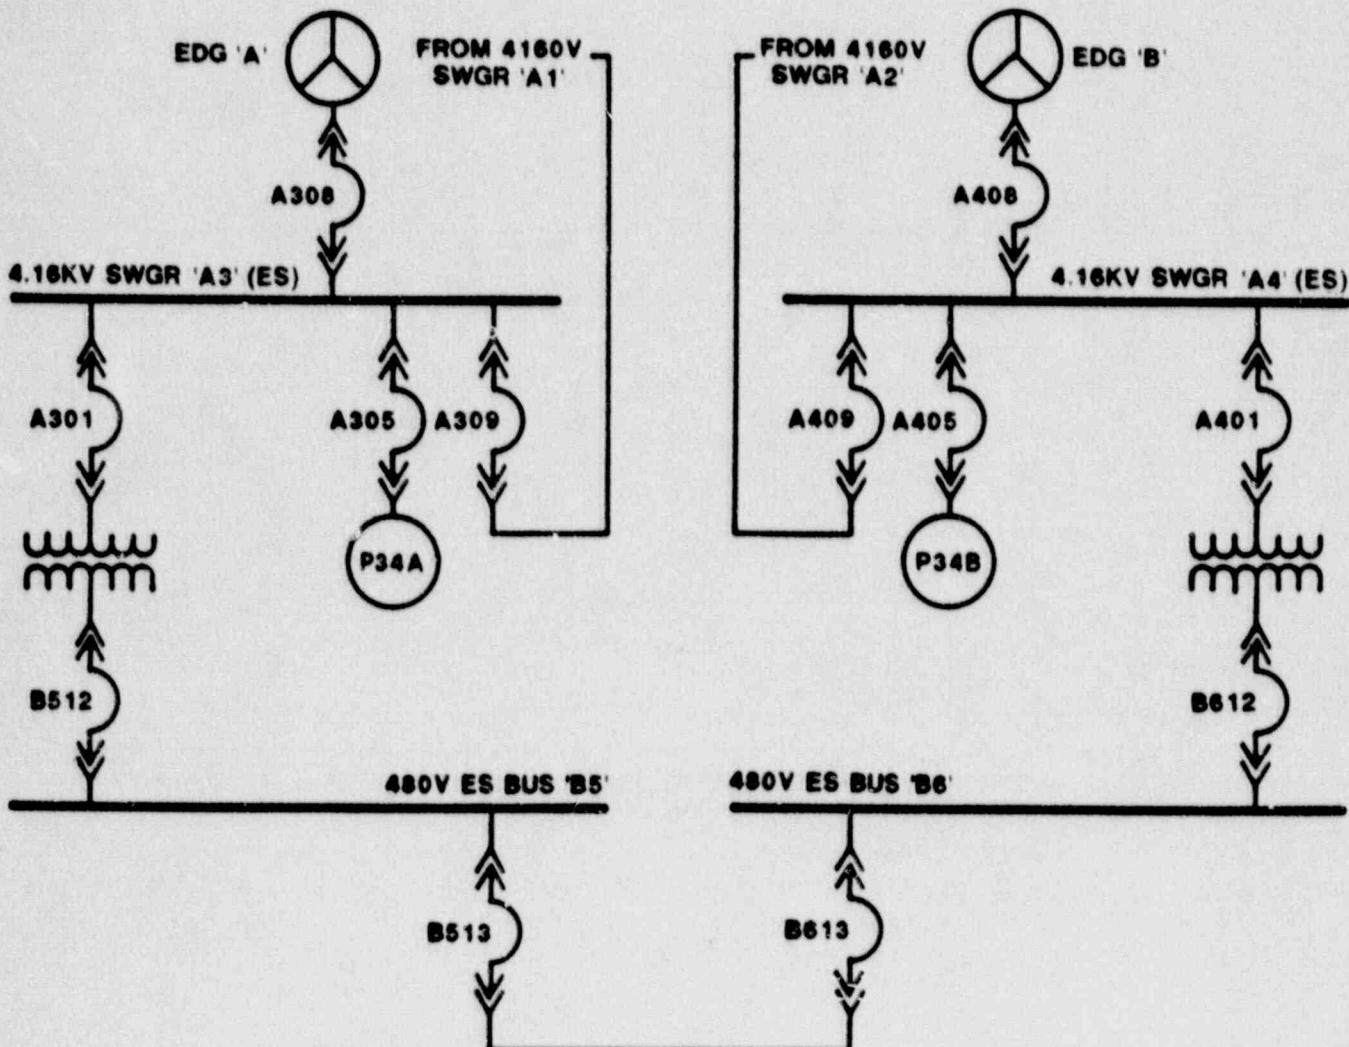
FIGURE 1

The electrical distribution lineup prior to this event was as follows (see Figure 1): 4.16KV switchgear A3 was being powered from switchgear A1 (supplied by offsite power) and 4.16KV switchgear A4 was being supplied by A2. 480V ES bus B5 was being supplied by A3 via circuit breakers A-301 and B-512. 480V ES bus B6 was crossconnected to B5 through circuit breakers B-513 and B-613. The feeder breakers from A4 to B6 (A-401, B-612) were open. The 'A' EDG was being run for surveillance testing and was tied to A3 and operating in parallel with the offsite power system. Decay Heat Removal [DHR] pump P-34A was in service.

SIMPLIFIED SCHEMATIC OF ES ELECTRICAL DISTRIBUTION SYSTEM
