WOLF CREEK

Subject: Docket No. 50-482: Special Report 89-003

Special Report 89-003

**Failures of Emergency Diesel Generator "B"
Due to Failure of a Temperature Control Valve
and a Generator Synchronizing Relay**

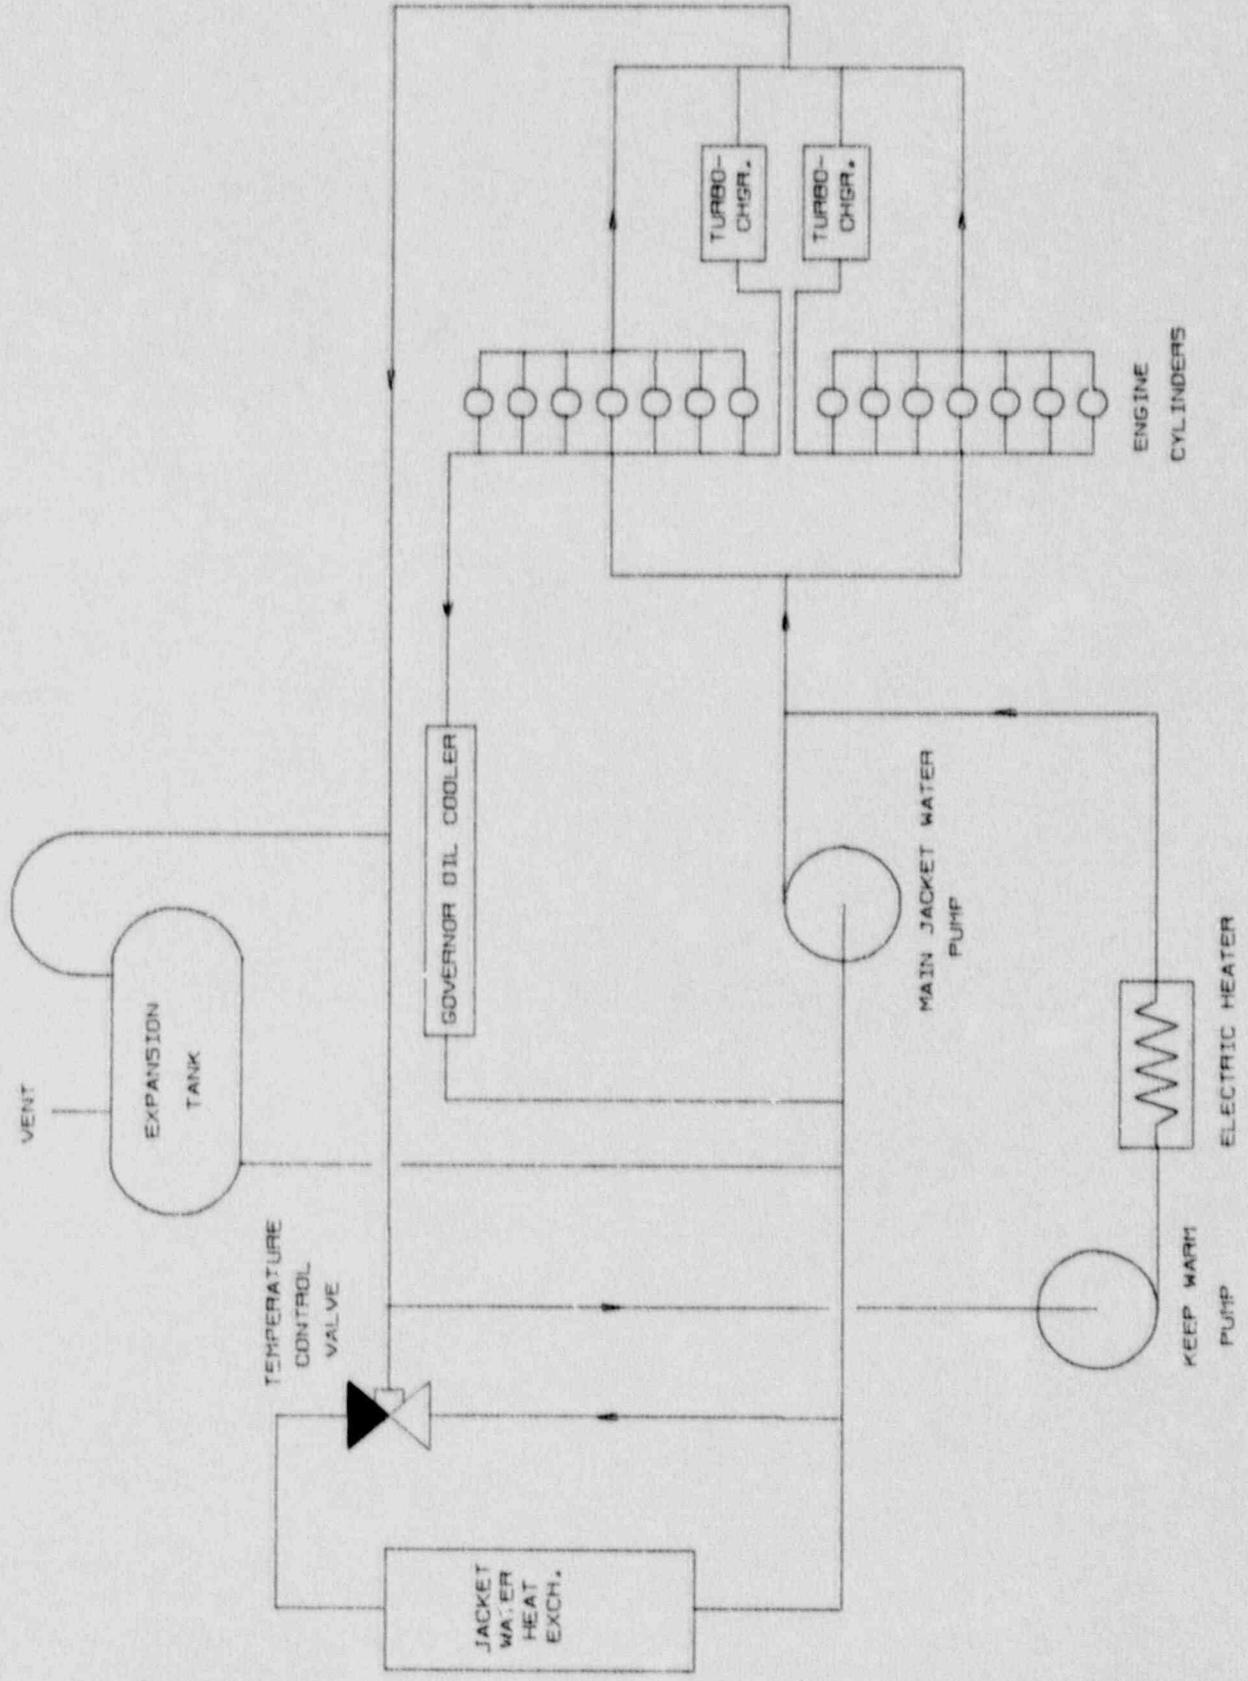
On December 9, 1989, with Emergency Diesel Generator "B" (D/G "B") in standby, the Turbine Building watch reported to the Control Room that the normally warm D/G governor oil cooler was cold, indicating that no jacket water was flowing through the oil cooler. Normally while in standby, a small "keep warm" pump circulates the D/G jacket water, which is heated with an electric heater, through the D/G jacket water lines to reduce engine wear and facilitate a quick startup of the D/G. Although the D/G governor does not need to be kept warm, the design of the jacket water system causes a small amount of the keep warm pump's flow to normally pass through the governor oil cooler (see Figure 1). With the governor oil cooler cold, it was decided at 0345 CST on December 9, 1989, to declare D/G "B" inoperable to allow Maintenance personnel to investigate. No blockage of the governor oil cooler or the supply line was found. It is believed that the lack of flow was caused by an air bubble in the supply lines. Several days earlier, on December 5, 1989, the jacket water system was partially drained in order to clean the interior of the jacket water expansion tank. This tank is periodically cleaned in order to remove any loose corrosion that may have developed in the upper portion of the tank. The upper portion of the tank is exposed to humid air and does not receive protection from the corrosion inhibitor which is present in the jacket water. Following cleaning of the tank, the jacket water system was refilled. In the past, several maintenance activities have taken place while the jacket water expansion tank was being cleaned and an operability test was required before placing the D/G back in service. On December 5, 1989, however, no other maintenance activities were performed, and therefore, the D/G was not run after filling of the jacket water system. As a result, any air bubbles that may have existed in the jacket water lines did not get flushed out to the expansion tank. Most of the air bubbles were likely flushed out with the start of the keep warm pump, however, some accumulated in the governor lube oil cooler line which is a low flow area and a high point in the system. This prevented the jacket water from circulating through the cooler while in standby. As previously stated, the governor is not required to be kept warm while in standby and the main jacket water pump would have immediately flushed out the air bubble upon D/G start to cool the governor oil cooler. Therefore, this event had no affect on the operability of the D/G.

Figure 1 - Diesel Generator Jacket Water System (simplified)
"Keep Warm" Flow Path
