U.S. NUCLEAR REGULATORY COMMISSION
REGION I

Report No. 70-687/89-05

Facility Name: Reactor and Hot Laboratory

Inspection Summary: Inspection on December 19, 1989 (Inspection Report Number
70-687/89-05)

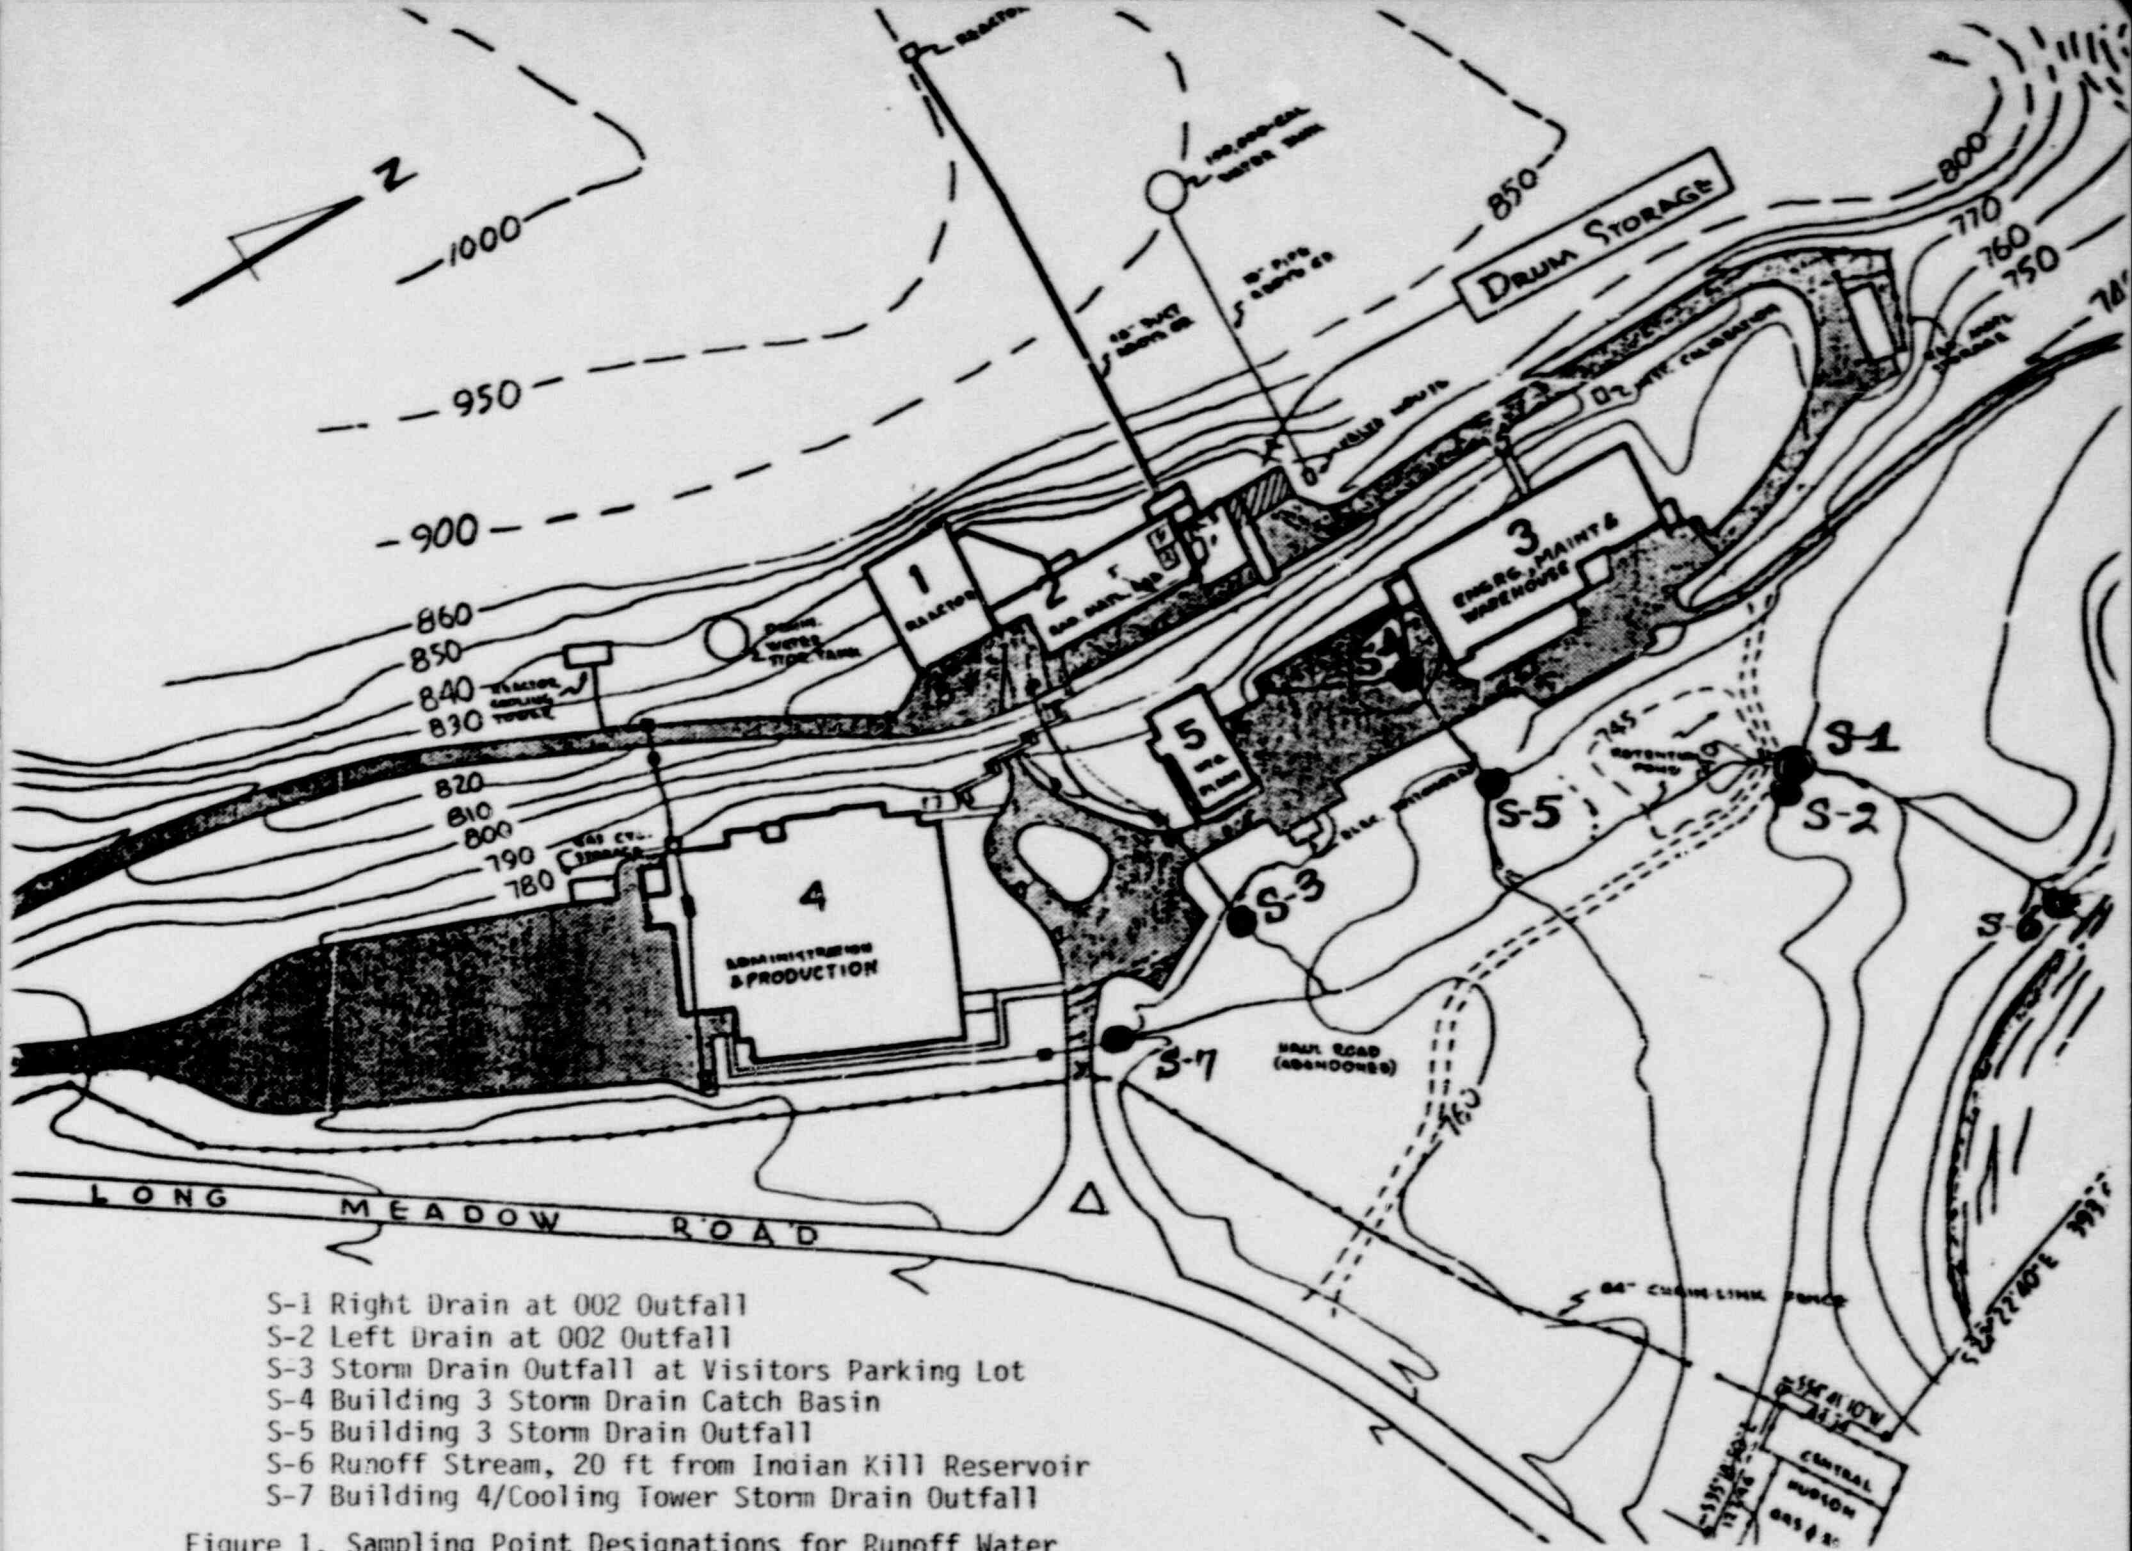
Figure 1. Sampling Point Designations for Runoff Water

During April 1989 the licensee identified a possible discharge of slightly contaminated water through a storm drain located in the onsite parking lot (See Figure 1 for detail of sampling points). This storm drain is used to catch the runoff from (1) the parking lot, (2) Building 3 (Engineering and Maintenance Warehouse), and (3) possibly from the hot laboratory building (Building 2) area, including the roof of the building. Water collected in the storm drain discharges into a retention pond (sampling point S-5) and then flows to the Indian Kill Reservoir. The licensee identified elevated radioiodine (I-131) levels in water in the same storm drain in the parking lot (sampling point S-4) on November 28, 1989 through the routine monthly environmental surveillance program. The November 28 measurement of I-131

The licensee also measured a wet sediment sample collected from the storm drain discharge point (S-5) on December 12, 1989. The analytical result for I-131 was approximately $1.0E-6$ uCi/ml. The licensee determined that the contamination from the storm drain discharge to the retention pond was limited to an area within a 10-foot radius from the end of the discharge pipe.

The licensee also measured water samples collected from the retention pond outfall (002 Outfall, Sampling Point S-1) and the analytical results for I-131 were less than $1.0E-8$ uCi/ml. Water samples collected from the storm drain outfall at the visitors parking lot (Sampling Point S-3) indicated background levels for I-131.
