SUBJECT: AUDIT OF ACTIONS RELATING TO NRC BULLETIN 38-09, "THIMBLE
TUBE THINNING IN WESTINGHOUSE REACTORS," FOR JOSEPH M. FARLEY
NUCLEAR PLANT, UNITS 1 AND 2, (TAC NOS. 72659 AND 72660)

AUDIT TRIP REPORT

PURPOSE: Audit of Joseph M. Farley Units 1 & 2 on Bulletin 88-09 Issues (BMI Thimble Tube Wear)

LOCATION: Joseph M. Farley Nuclear Plant, Dothan, Ala.

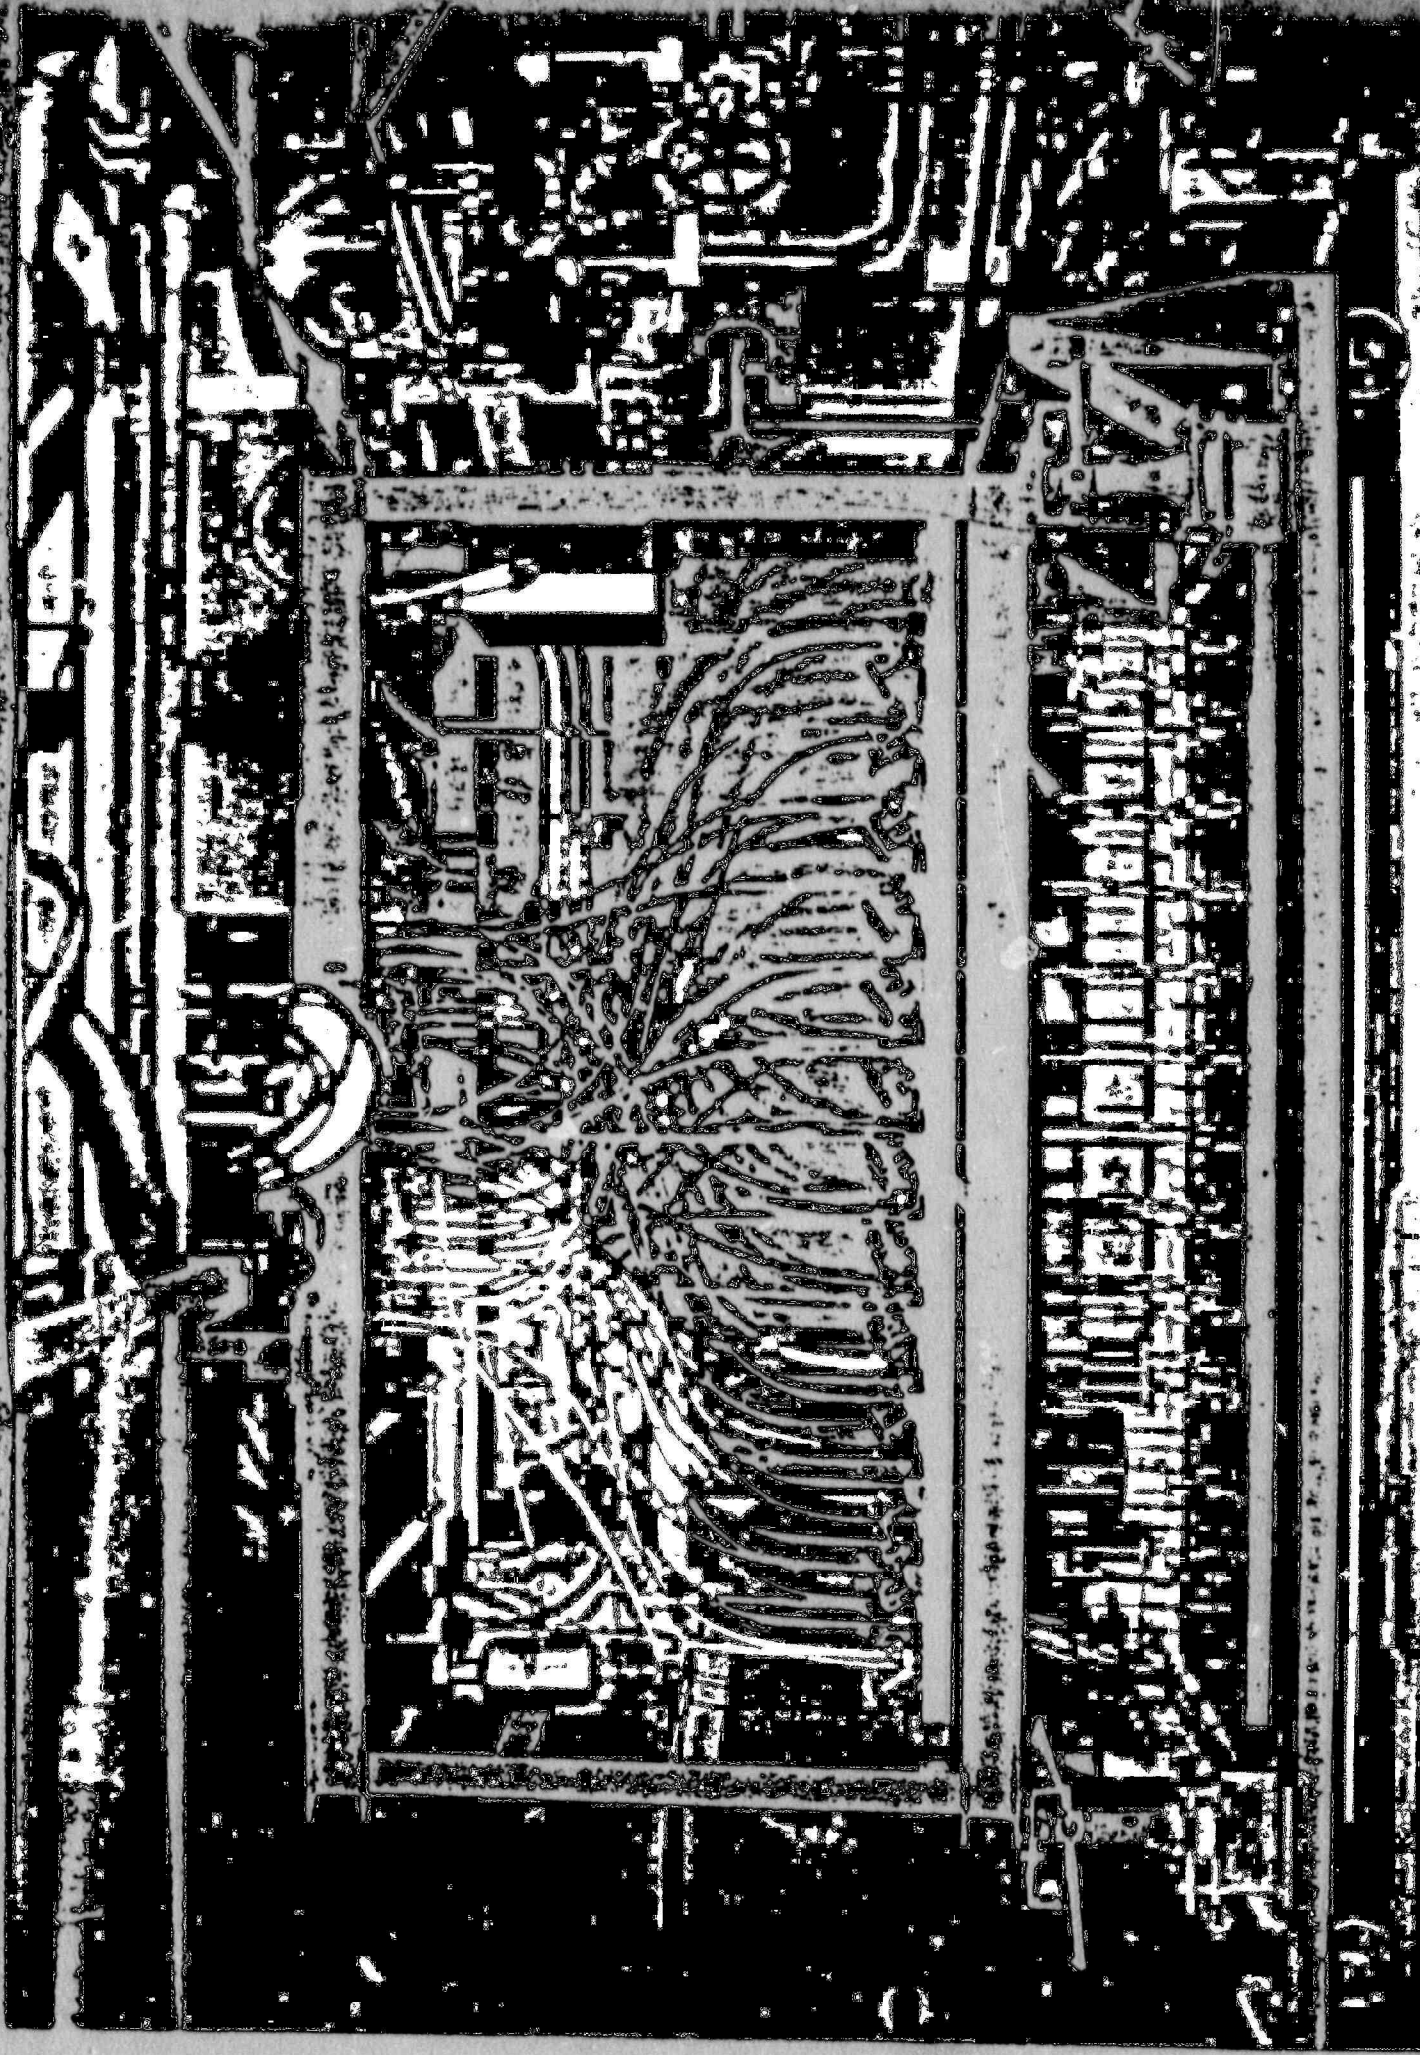
The Licensee provided a set of photographs of the seal table (see Attachment 4). The photographs show the BMI transfer cart which is a frame structure that supports the isolation valves and 10 path transfer devices. During refueling, the thimble tubes must be withdrawn. This is accomplished by disconnecting the tube coupling at the seal table, jacking up the upper portion of the transfer cart and rolling the entire assembly to the side to provide vertical clearance for tube withdrawal (see photograph). When the transfer cart is in the normal operating position, the upper part of the cart is bolted to supports at each end. However, it was not clear that the lower part of the cart was restrained. A concern was raised that during an earthquake the cart could roll and sever the thimble tubes. The Licensee could not explain how the lower portion of the cart is restrained but agreed to provide additional information (see Section 3.4).

- Photo # 1 - Seal Table with BMI Transfer cart in normal operating position.
- Photo # 2 - Seal Table with BMI transfer cart rolled to side and thimble tubes withdrawn.

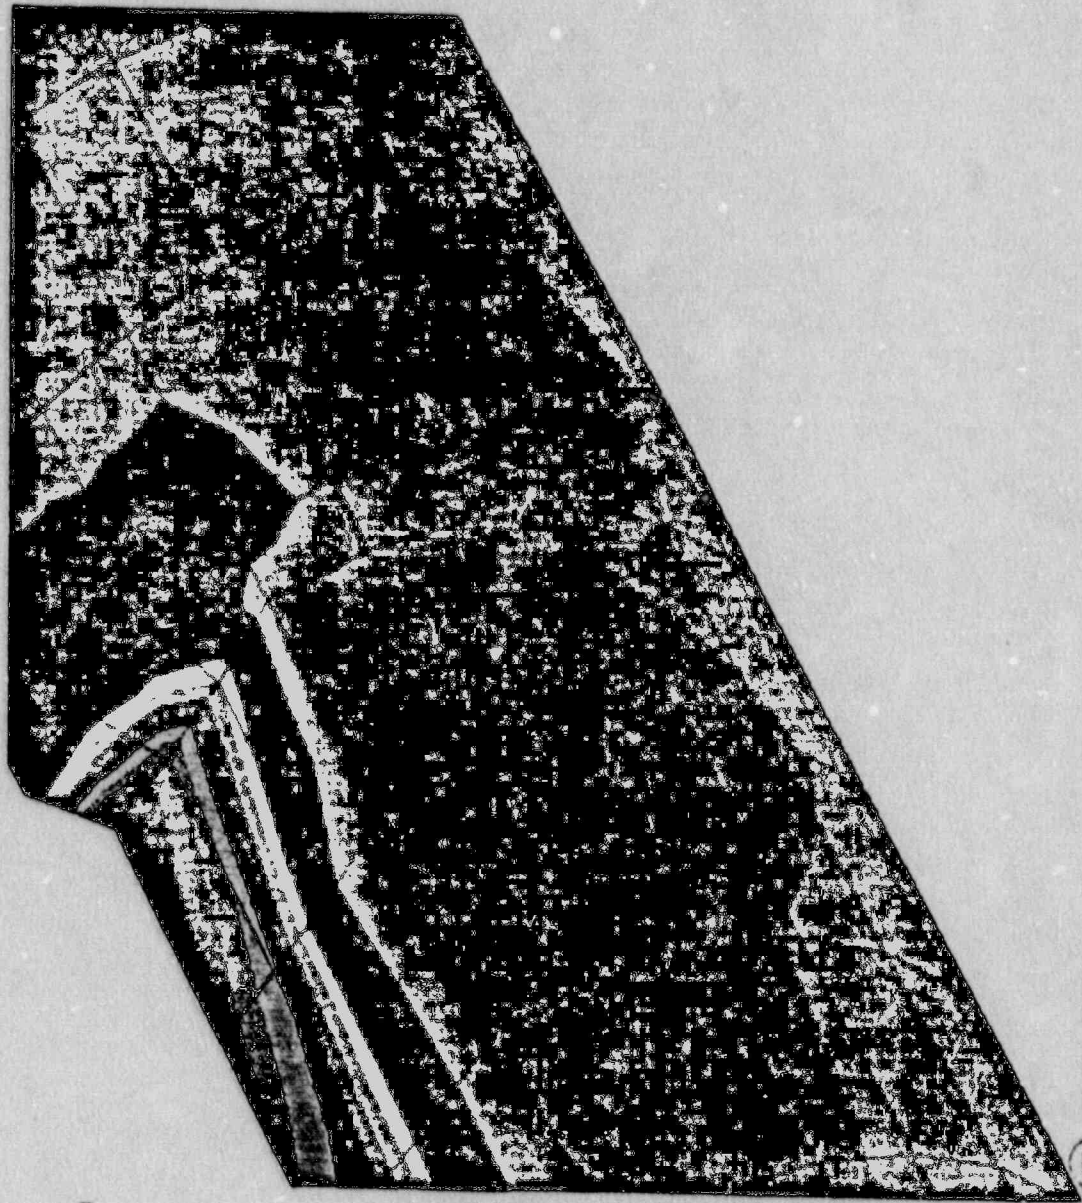
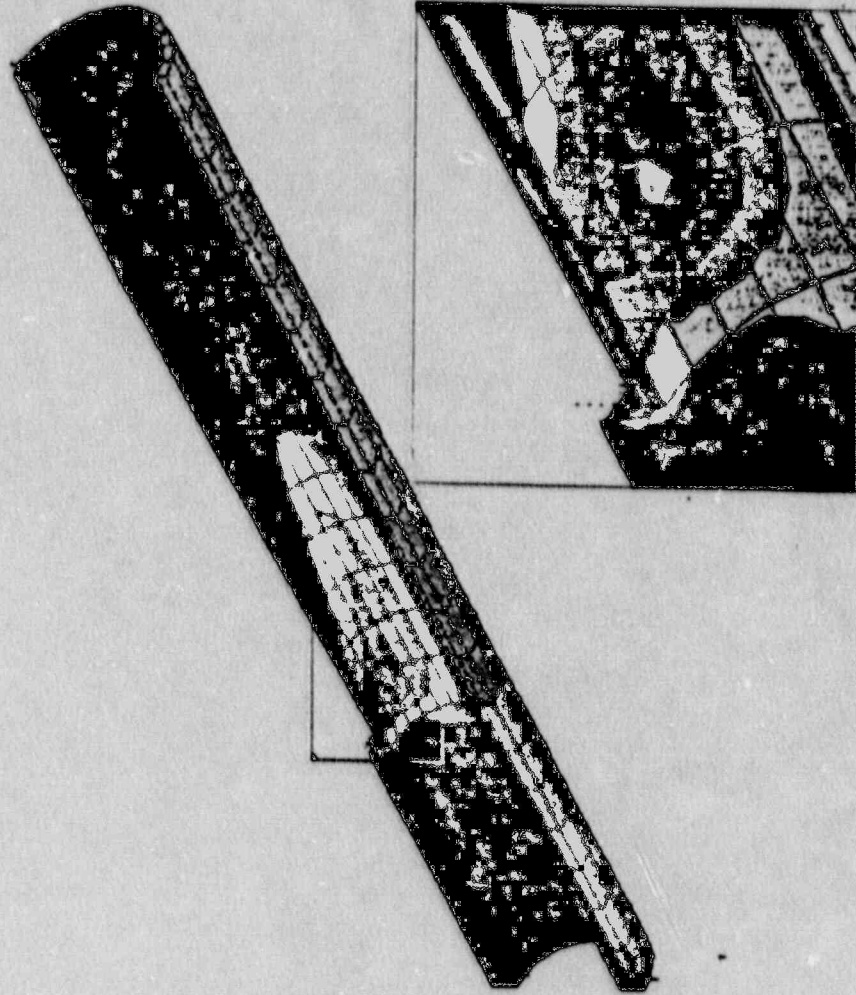
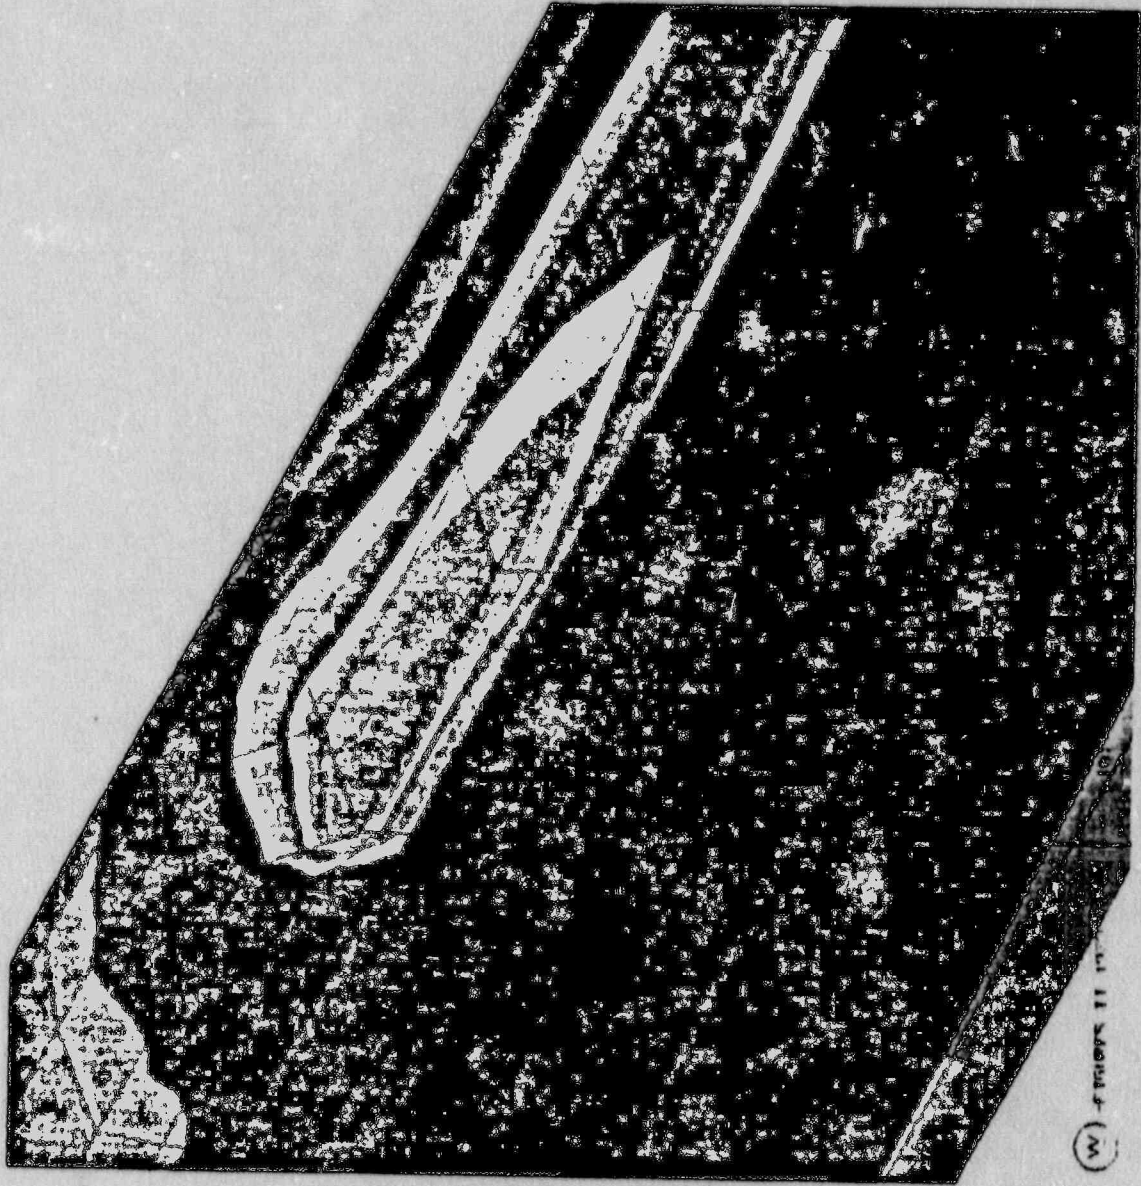
As a follow-up to conversations between Primary Component Engineering personnel and the ALA customer we have completed, and are hereby documenting the evaluation of the Echoram wear scar with the "check-mark" configuration. The results for the "check-marked" configuration indicate a maximum stress intensity of 22,109 psi which is less than the previously report value of 23,318 psi.

This analysis was based on wear scars identified in Echoram drawing WS-A-007-89, and can be described as a 90° wear scar, with 65% wall loss, and a length of 0.97 inches.
