Connecticut Yankee Atomic Power Company

Haddam Neck Plant

1989 Refueling Outage

Steam Generator Tube Inspection Report

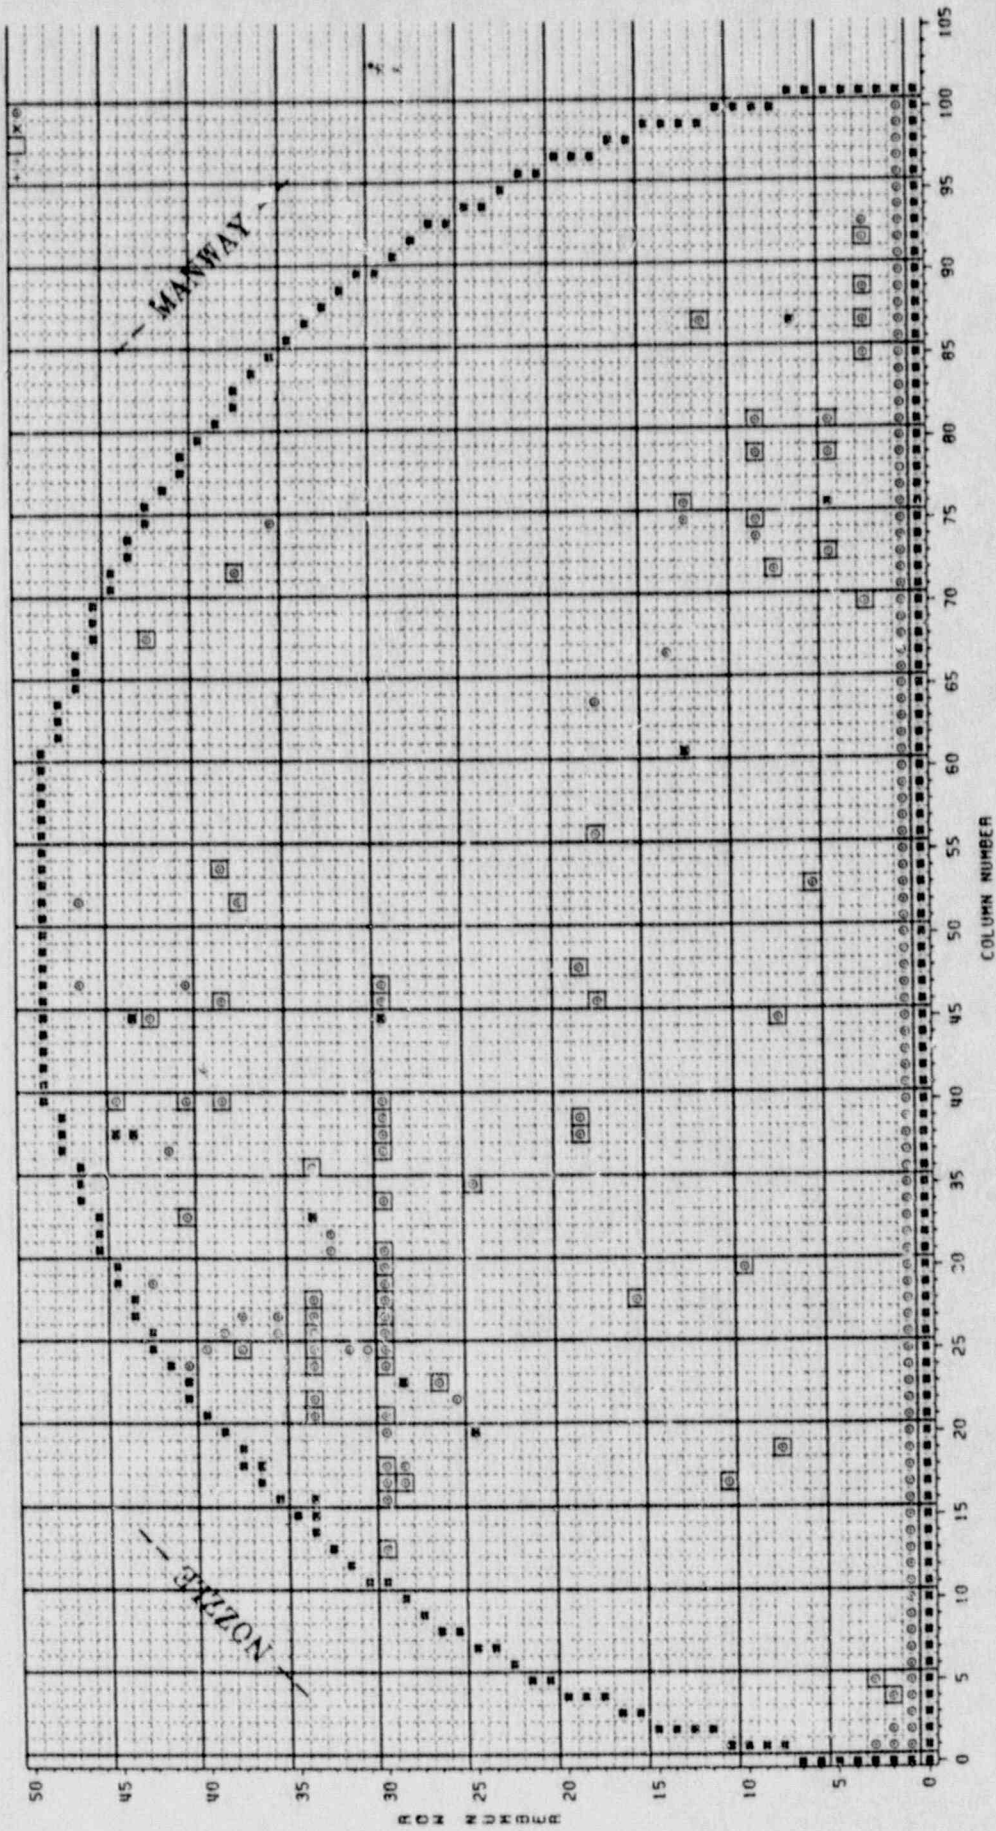
Figure 1

Location of all Plugged Tubes and Popped Plugs
For Connecticut Yankee Steam Generator #1

Connecticut Yankee installed plug repair inserts, designated as PAPs, in all hot leg mechanical plugs produced from Heat# 3513 (587 PAPs installed). Figures 1, 2, 3, and 4 show locations of PAPs installed to date.

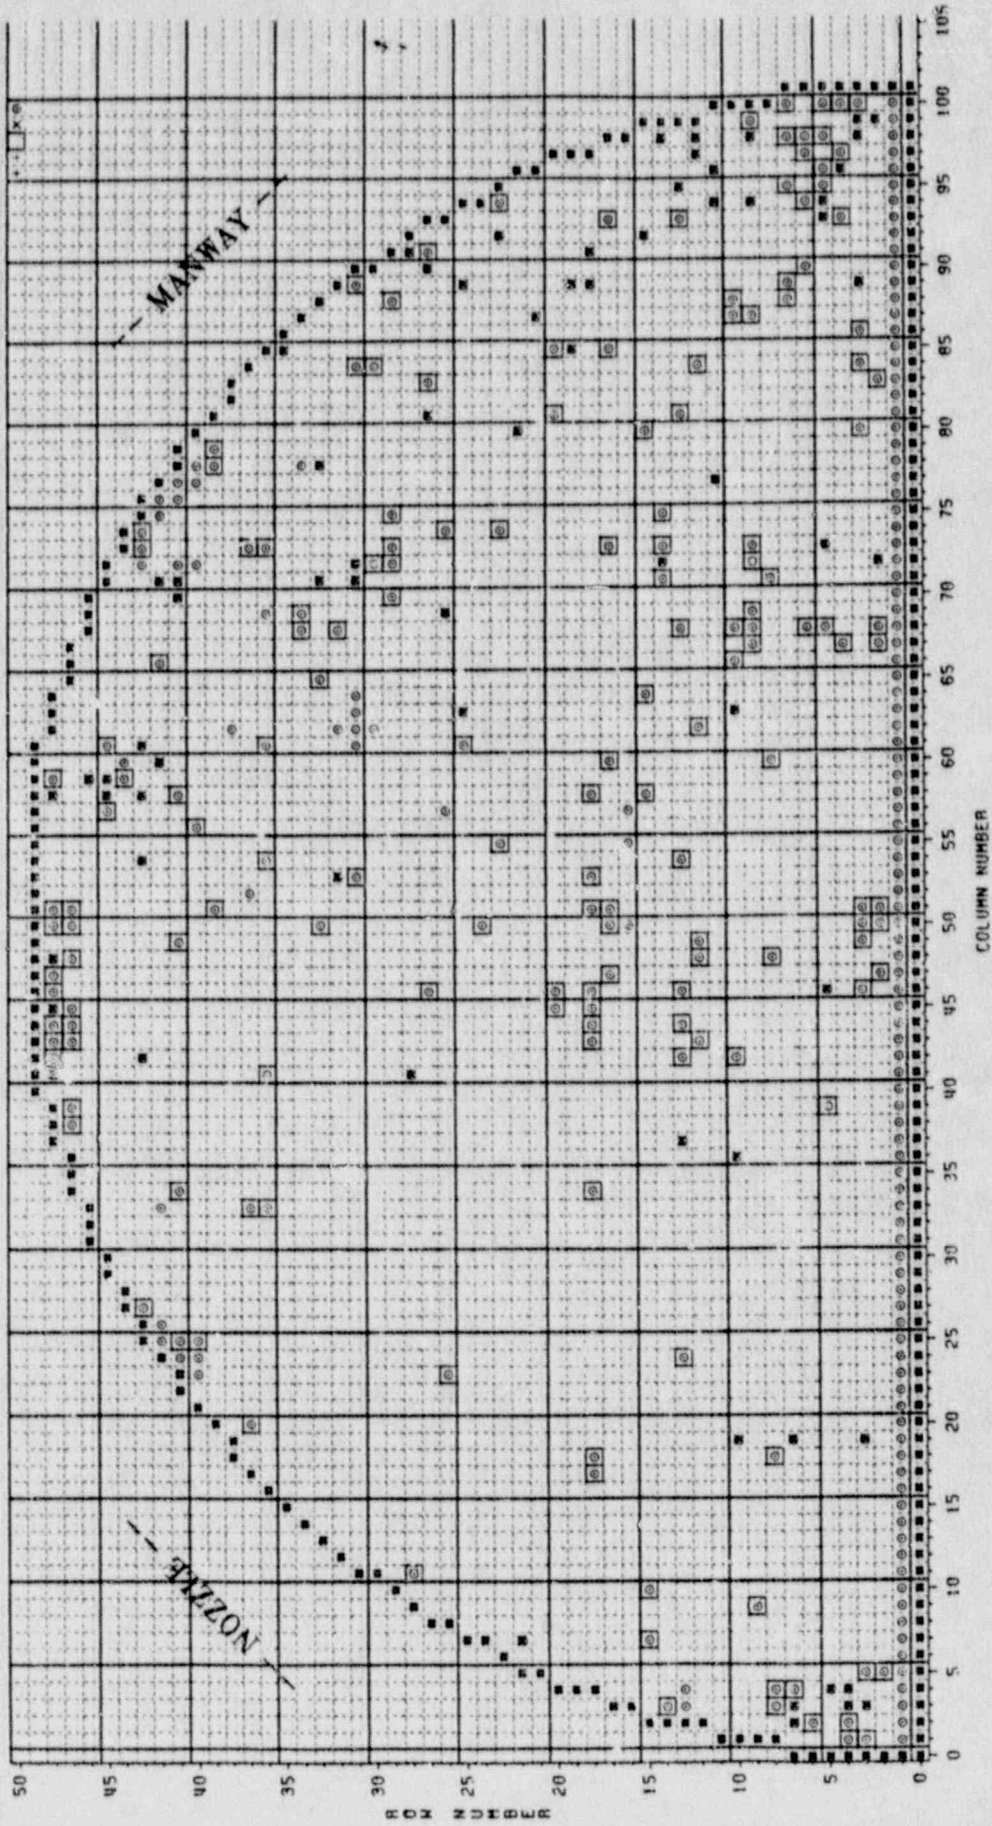
Figure 2

Location of all Plugged Tubes and Papped Plugs
For Connecticut Yankee Steam Generator #2

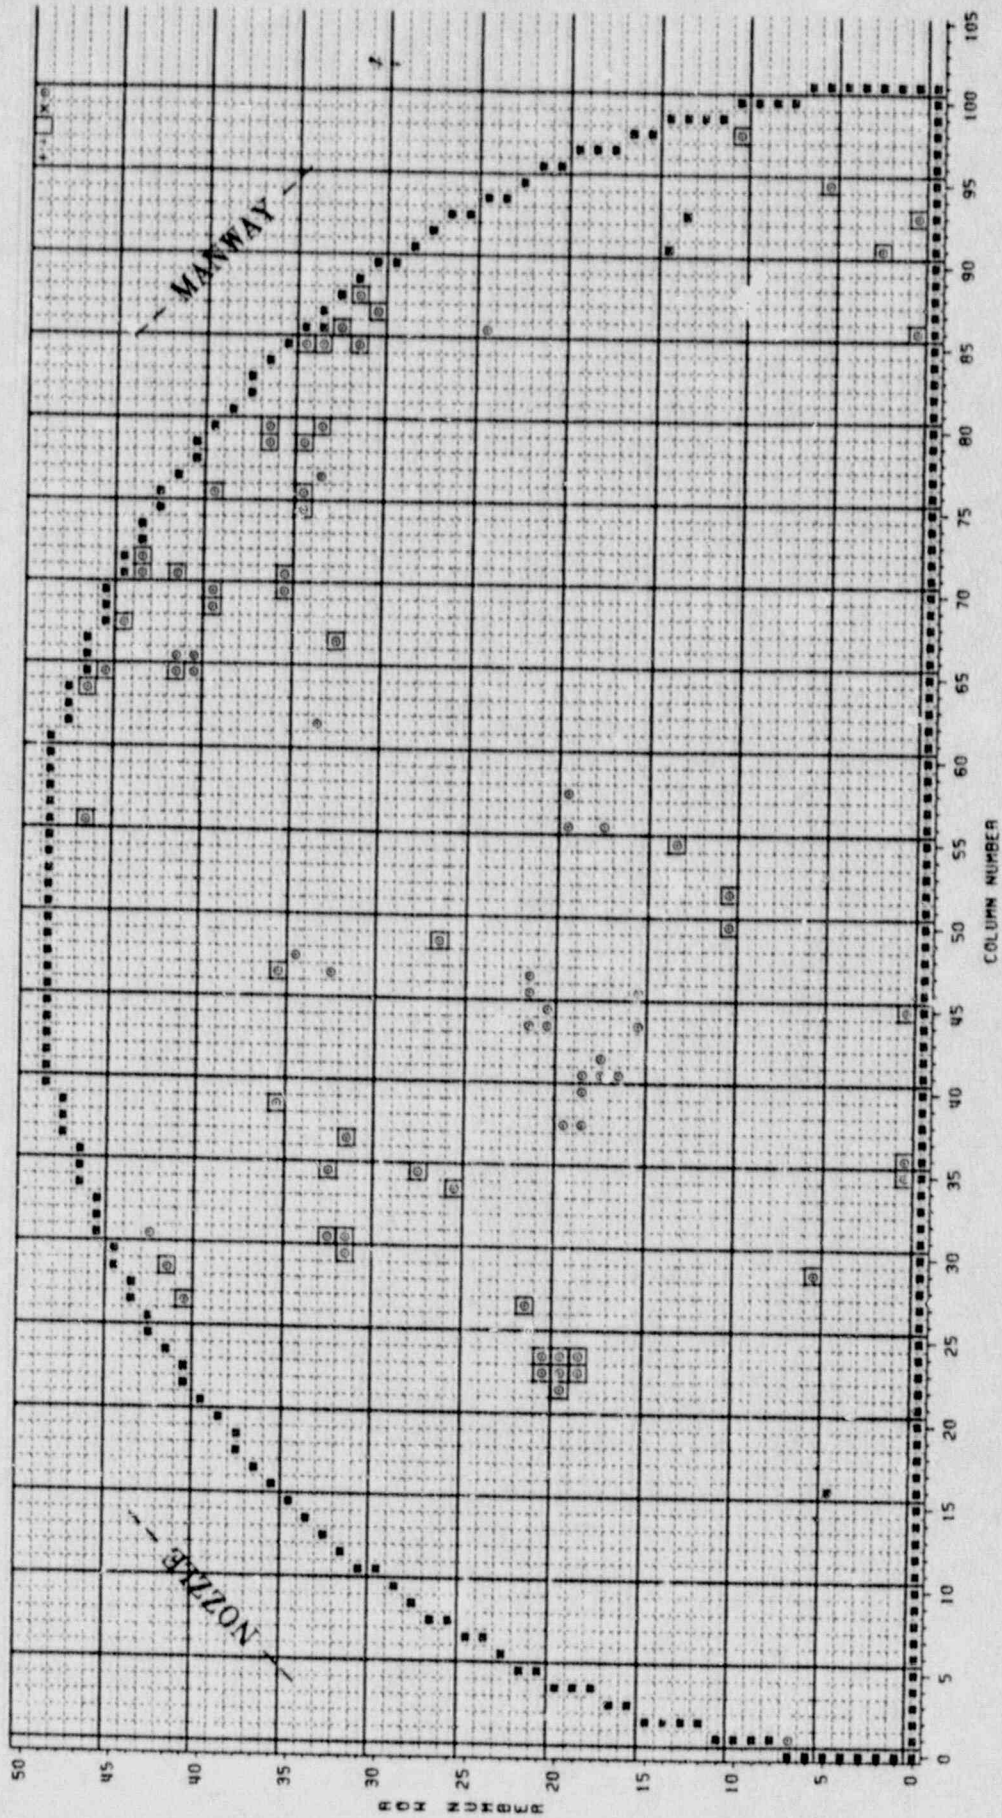
Figure 3

Location of all Plugged Tubes and Papped Plugs
For Connecticut Yankee Steam Generator #3

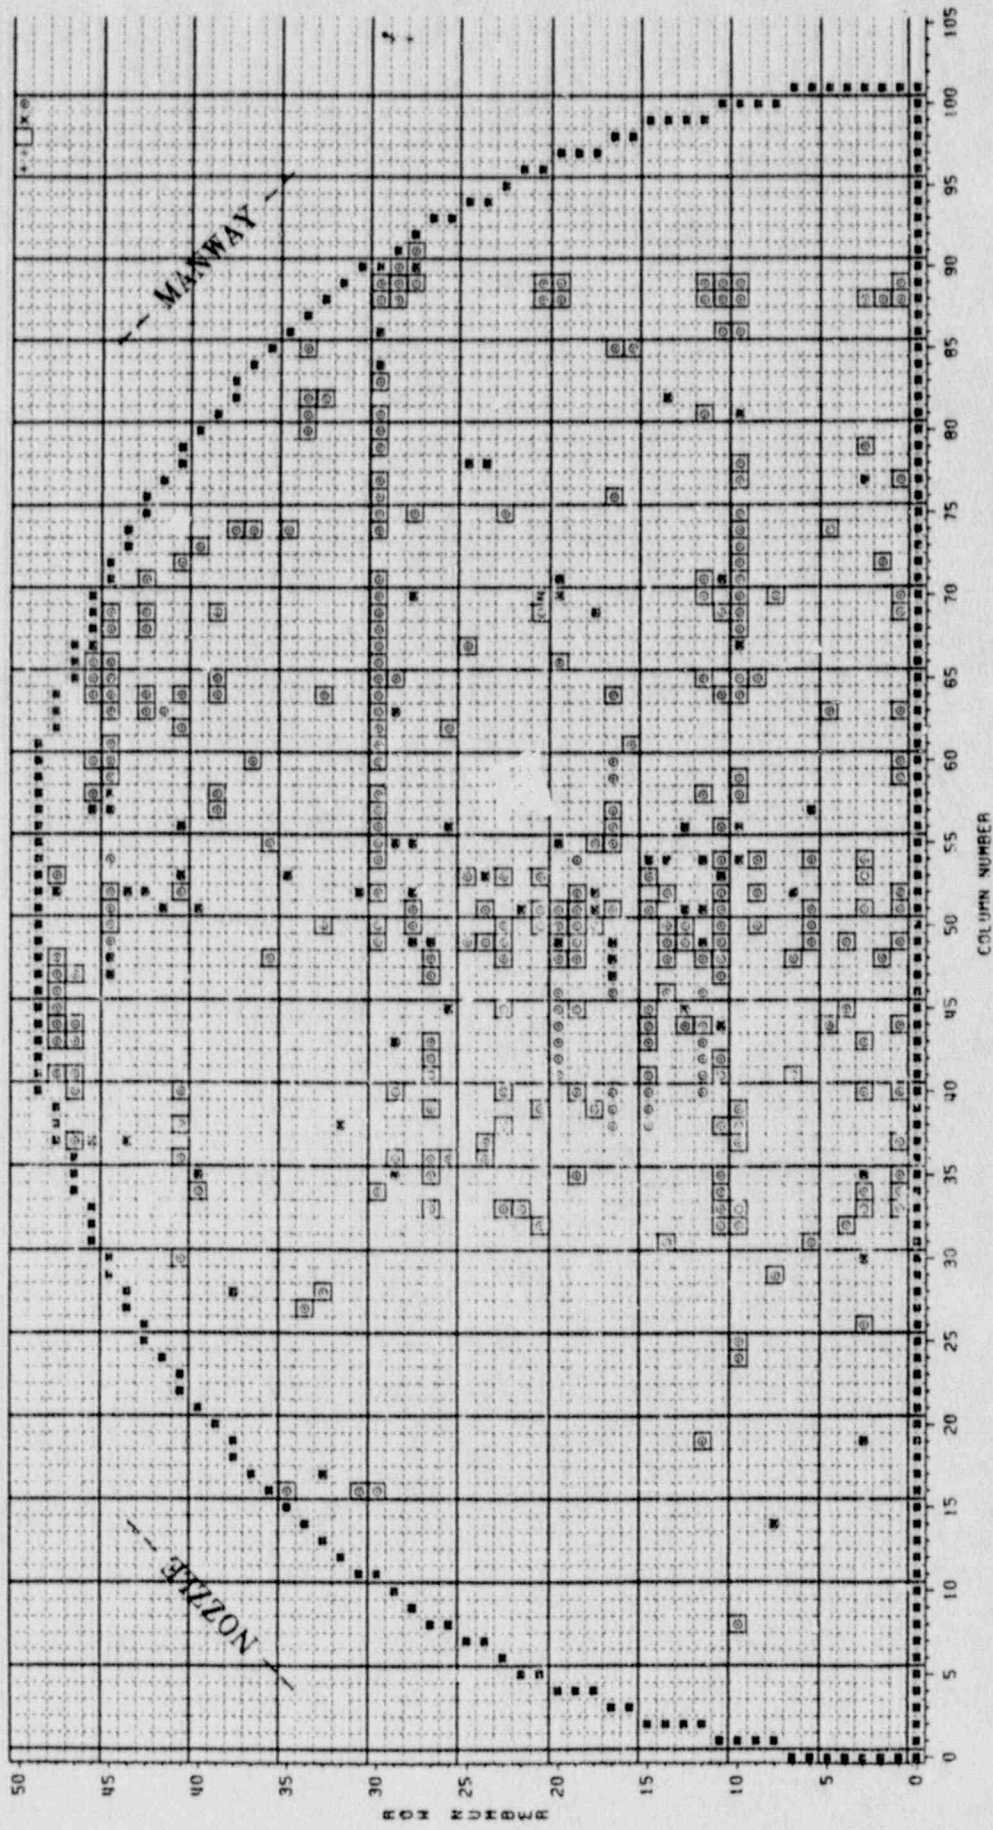
Figure 4

Location of all Plugged Tubes and Papped Plugs
For Connecticut Yankee Steam Generator #4
