U.S. NUCLEAR REGULATORY COMMISSION

Reports No. 50-266/89033(DRP); 50-301/89033(DRP)

Facility Name: Point Beach Unit 1 and 2

Areas Inspected: Special, unannounced inspection by resident inspectors of issues relating to the inadequate original design of the facility's DC electrical distribution system and the licensee's corrective actions.

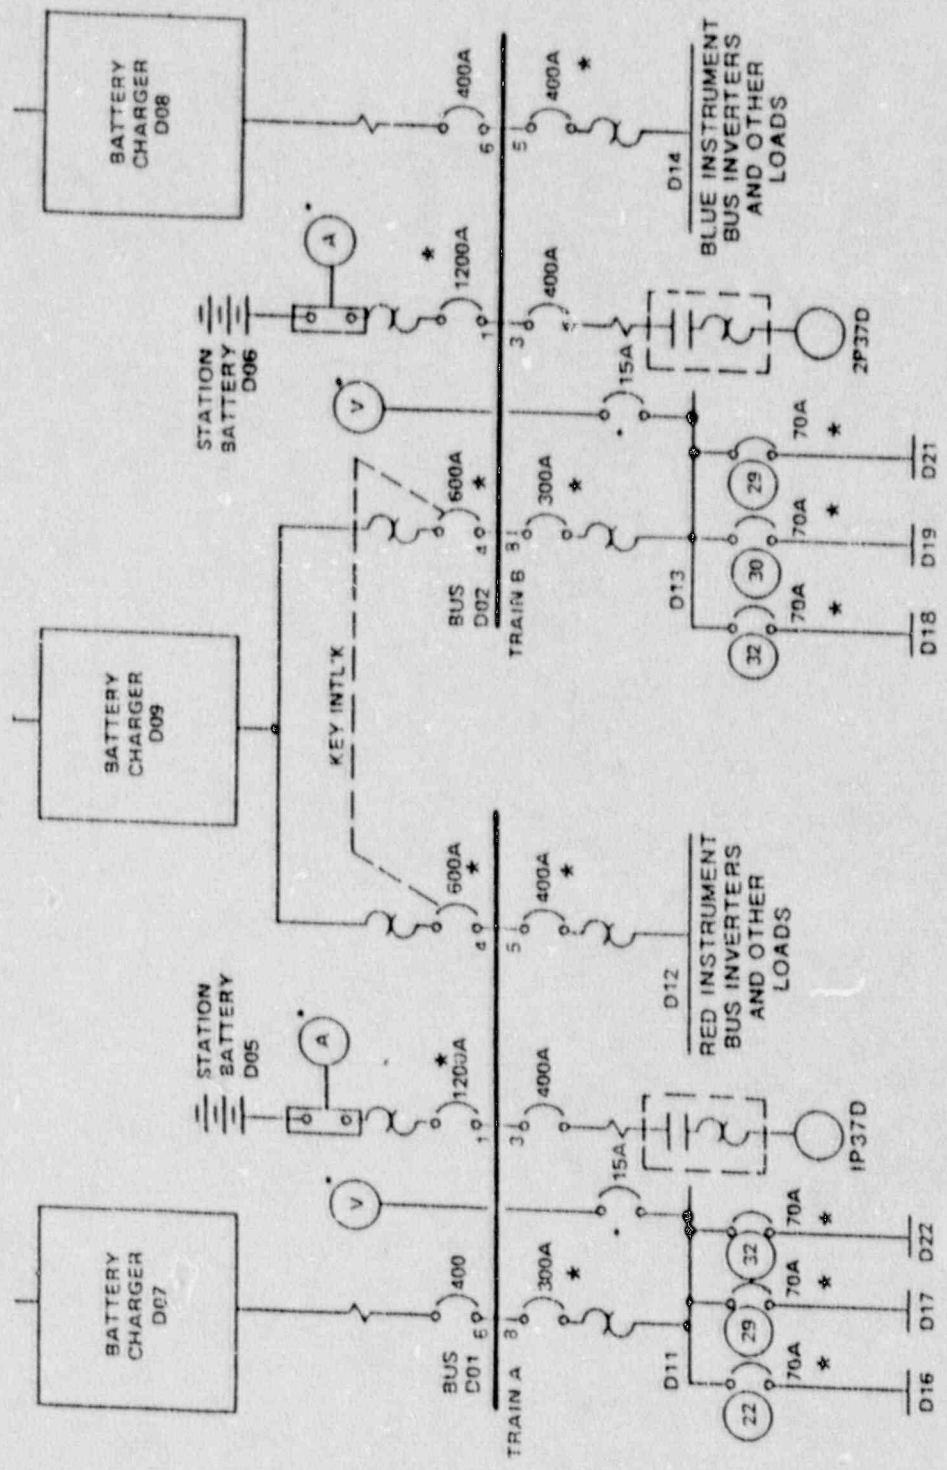
DC ELECTRICAL DISTRIBUTION SYSTEM

The original facility design utilized thermal-only trip breakers on the lines connecting the main DC busses (D01 and D02) to the DC distribution panels (D11, D12, D13, and D14); to the batteries (D05 and D06); and to the common battery charger (D09). The remaining lines to the independent battery chargers (D07 and D08) and to the turbine emergency lube oil pumps (1P37D and 2P37D) were equipped with breakers having thermal and magnetic tripping capabilities. These conditions are still present at the facility.

Two of the DC distribution panels (D11 and D13) have 32 breakers on each panel. Of the 32 breakers on each panel, 30 were equipped with thermal-only trip capability. The other two breakers on panels D11 and D13 and all the breakers on panels D12 and D14 were equipped with breakers having both thermal and magnetic tripping capabilities.

Further analysis by the licensee's engineering group identified the possibility of generating a fault current on a nonsafety load commonly supplied by distribution panels D11 and D13 in excess of the tripping capability of the thermal-only breakers. A fault on one of these non-safety related circuits could result in currents which would not be interrupted by any of the breakers in the DC system. This could result in the fault current being sustained until one of the components in the DC system catastrophically fails or until both batteries supplying the system are discharged to a point where they can no longer provide sufficient energy for their safety-related functions.

Breakers for unit 1 nonsafety-related loads on station battery D05 were replaced with breakers equipped with thermal and magnetic tripping capabilities returning D05 to an operable condition.

Further actions were taken to replace breakers for unit 2 nonsafety-related loads with breakers equipped with thermal and magnetic tripping capabilities. This allowed the reconnection of these loads to the DC busses and permitted the restart of unit 2.
