Pathfinder Atomic Power Plant

REPORT TO UNITED STATES ATOMIC ENERGY COMMISSION

SIX-MONTH OPERATING REPORT NO. 4

NOV. 19, 1967 TO MAY 19, 1968

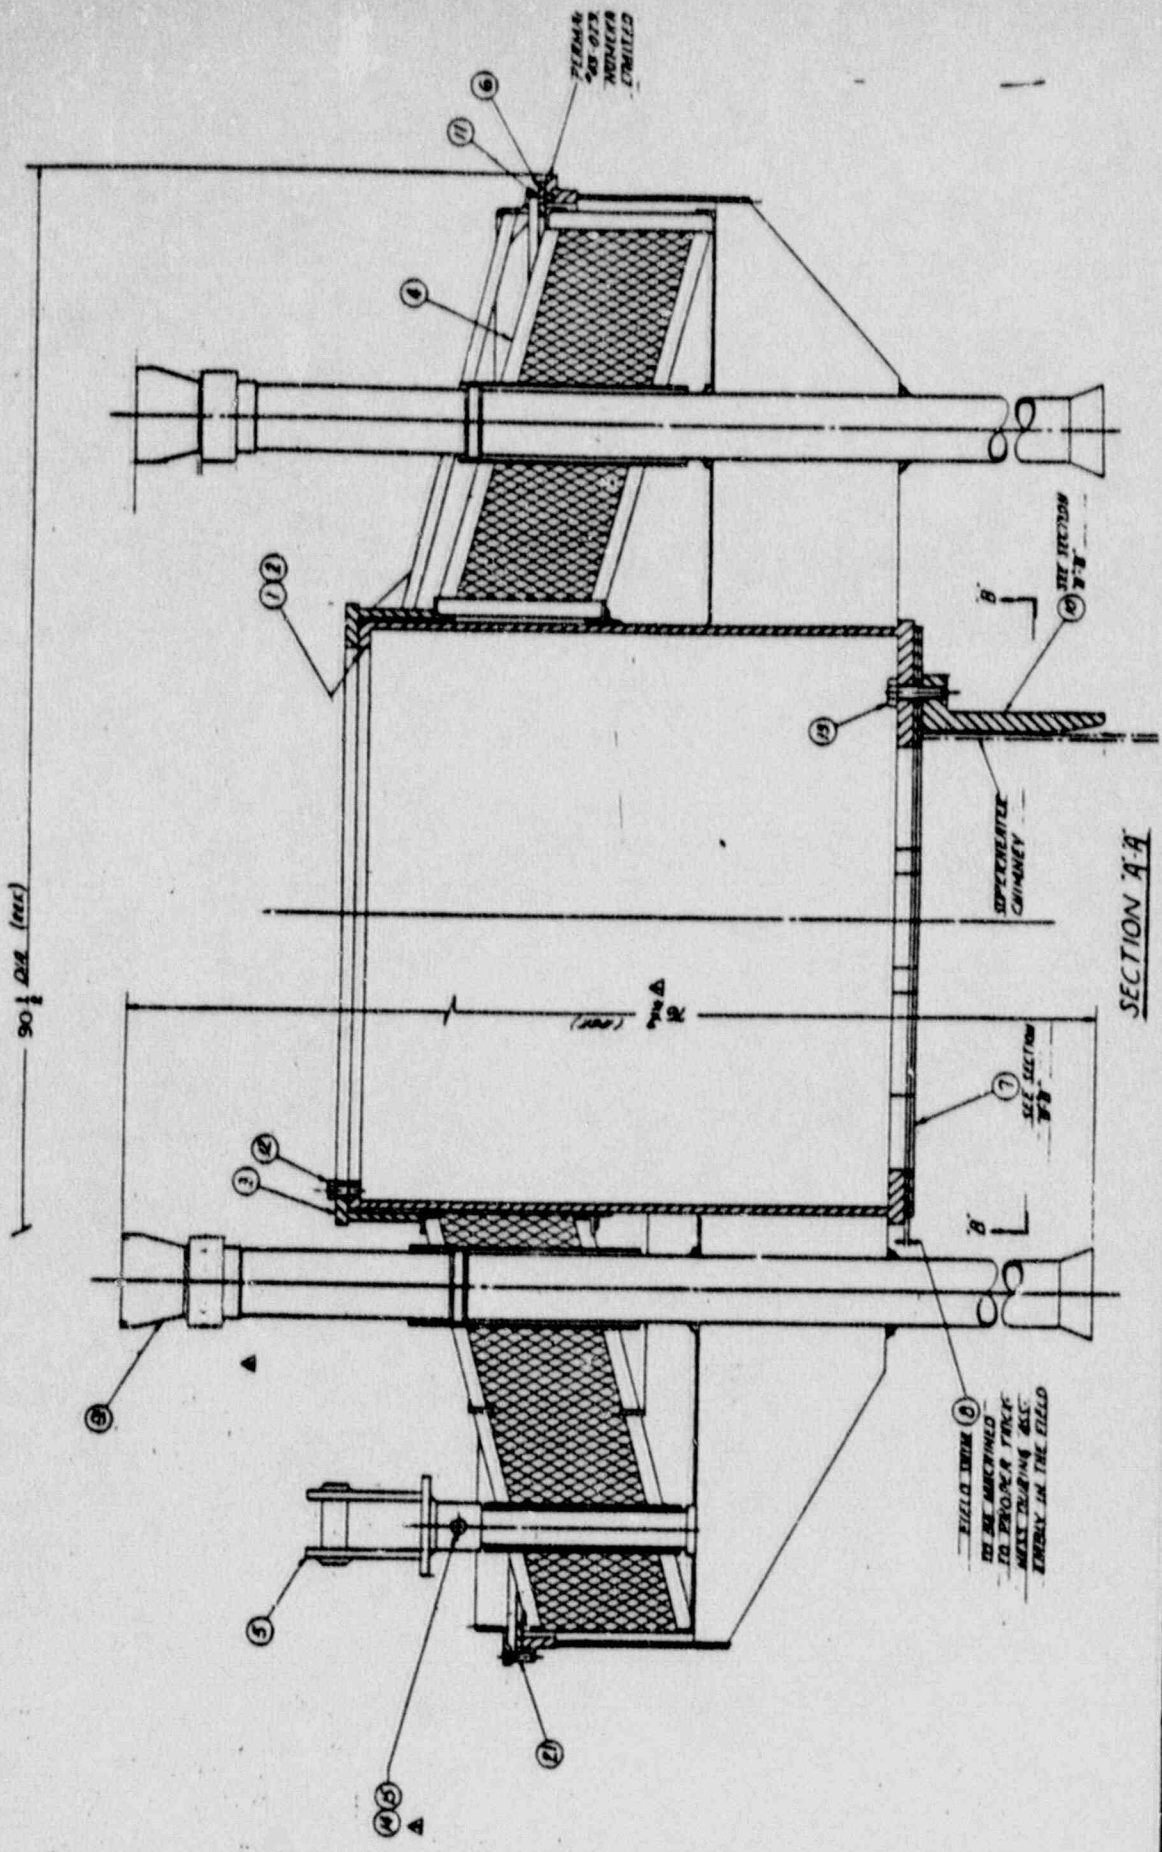
FIGURE 1

A general inspection was made with the steam dryer removed from the shield pool. With the exception of guide tube wear, the steam dryer assembly was in good condition. Measurements were taken to determine the amount of metal loss from the collar sections of the guide tubes. Seven tubes were found to have measureable metal loss in at least one quadrant with the remaining tubes showing evidence of rubbing in one or more quadrants. See Table 1, page 23. The design thickness of the collar sections is 5/32 inch. The most severe wear is in the east quadrant of the No. 10 tube collar with a groove 1/2 inch wide, 3/4 inch long, and 0.070 inch deep. This groove represents approximately 45% metal loss in the collar section. Rub marks were also noted on the inside surface of the tubes. These marks extend varying distances up from the bottom of the tubes and show no evidence of metal loss. Slight rubbing of the control rod drive latch head with the guide tubes is the apparent cause of these marks.

The alignment of the guide tubes with the dryer structure was suspected as a possible cause of the evidenced wear. Positioning plates were fabricated to facilitate an alignment check of the tubes. A top plate was turned to fit the inside diameter of the top reducer and a hole

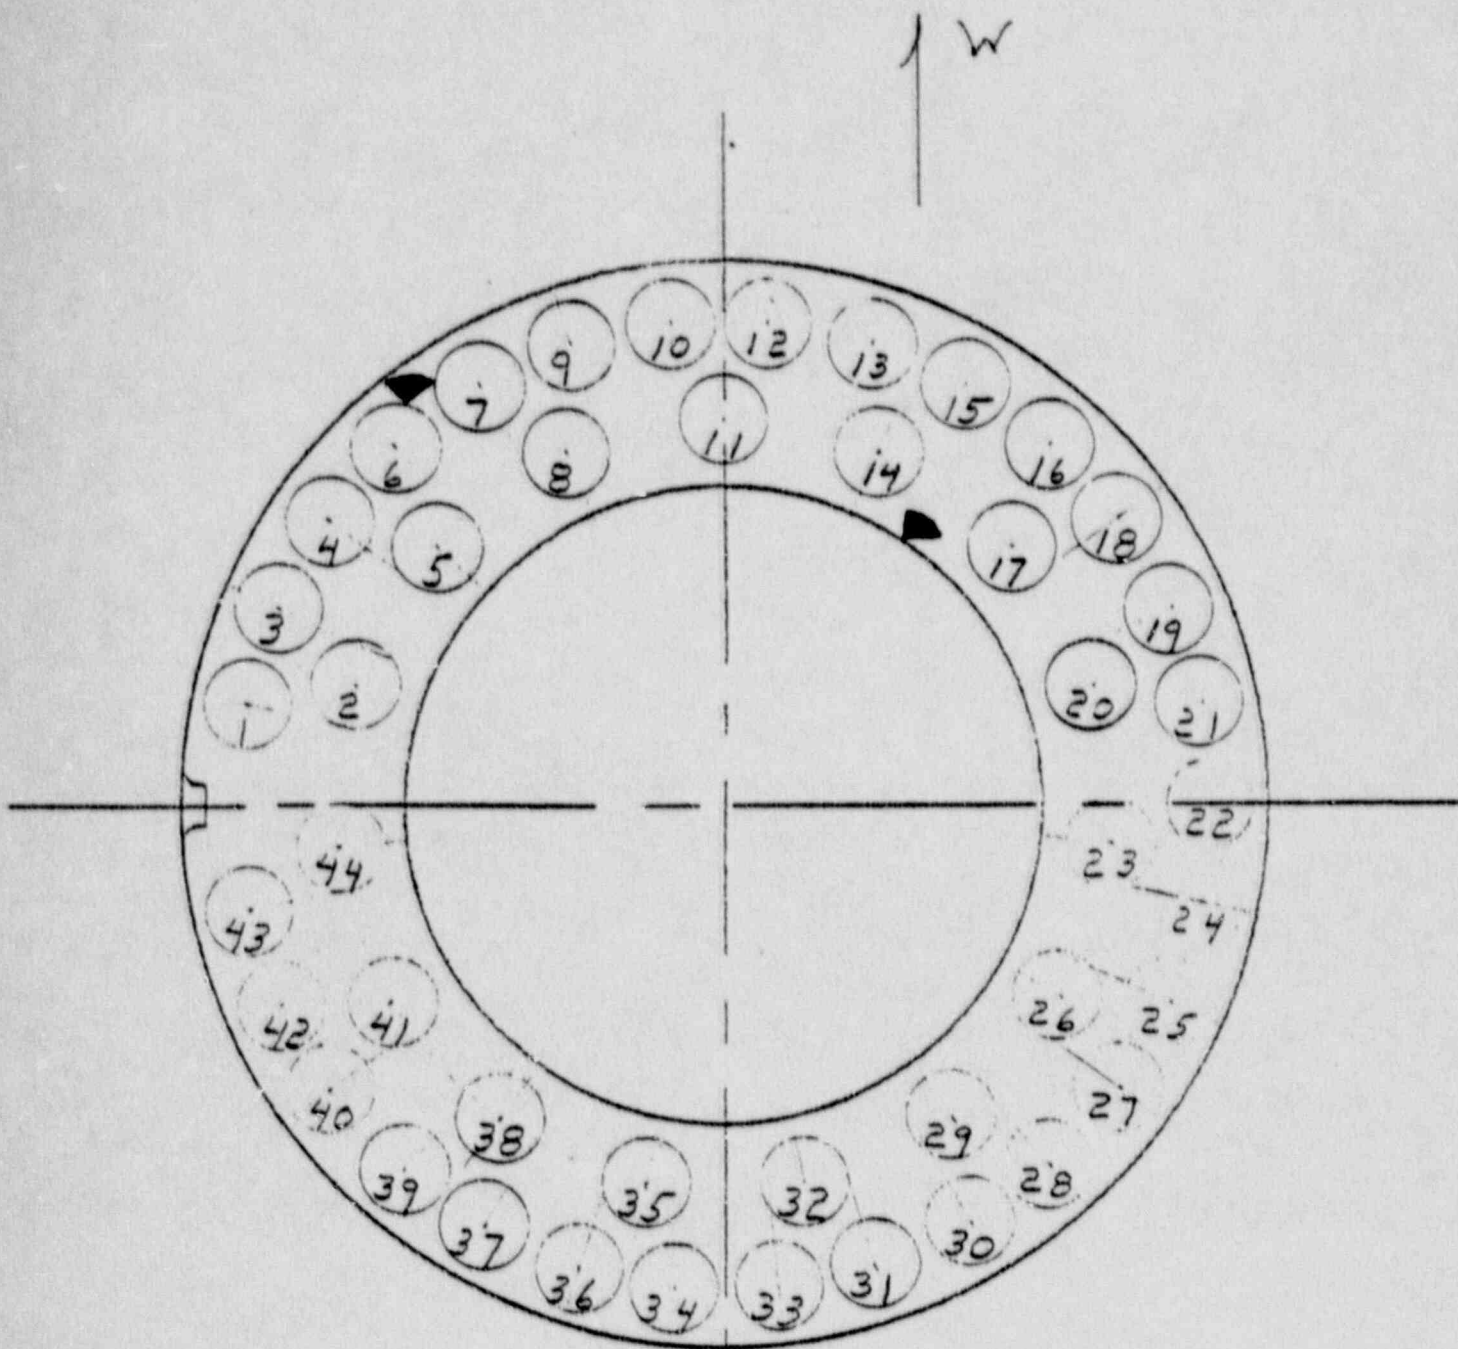
FIGURE I

LOCATION OF THE TRIANGULAR SHAPED PIECES
FROM THE LOWER BAFFLE FOUND
ON THE SEPARATOR SHELF

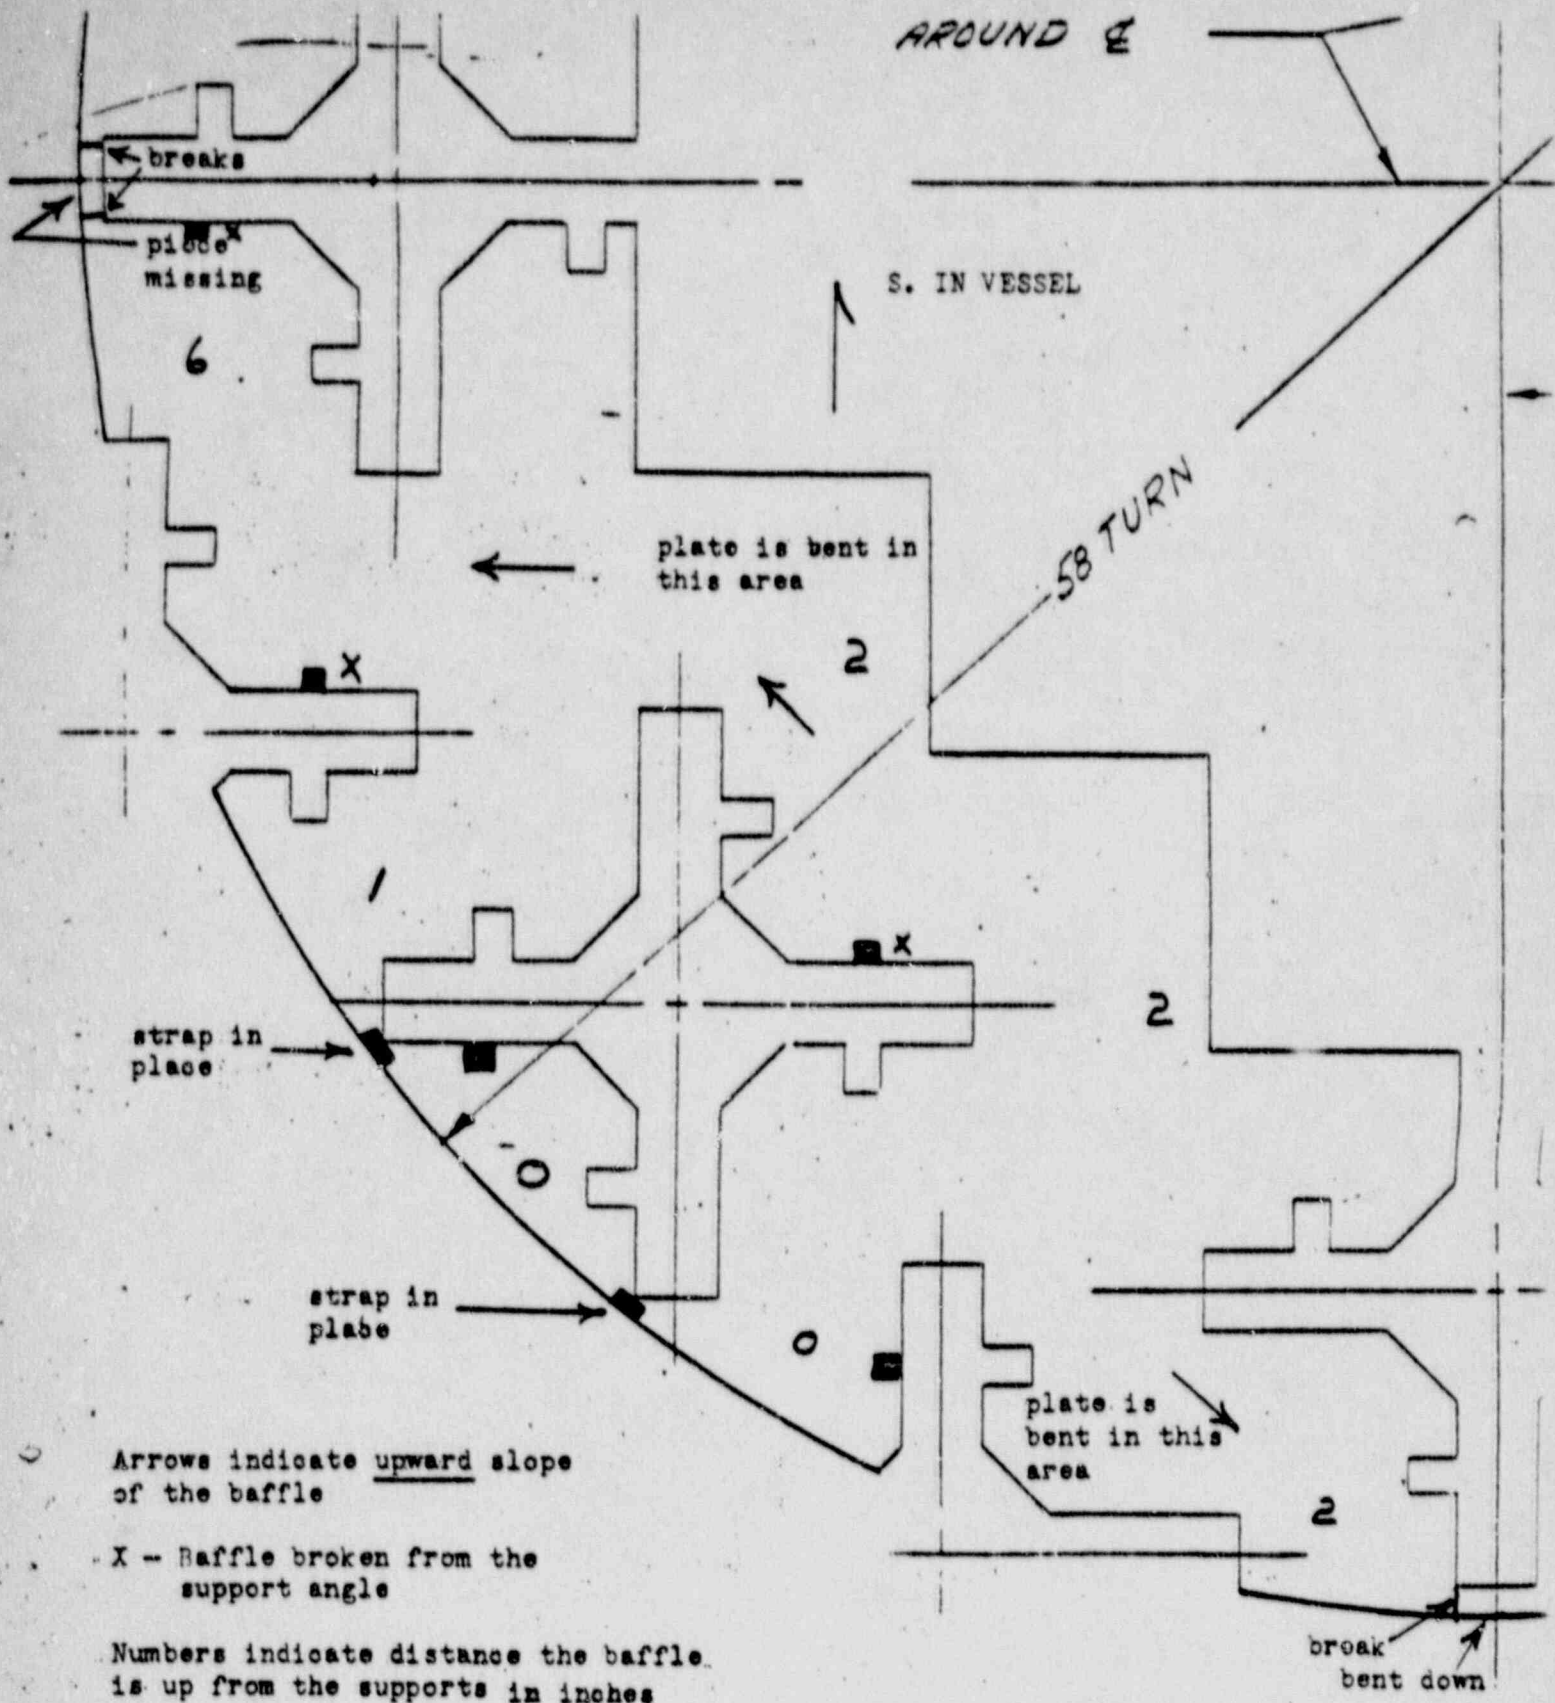
FIGURE II

Arrows indicate upward slope of the baffle

X -- Baffle broken from the support angle

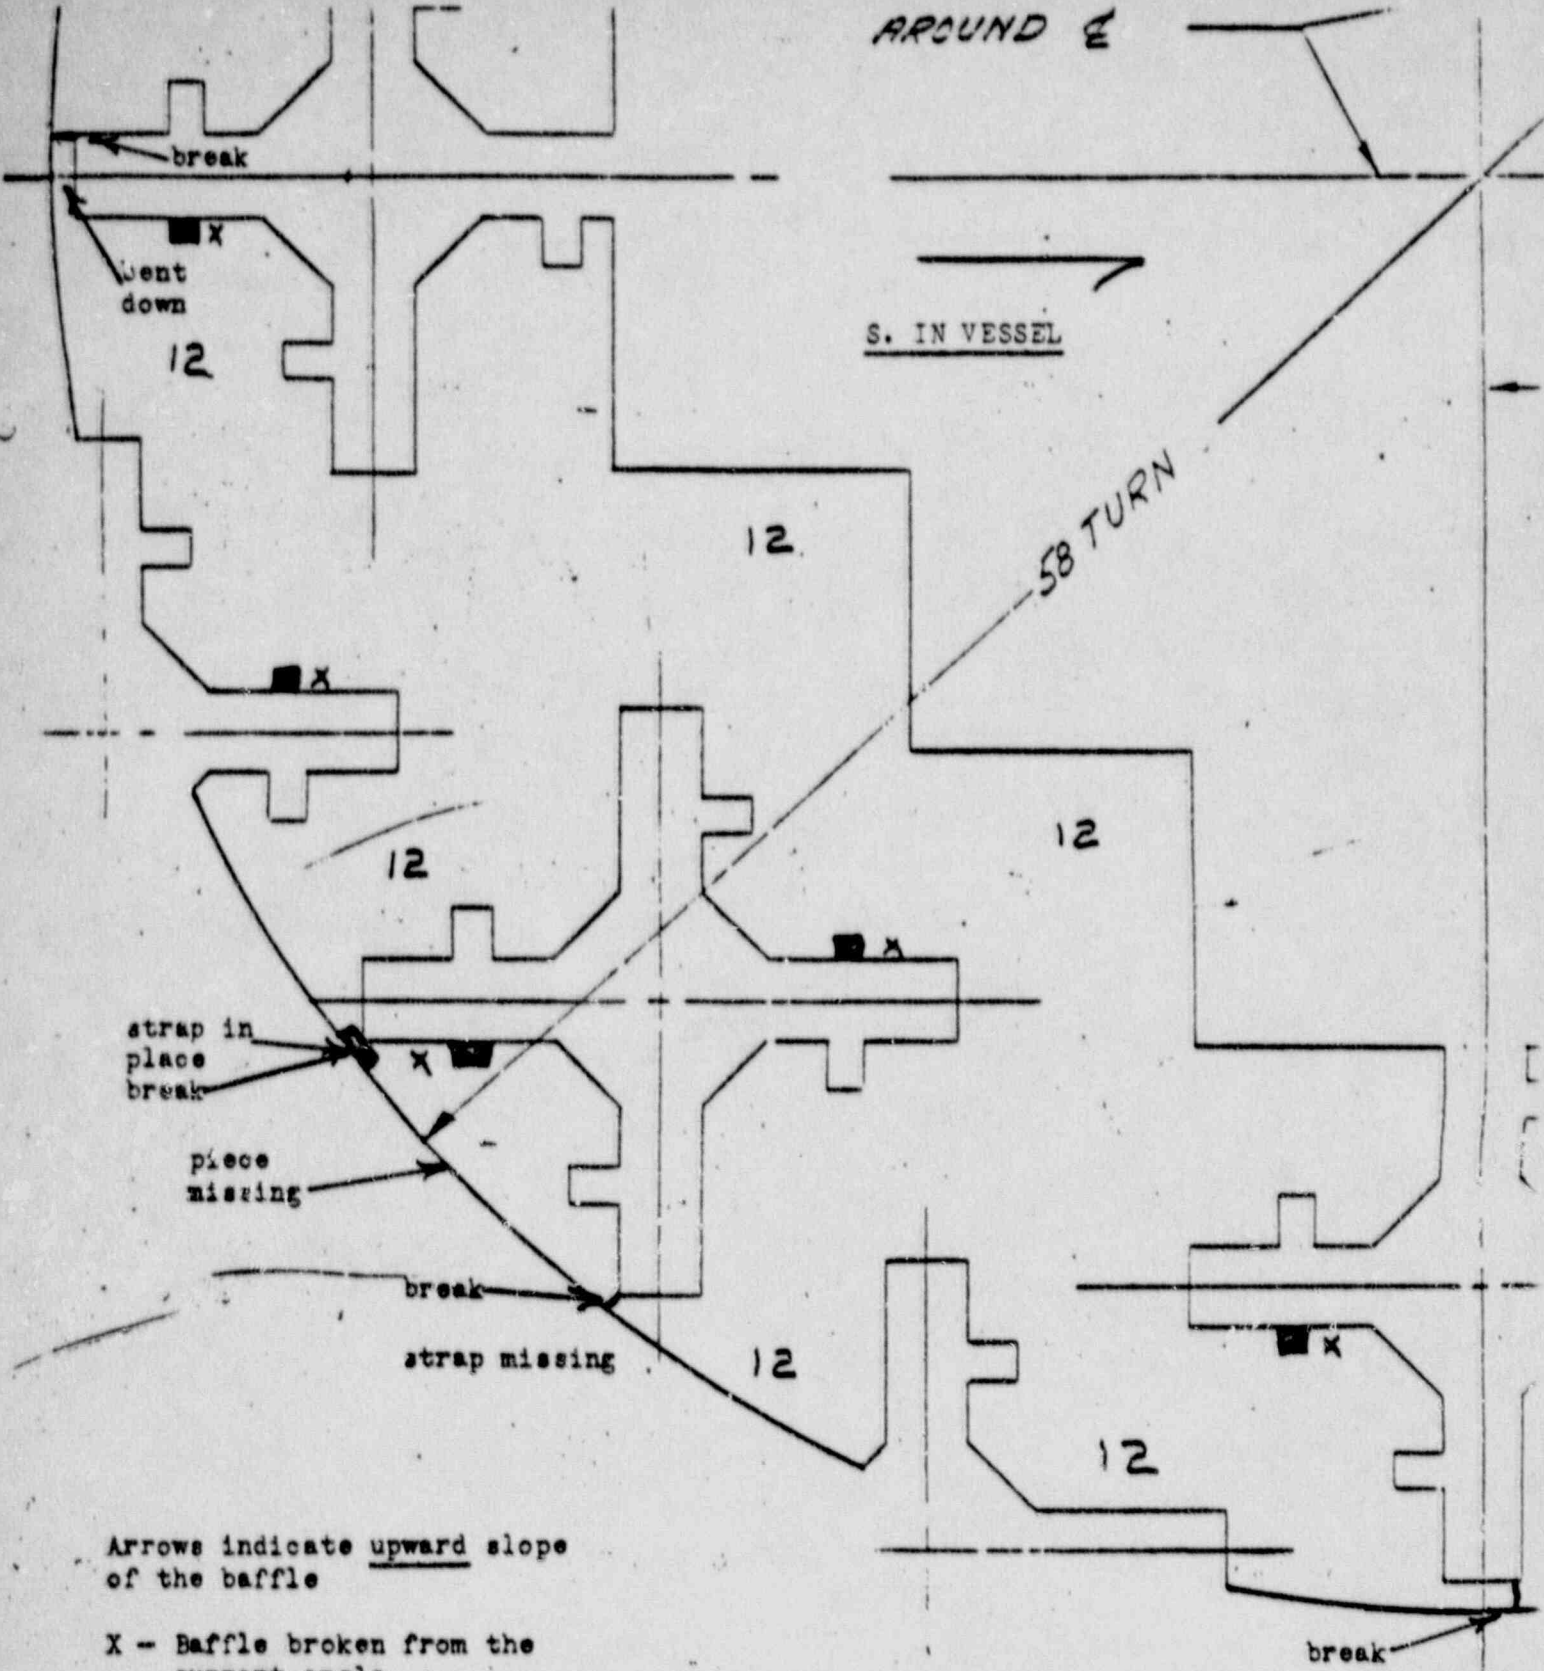
FIGURE V

Arrows indicate upward slope of the baffle

X - Baffle broken from the support angle

N.W. Quadrant of Lower Baffle

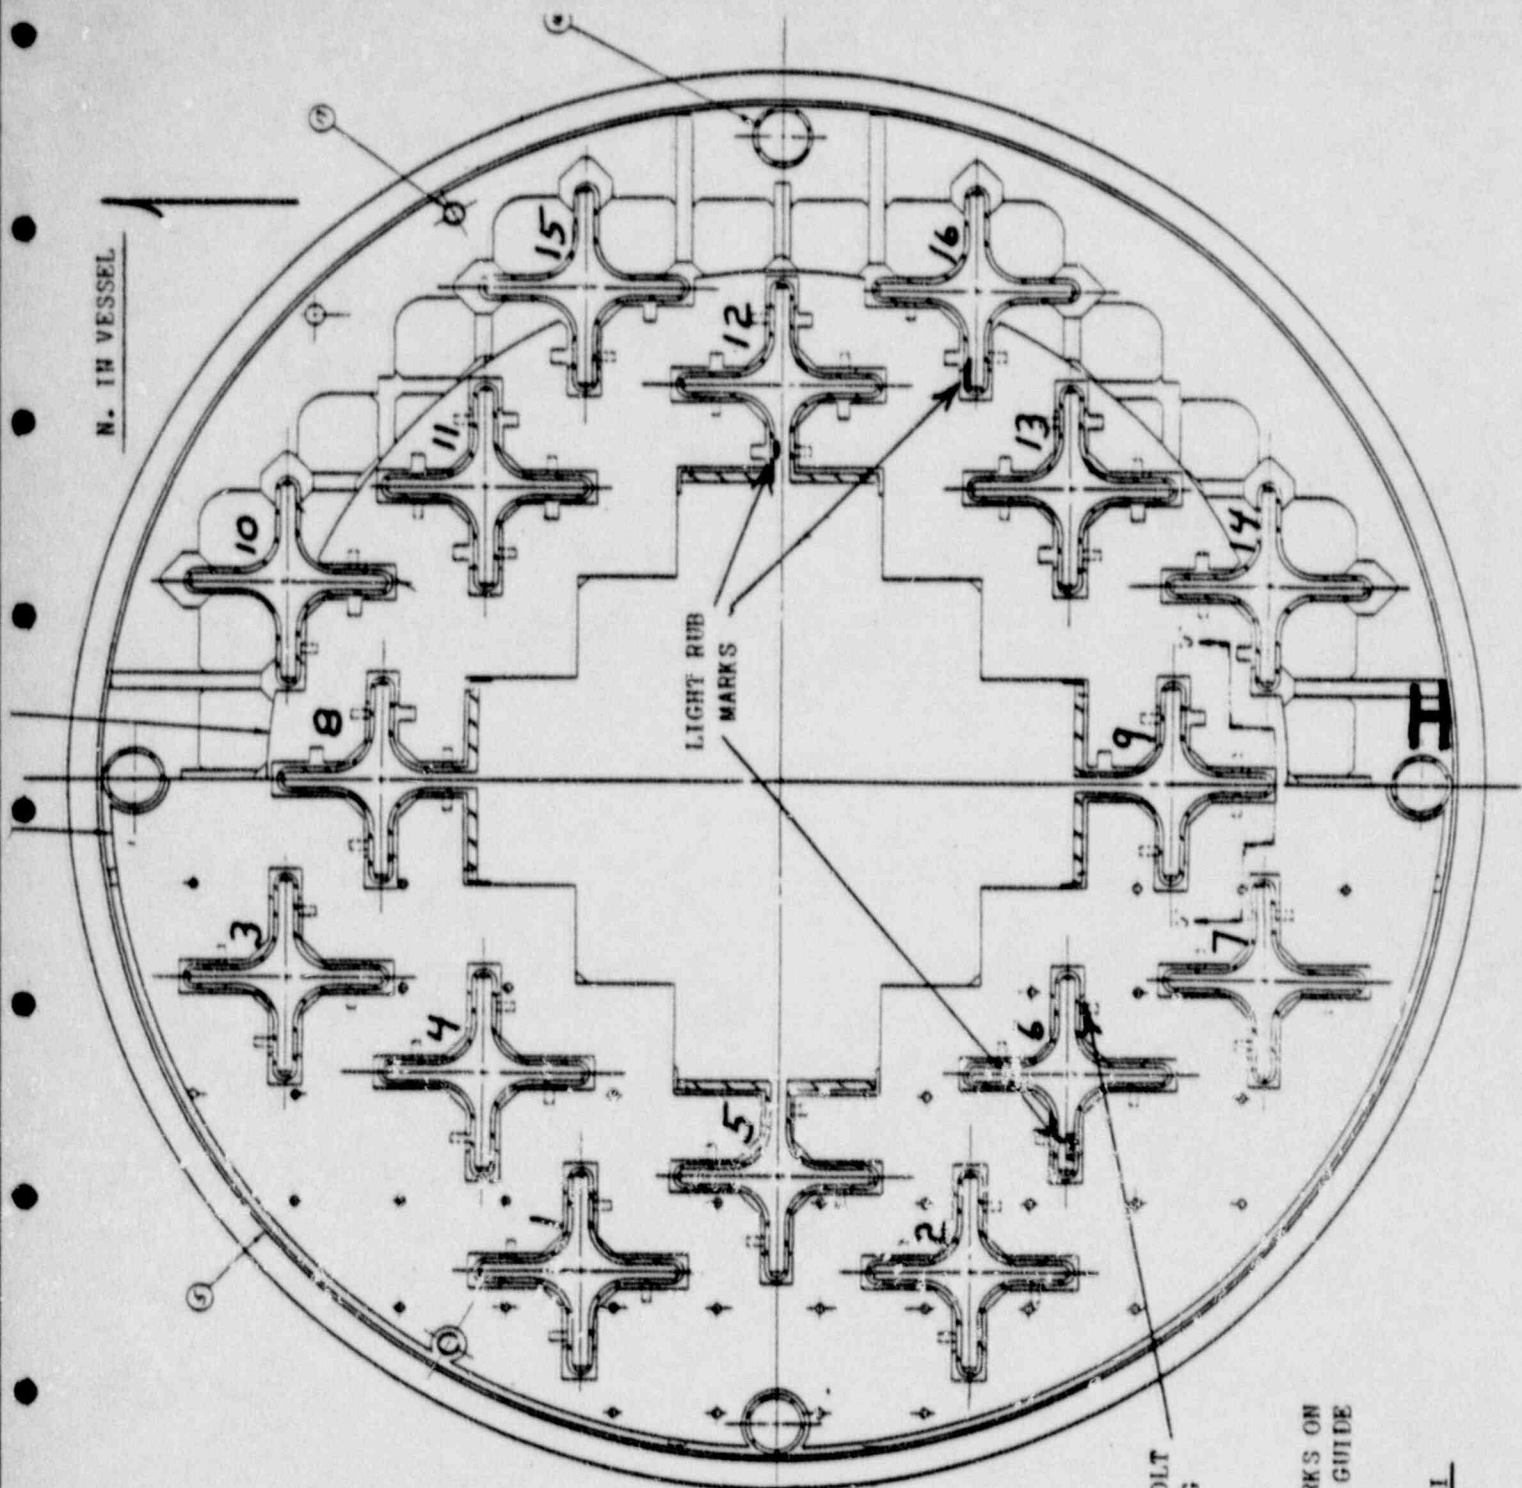
FIGURE VII

LIGHT RIB MARKS

LOWER BOLT MISSING

MAP OF RIB MARKS ON HOLD-DOWN FOD GUIDE CHANNELS

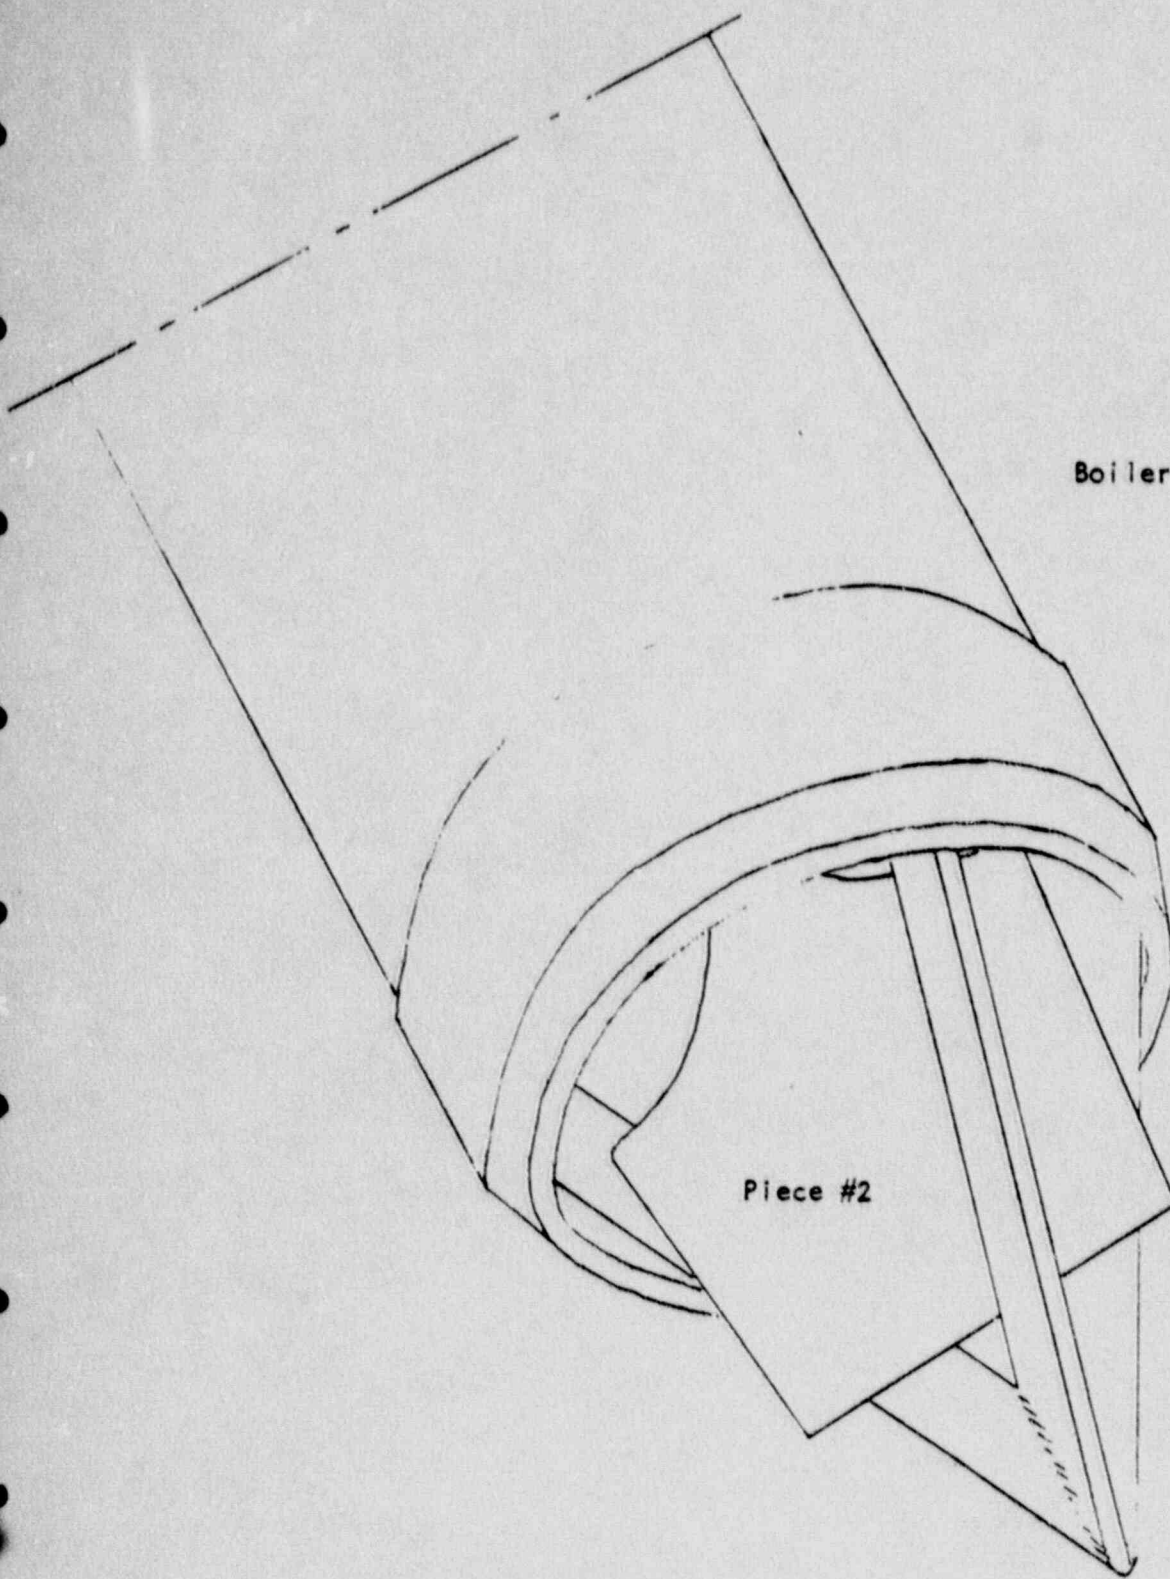
FIGURE 4

Boiler Fuel Inlet Nozzle

Piece #2
