CEN-393-NP

EVALUATION
OF
PRESSURIZER HEATER SLEEVE
SUSCEPTIBILITY TO PRIMARY STRESS
STRESS CORROSION CRACKING

A REPORT TO THE
C-E OWNERS GROUP

NOVEMBER, 1989

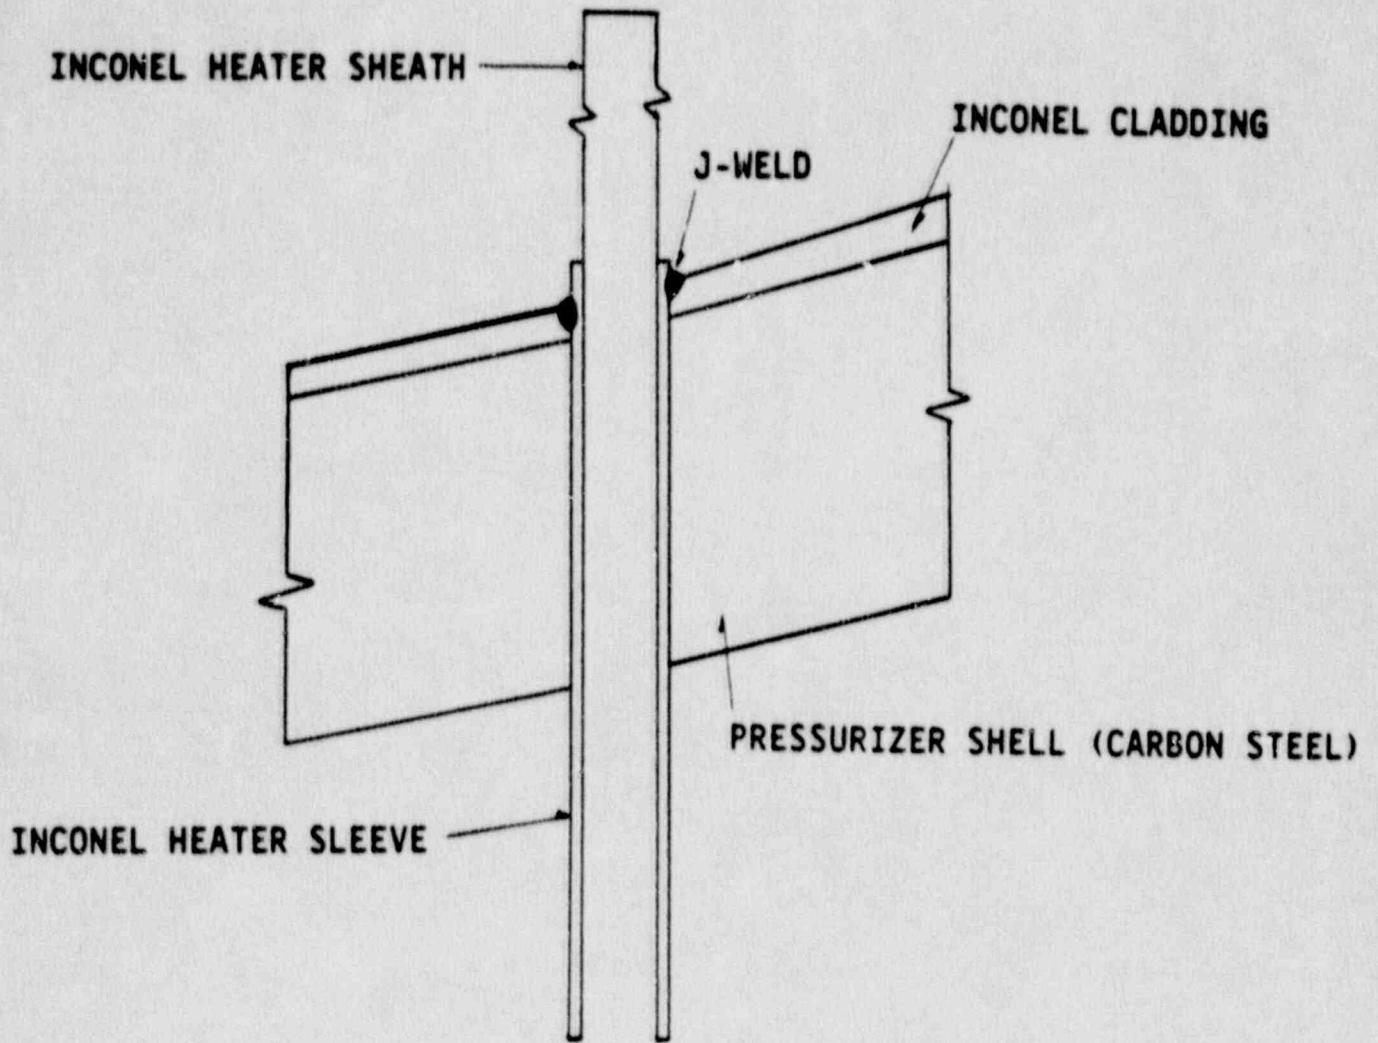
FIGURE 2

Although different pressurizers used either of two heater sizes (watt density, diameter), the heater sleeve to bottom head connections were of essentially the same design for all CEOG pressurizers. Figure 2 shows a typical heater installation assembly. Holes are machined in the Inconel-600 clad low alloy steel bottom head, parallel to the axis of the pressurizer, and a "J-weld" preparation is machined in the Inconel cladding. An Inconel-600 heater sleeve is inserted into the hole and the "J"-weld completed between the sleeve OD and the cladding, forming a partial penetration assembly in accordance with ASME Section III rules. Subsequently the heater is inserted through the sleeve and seal welded with a fillet weld between the lower end of the sleeve and the OD of the heater sheath.
