SUBJECT: AUGMENTED INSPECTION TEAM (AIT) CHARTER

PRAIRIE ISLAND PLANT TRIP AND ACCOMPANYING LOSS OF REACTOR COOLANT PUMP POWER SUPPLIES

This confirms the telephone conversation between Edward G. Greenman of this office and you on December 27, 1989, related to the Prairie Island Unit 2 plant trip caused by the opening of both Reactor Protection System motor generator set output breakers. With regard to this event, we understand that you will:

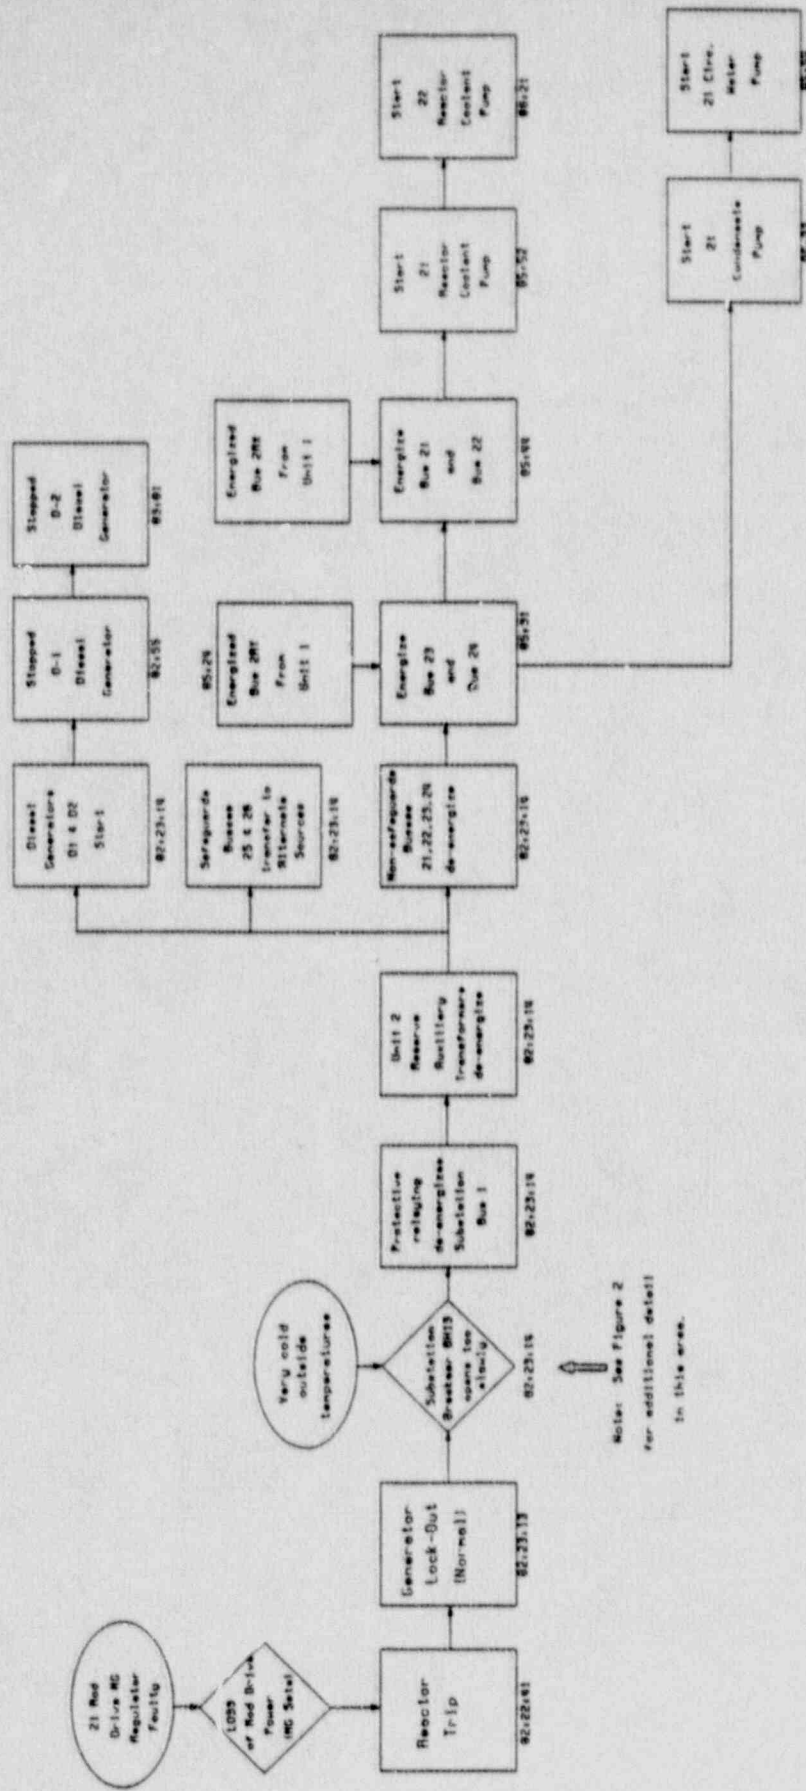
Figure 1
 Event Chart
 Reactor Trip and Loss of
 Non-Safeguards Power 12/21/89
 As Determined for Return to Power 12/22/89

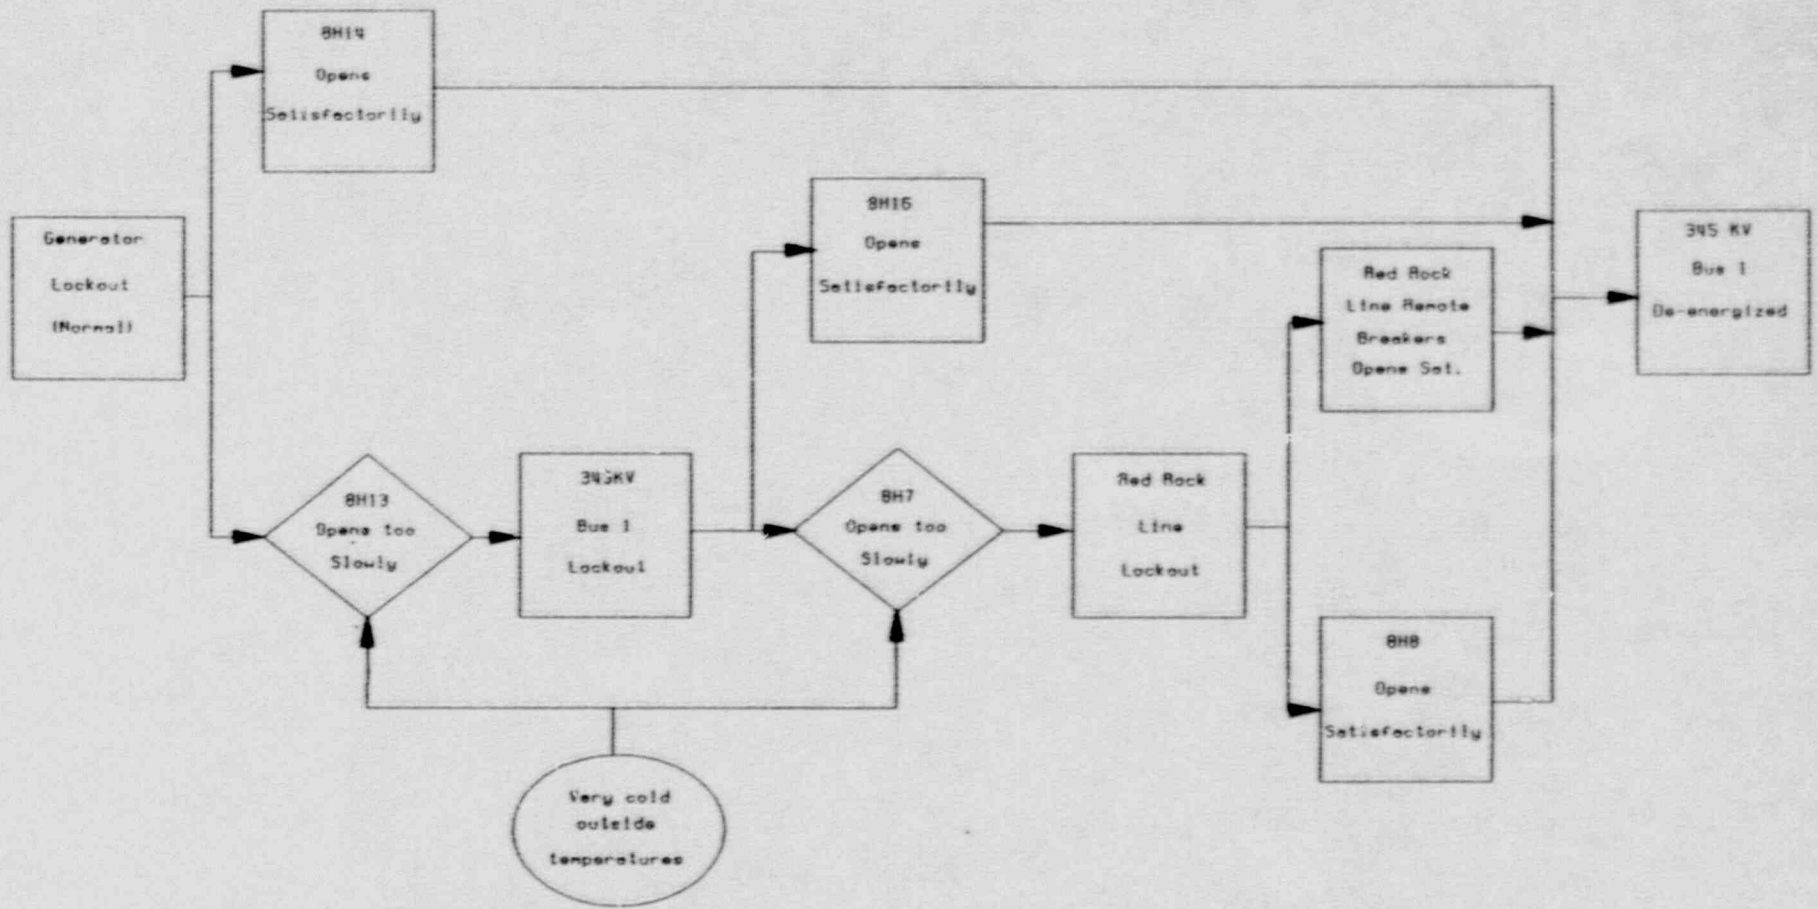
Figure 2
Event and Casual Factor Chart
Detail of Loss of Substation Bus 1
As Determined for Return to Power 12/22/89

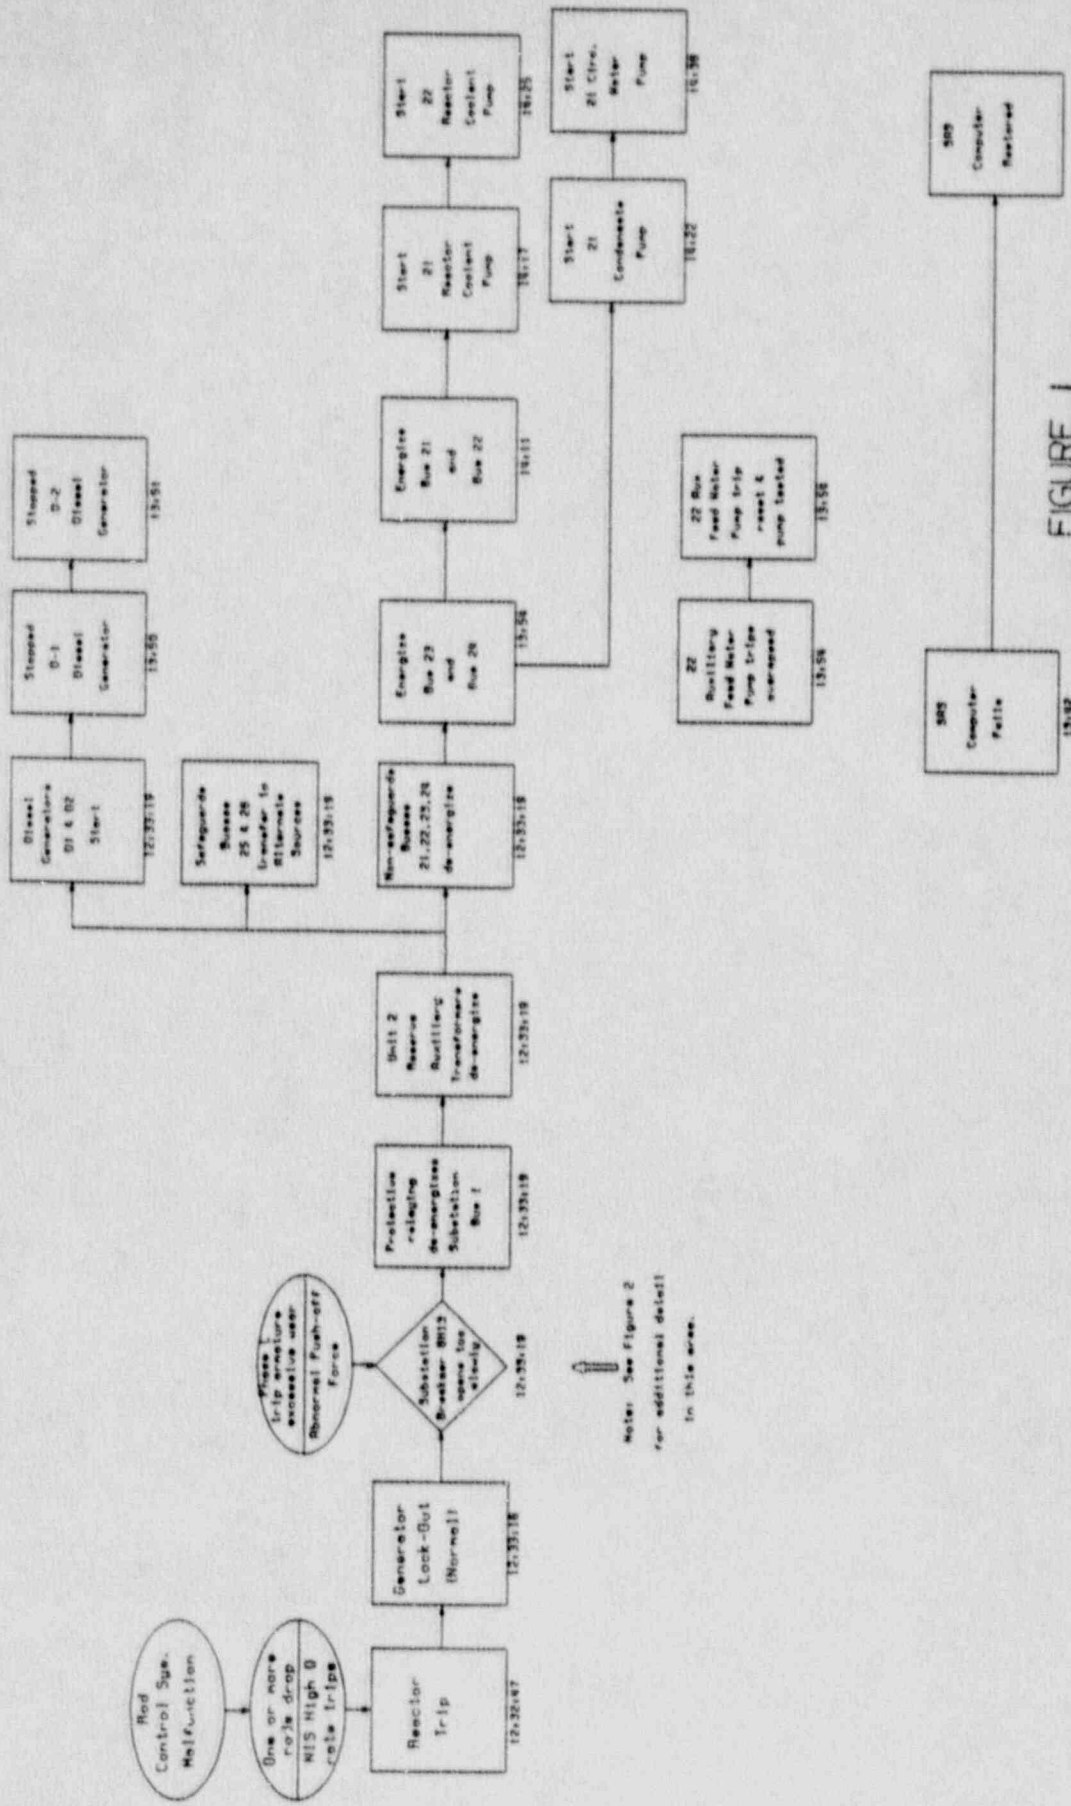
FIGURE 1
Event Chart - Preliminary
Reactor Trip and Loss of
Non-Safeguards Power 12/26/89

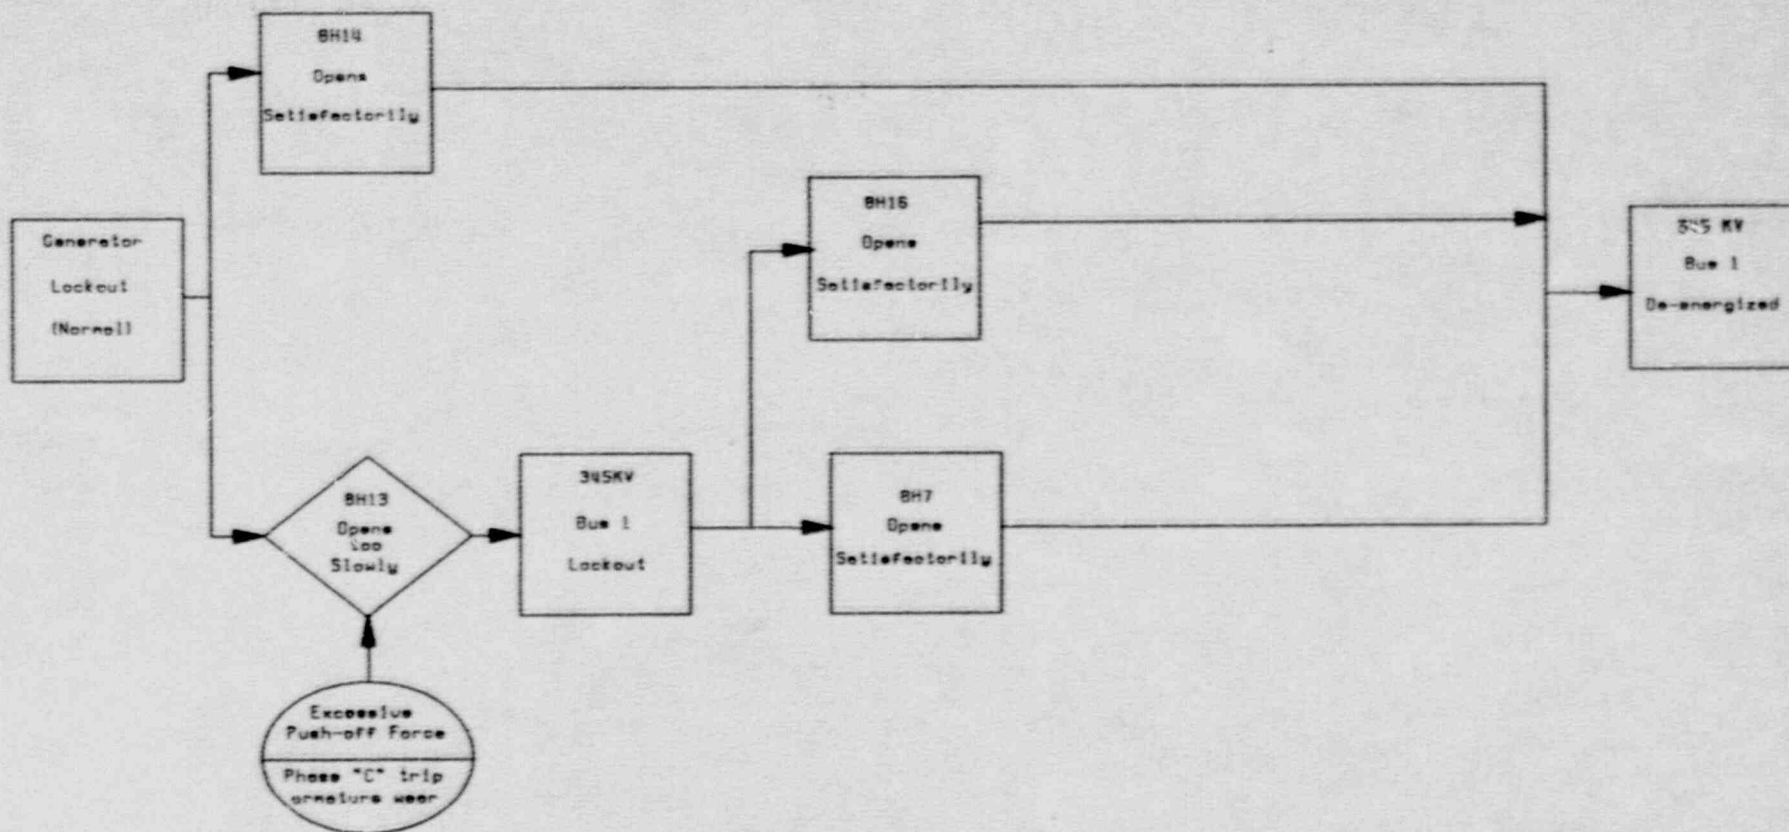
Figure 2
Event and Casual Factor Chart
Detail of Loss of Substation Bus 1
Non-Safeguards Power 12/26/89
