U.S. NUCLEAR REGULATORY COMMISSION
REGION I

Report No.: 50-219
Docket No.: 50-219/89-81
Licensee: GPU Nuclear Corporation
Facility Name: Oyster Creek Nuclear Generating Station
Inspection At: Forked River, New Jersey
Inspection Conducted: December 8 - 12, 1989

SUBJECT: AUGMENTED INSPECTION TEAM (AIT) - LOW CONDENSER VACUUM
ALARM AND POSSIBLE FAILURE TO SCRAM AT OYSTER CREEK

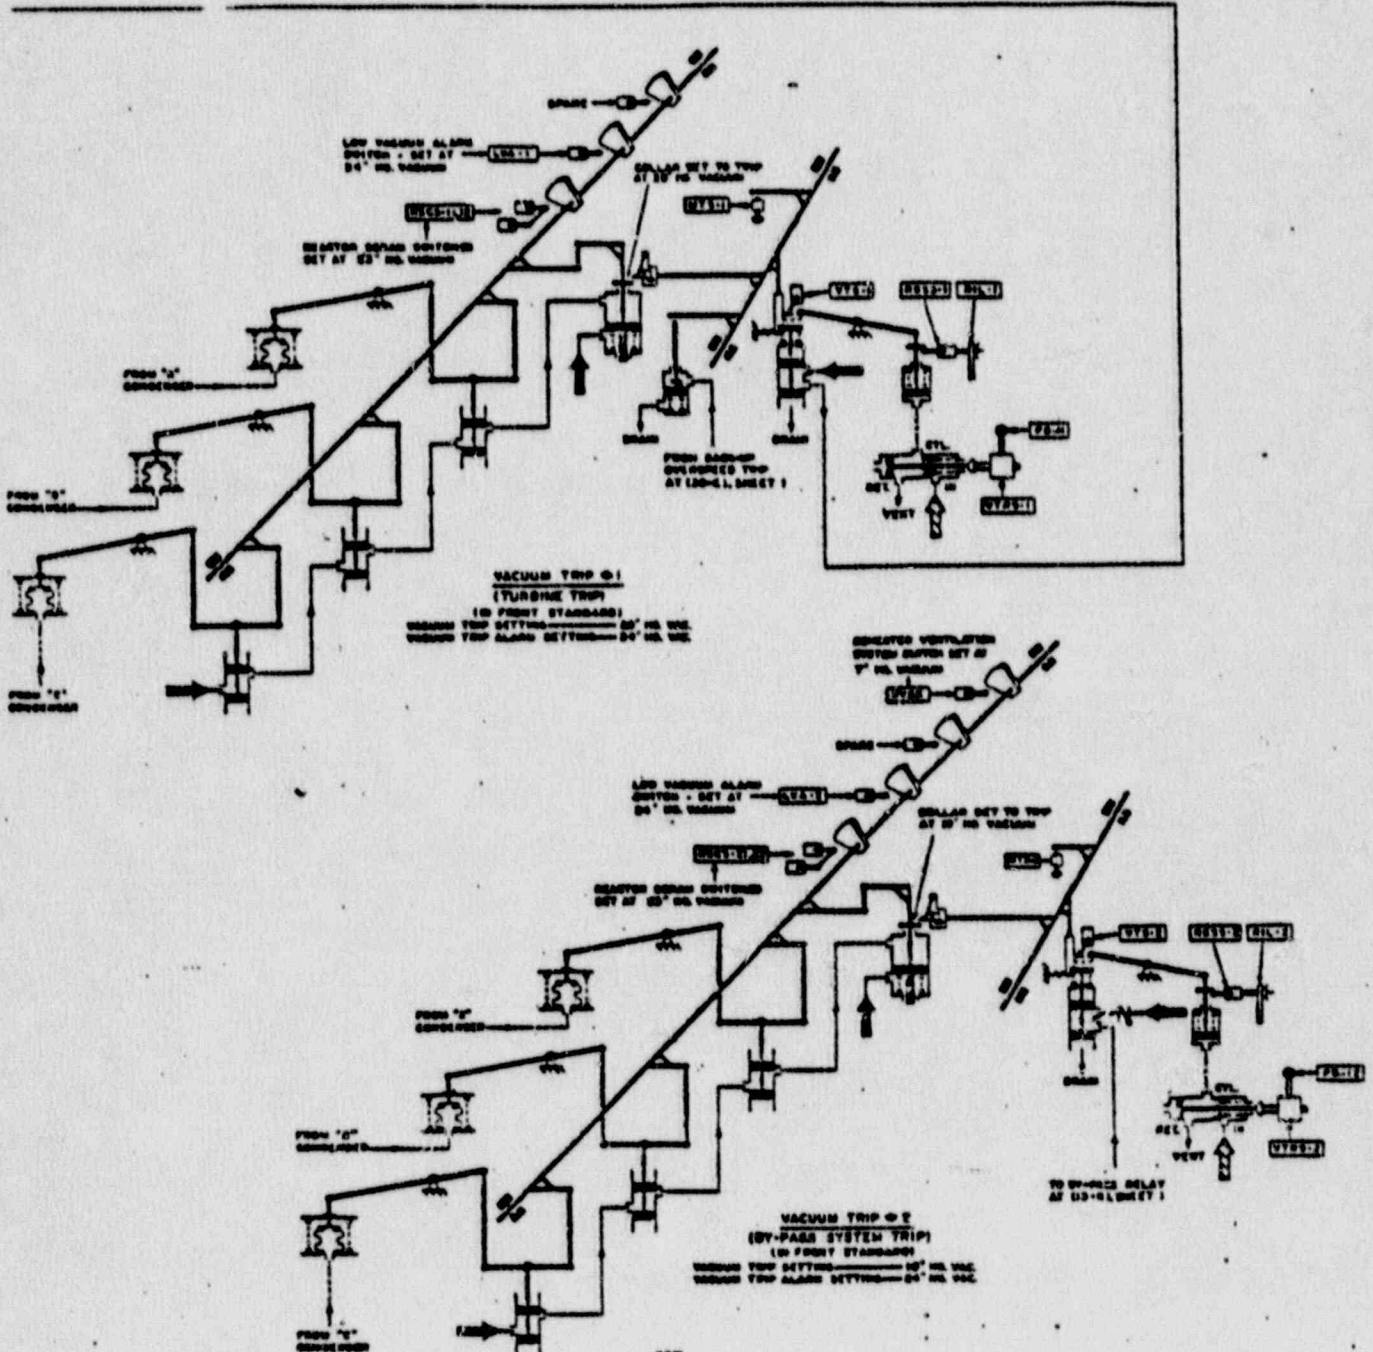
ATTACHMENT 1

The above control is achieved by having three of the bellows in a train move a piston and cylinder assembly which control a master cylinder that operates a cam (See Appendix 5-2). The cylinder and piston assembly supplies fluid to the master cylinder and piston. The design of the pistons are such that a drop in pressure on the top side of the master cylinder piston (the result of a low vacuum in any condenser) will cause a movement of the master piston in the upward direction. Low vacuum sensed in any chamber can vent the fluid and transmit reduced pressure to the top of the cylinder and cause an upward movement. This operates a cam which, in turn, operates various limit switches. A mechanical feedback lever is provided for proportional motion control to assure that the rotation position of the cam corresponds to a particular value of vacuum.
