SUBJECT: REQUEST FOR A TECHNICAL REVIEW OF A DRAFT INFORMATION NOTICE
 REGARDING FIRES IN EMERGENCY DIESEL GENERATOR EXCITERS DURING
 OPERATION FOLLOWING UNDETECTED FUSE BLOWING

NRC INFORMATION NOTICE 95-XX: FIRES IN EMERGENCY DIESEL GENERATOR EXCITERS
DURING OPERATION FOLLOWING UNDETECTED FUSE
BLOWING

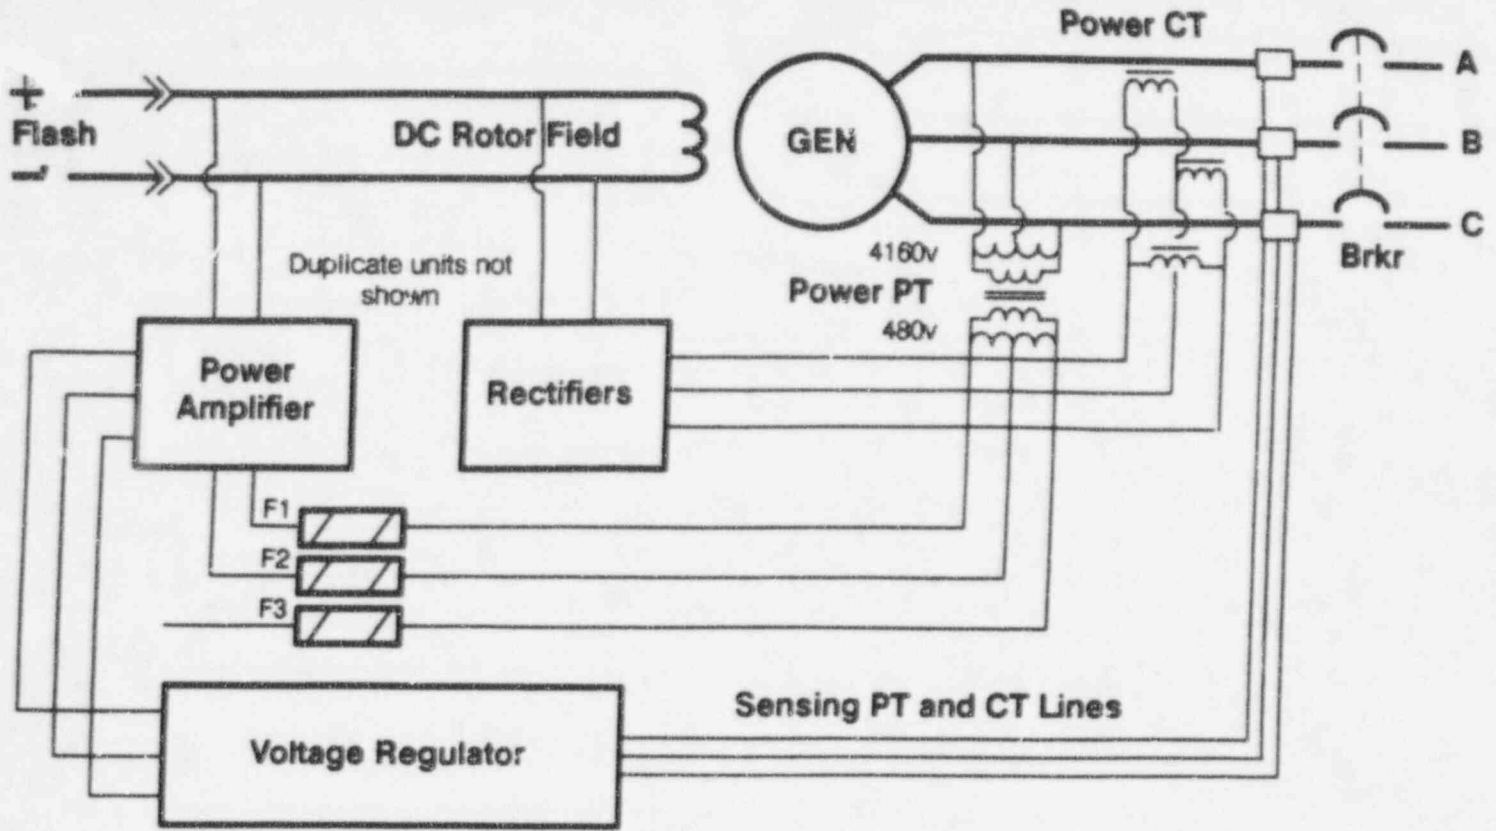
Figure 1: Emergency Diesel Generator Static Exciter-Voltage Regulator Simplified Functional Block Diagram

Engine shutdown without exciter shutdown caused a potential transformer secondary fuse to blow in each case as follows: The exciters at Wolf Creek (and Callaway) are type WNR manufactured by the Applied Products Division of Westinghouse Electric Corporation (Westinghouse). Figure 1 of Attachment 1 to this notice is a simplified functional block diagram of the affected static exciter-voltage regulator design. The potential transformers that caught fire (designated "PT" in Attachment 1) are Model 26616, delta-connected, 3-phase, step down 4160-Vac to 480-Vac, 45-kVA, 60-hz transformers, manufactured by the NWL Transformer Company in Bordentown, New Jersey. The primary windings of the PT are connected to the 4160-Vac, 3-phase generator output busses. The PT secondary windings supply a portion of the generator DC field excitation through power amplifiers. A major portion of the generator field excitation with the generator under load is supplied by current transformers (designated "CT" in Attachment 1) from the generator output through rectifiers. However, with a generator unloaded and its output breaker open, only a minimal amount of excitation is provided by the current transformers; most of it being provided by the potential transformers.

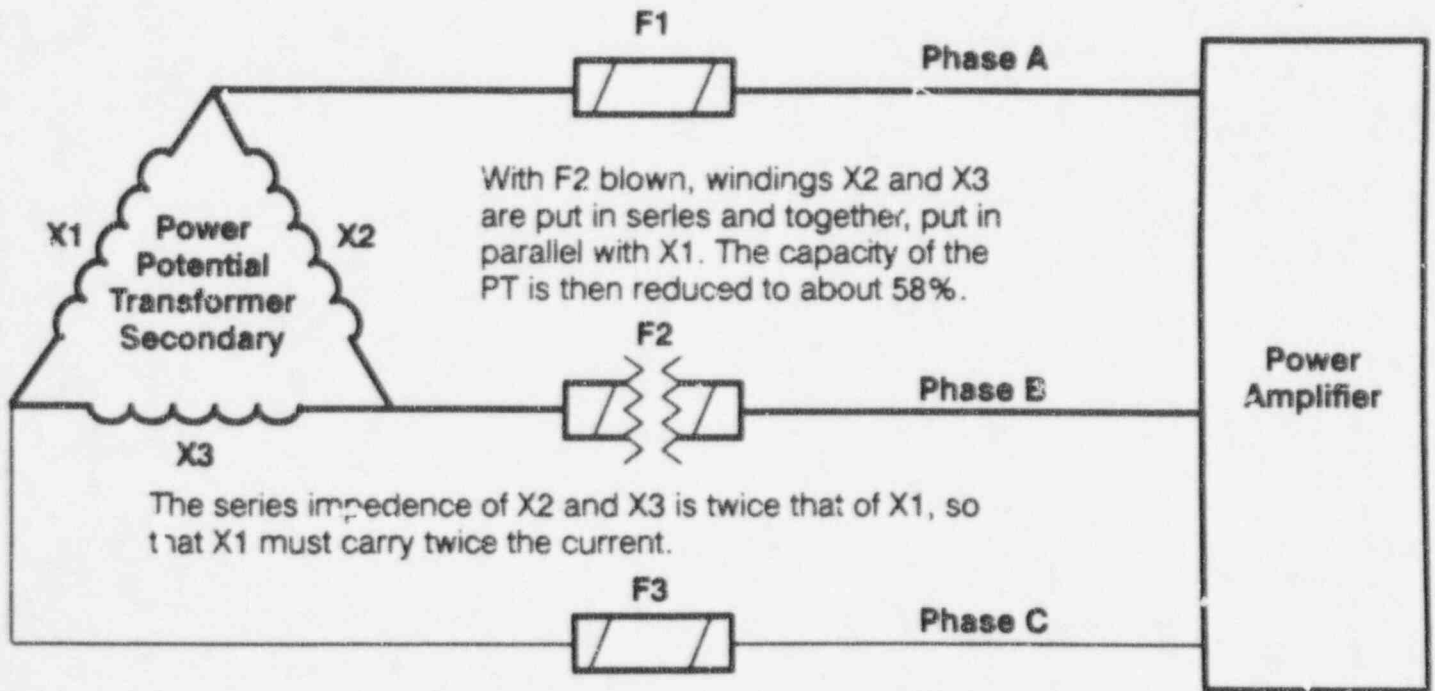
Figure 2: Effect on Potential Transformer Secondary Windings of Single-Phasing Due to Blown Fuse

Single-phasing the secondary windings of the delta-connected potential transformers, as a result of the blown fuses, left them at about 58 percent of rated capacity with one phase winding carrying two-thirds of the total load. The other two windings were effectively put in series with each other; together they were now in parallel with the first winding, but with twice the total impedance and hence, only one-third total load. This effect is illustrated in Figure 2 of Attachment 1 to this notice. Subsequent operation with the undetected blown fuse for about 1 hour at or above full load severely overloaded the affected windings. It is expected that prolonged operation at any power level significantly above the reduced capacity of the single-phased potential transformers would eventually cause damage. However, even with the imbalanced load, total excitation current demand from the potential transformer, being within expected limits, was not sufficient to blow either or both of the other two fuses. Operation continued until the overloaded windings overheated and suffered progressive insulation breakdown, internal short circuiting of the windings, and the resultant fire.

The licensee is evaluating installation of blown fuse indication on the EDG exciter cabinets. As a temporary measure, the licensee established procedures and trained operators to verify the condition of the potential transformer secondary fuses following all EDG shutdowns, particularly those in which there are indications (such as no exciter shutdown light) that the exciter was not turned off automatically. Procedures and training will also cover the conditions under which the exciter shutdown pushbutton is to be actuated and under which the alternate power amplifier is to be selected to maintain operability, e.g., in case an EDG demand signal is received during the fuse verification, or in case a fuse should blow during operation with or without an attendant fault or overload condition.
