U.S. NUCLEAR REGULATORY COMMISSION  
OFFICE OF INSPECTION AND ENFORCEMENT

Report No. 50-146/79-01

Facility Name: Saxton Reactor (in decommission status)

Inspection conducted: September 20-22, October 19, 1979, and March 25, 1980

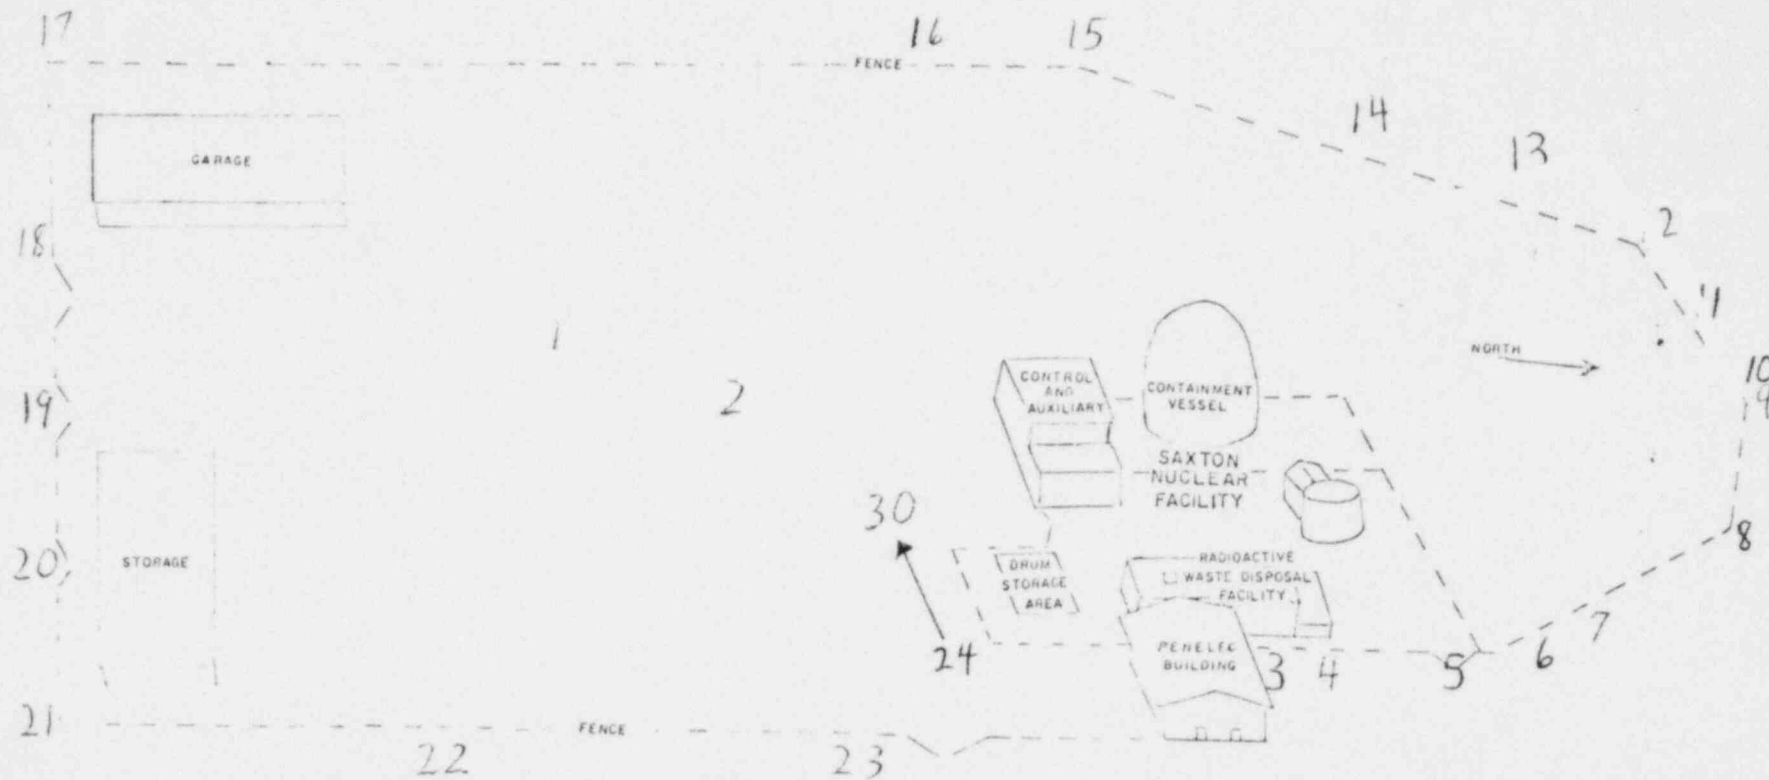
FIGURE 2

Figure 2 is a rough sketch showing the relative positions of the fence surrounding the Saxton Nuclear facility, (also referred to as the SNEC controlled area), and the longer fence surrounding the Saxton Steam Generating Station, (also referred to as the PENELEC fence). The PENELEC fence is, in turn, located approximately in the center of a 150 acre PENELEC tract of land with a minimum distance of a thousand feet between the fence and any boundary with the PENELEC tract.

Sample locations are shown in Figure 2. The results of the analysis of these samples are presented in Table III.

With the exception of points #10 on Figure 1 (which corresponds to a point near #6 on Figure 2) and #5 on Figure 2, no indication of radioactivity was noted as a result of the Ludlum survey. At points #10 and #5 an increase above background levels was noted. These points were then measured with an Eberline E 120 with an HP 190 probe because this instrument, although less sensitive than the Ludlum, is accurately calibrated to read in mr/hr (dose rate). At both points a dose rate of about 0.25 mr/hr was observed on contact with the undisturbed surface of the soil.

No health hazards to the public or to SNEC and PENELEC personnel were identified by surveys of the area outside the PENELEC fence.

Fenced areas around the Saxton Nuclear Facility and the Saxton Steam Generating Station. The Outside Fence is referred to as the PENELEC Fence. For Sample Results See Table III
