NUREG/CR-2046  
ORNL/NUREG/TM-451

## Analysis and Repair of Water- Contaminated Boron Nitride Insulation in BDHT-THTF Bundle 3 Fuel Rod Simulators

Engineering Technology Division

Manuscript Completed - May 20, 1981  
Date Published - June 1981

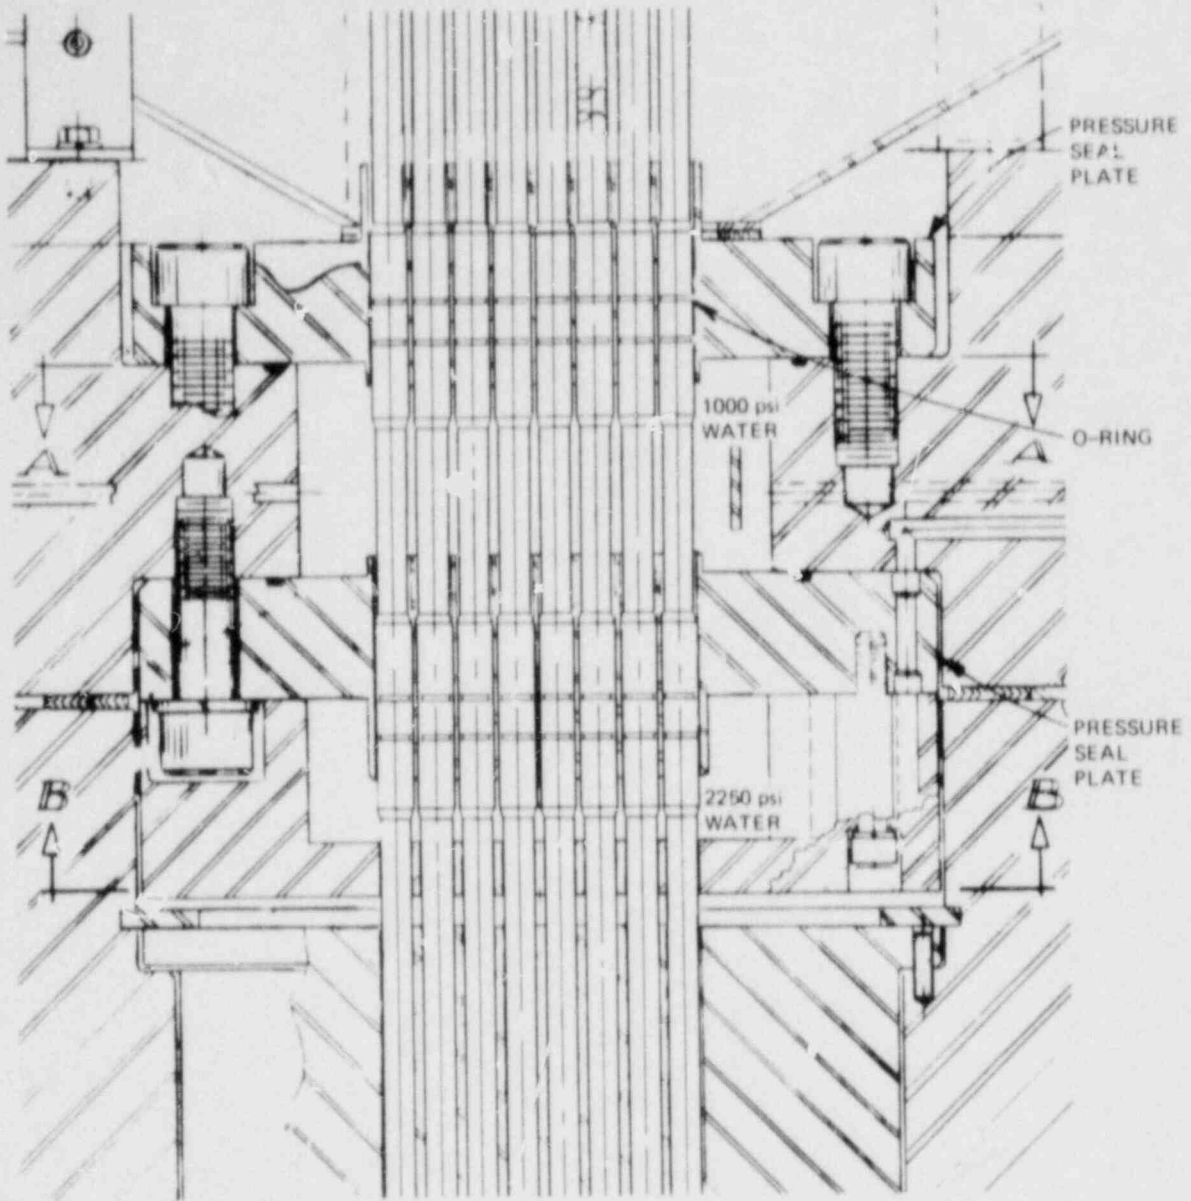
Fig. 1. Upper test section of THTF bundle 3.

Figure 1 shows the upper portion of the test section of THTF bundle 3. The FRSs are rigidly bolted to a nickel plate (not shown) at the bottom of the test section. Thermal expansion is accommodated at the pressure seal plates by the four O-rings. The lower pair of O-rings sustain a maximum pressure drop of 8.62 MPa (1250 psi) from 15.51 MPa (2250 psi) in the bundle region to 6.90 MPa (1000 psi) in an intermediate-pressure water coolant circuit. The upper O-rings isolate the 6.90 MPa (1000 psi) pressure in the water-cooled section from ambient conditions. The maximum temperature in the O-ring region is  $\sim 177^{\circ}\text{C}$  ( $350^{\circ}\text{F}$ ).

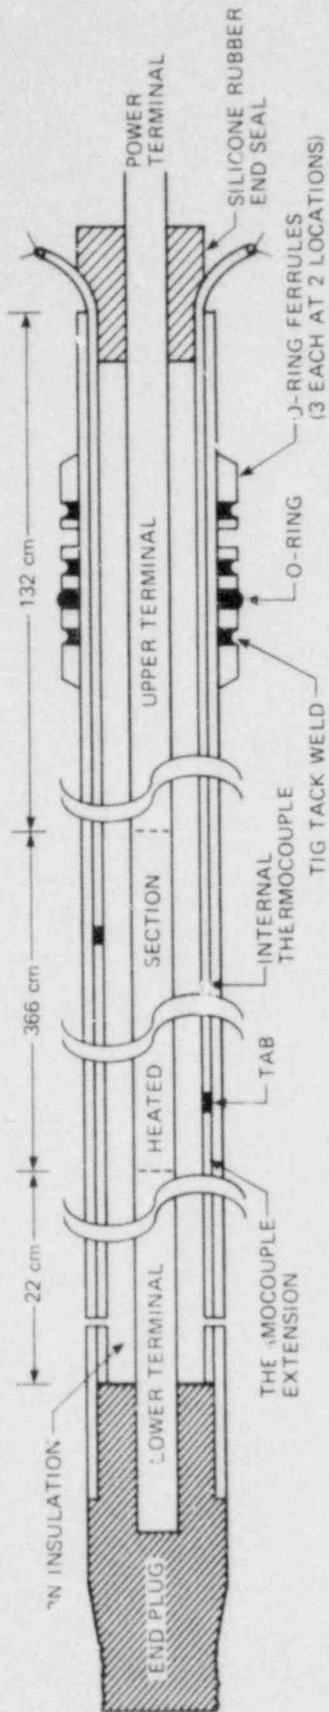
Fig. 2. BDHT-THTF bundle 3 FRS.

Testing in the THTF was discontinued in February 1980, and the rods were removed for examination in March. At this time, the third major problem (the first ones being crowbars and terminal leakage) was discovered; severe arcing had occurred between the FRS terminals in the power connection region (Fig. 2).

Figure 2 is a simplified diagram of the BDHT-THTF FRS. The heating element consists of a 132-cm (52-in.) upper terminal section, a 366-cm (144-in.) heated section, a 22-cm (8.7-in.) lower terminal, and an end plug, which grounds the lower terminal to the stainless steel clad. The heating element internal volume and FRS annular region are insulated with boron nitride (BN). The annular region contains 12 thermocouples (TCs) that extend the entire length of the FRS and are in contact with the inner diameter (ID) of the stainless steel clad. All clad TCs have BN-backfilled insulated junctions, followed by a short (3-mm) solid metal tab of the same diameter as the TCs and a "dead" length of sacrificial thermocouple material, which extends to the end plug. Details of one of the O-ring ferrule sets are shown. Each set of O-rings is held by three ferrules. Each ferrule is tacked to the stainless steel sheath in four places by a tungsten-inert gas (TIG) weld. The O-rings are positioned between the ferrules and contact both the rod surface and the IDs of holes through the pressure seal plates.

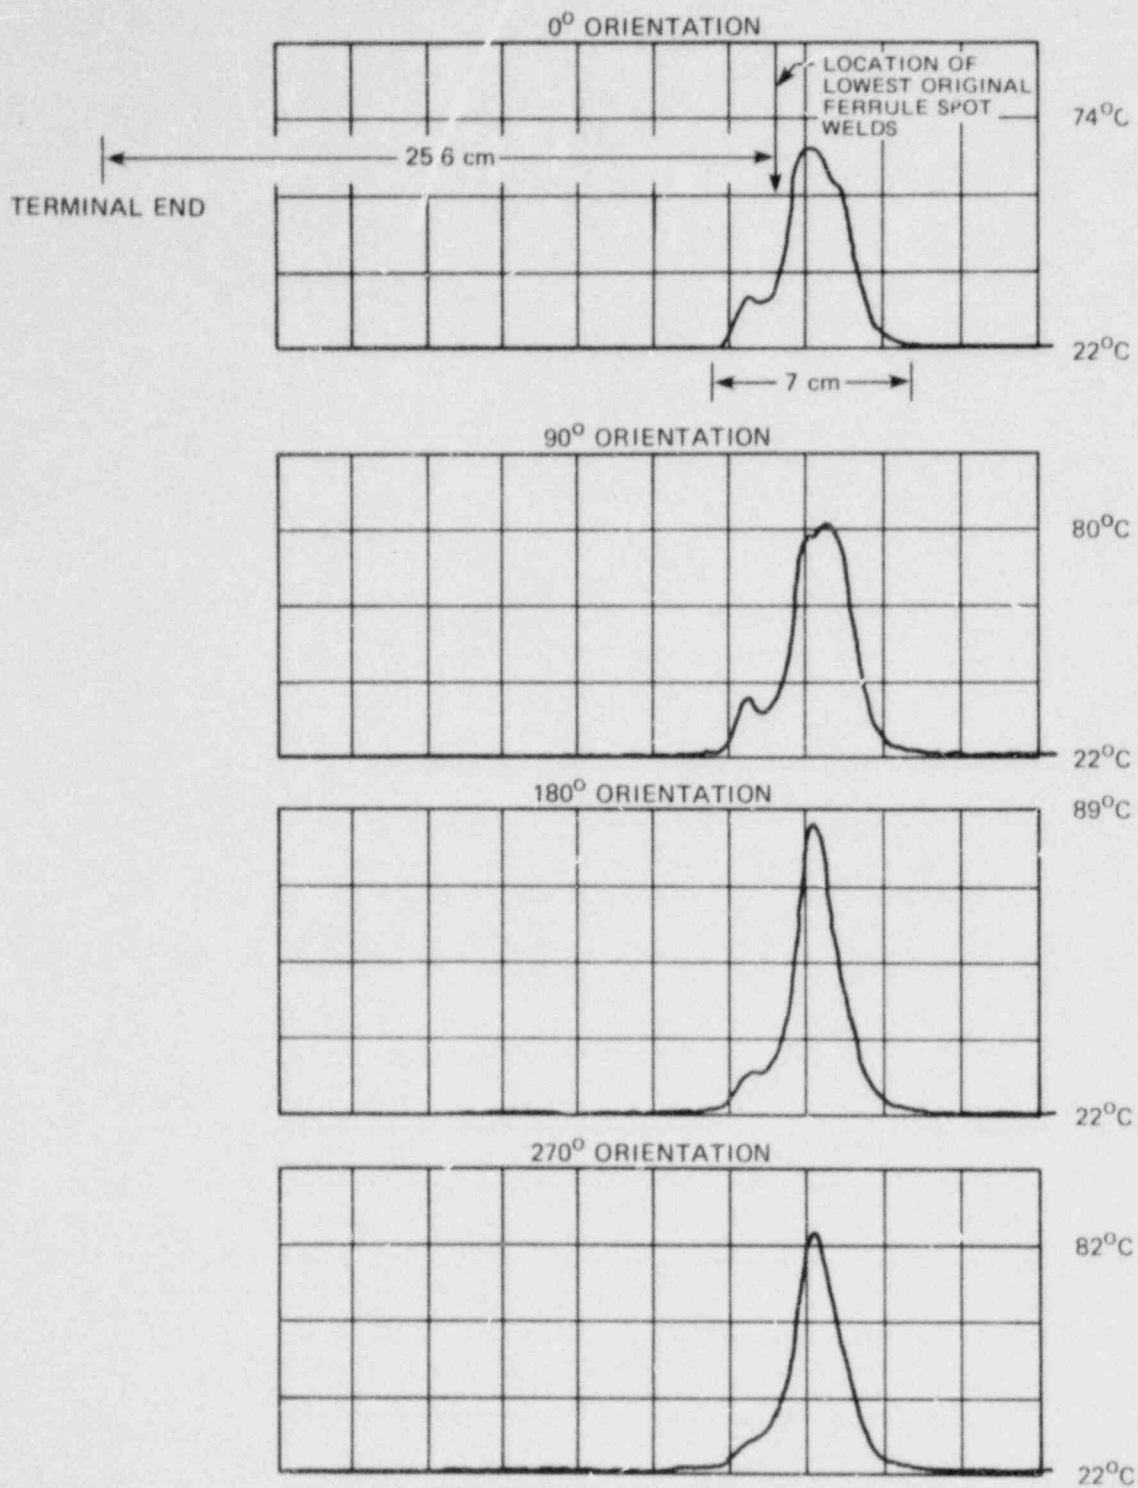
Fig. 4. Infrared scans used to precisely locate rod defects.

Figure 4 summarizes the results of a transient infrared scan of an FRS with defective ferrule welds. The four scans show the local axial clad temperature in 90° quadrants in response to a voltage impressed across the affected insulation. The IR of this specimen was ~200 Ω. The 180° orientation plot shows the circumferential location at which the insulation defect is most pronounced. More importantly though, these scans show that the defect is axially very localized with a total affected region ~7 cm (2.8 in.) in length and a peak hot spot ~1 cm (2.5 in.) in length.

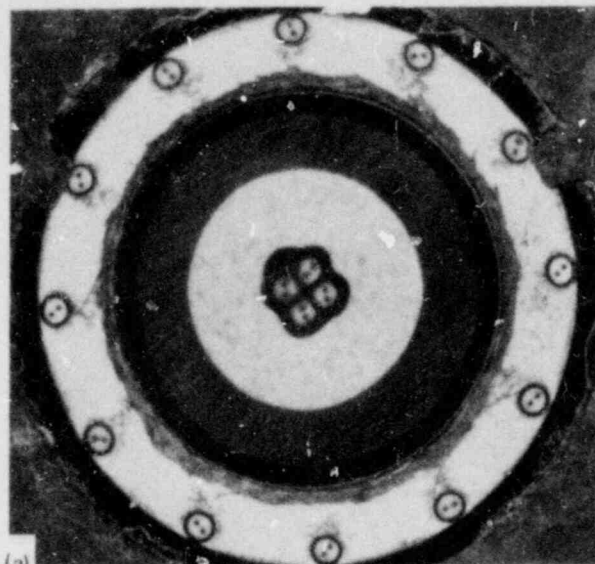
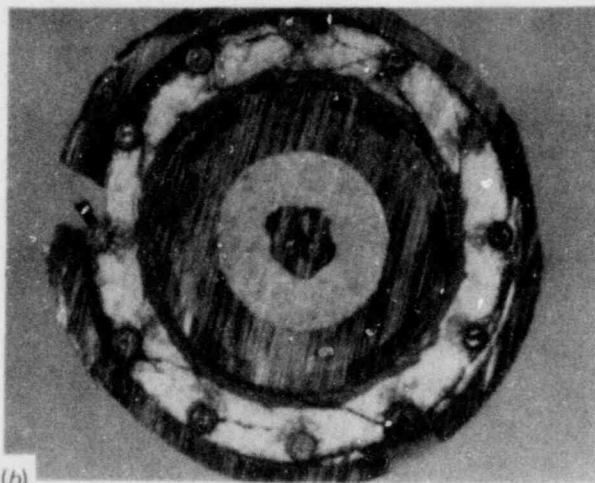
A severely damaged FRS for which the local defects had been isolated by infrared scanning was sectioned and photomicrographed. Figure 5 shows micrographs (a) close to and (b) at the affected area. A dark region is evident around the Inconel 600 heating element, cracks are visible in the annular BN, and stringers appear to run from the heating element to the annular thermocouples. The BN in the hot spot region is very dark and has a low resistance, whereas the BN only a few millimeters away is more normal.

Ion microprobe analysis of the region in (b) revealed 1.7% Ni present in the BN. X-ray fluorescence and X-ray diffraction showed the dark area to be nickel borate Ni<sub>3</sub>B<sub>2</sub>O<sub>6</sub>.

Although some conflicting evidence from X-ray analysis exists, it seems plausible that borates were formed in the rods that got very hot, permanently decreasing the IR. As the insulation became saturated with water, the resistance was lowered causing more local heat generation. This resistance decrease caused the temperature in the affected region to increase drastically, probably to 1000°C or more. At these temperatures, the nickel borate formation, as well as the other three reactions, took place rapidly. Above 600°C (1112°F), B<sub>2</sub>O<sub>3</sub> becomes a liquid and probably assists in the borate reactions.

Fig. 5. Micrographs of defective region of FRS. (a) Cross section of FRS 2.5 mm from peak in infrared scan, 10 $\times$ ; (b) cross section of FRS at peak in infrared scan, 10 $\times$ .
