UNITED STATES
 NUCLEAR REGULATORY COMMISSION
 WASHINGTON, D. C. 20555

SUBJECT: SANDIA CONNECTOR TEST RESULTS

Subject: Preliminary Assessment of D. G. O'Brien, Type K,
Electrical Penetration Assembly (EPA)

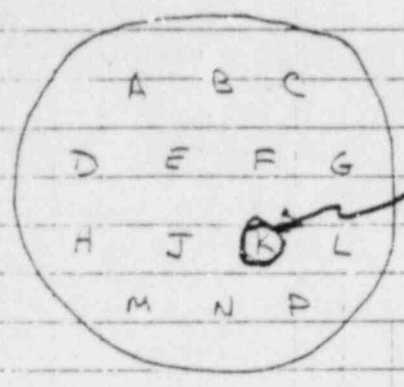
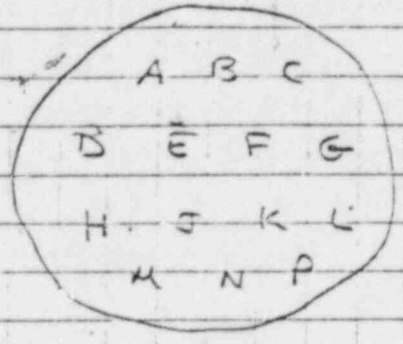
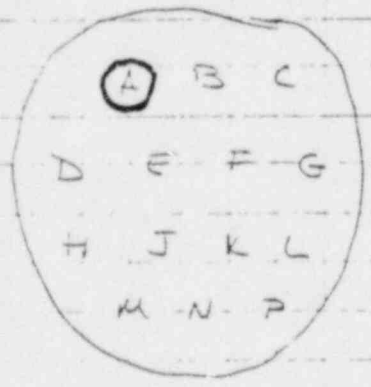
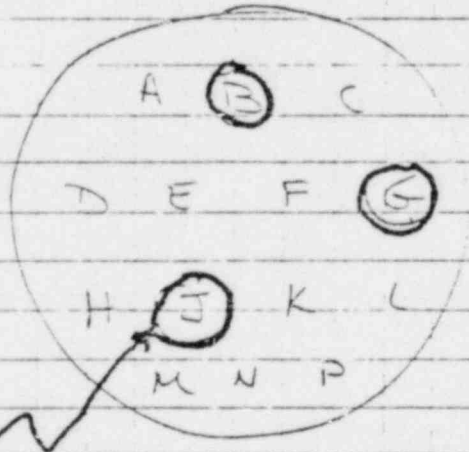
FAILED CKTS

SHORT

O = SHORT OR LOW IR READINGS

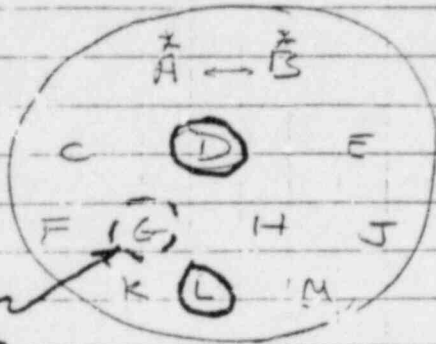
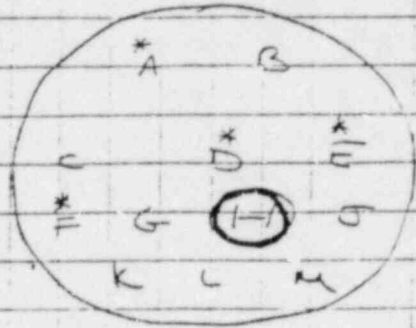
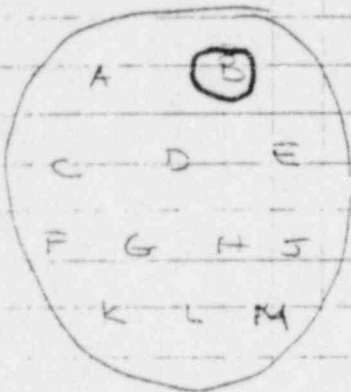
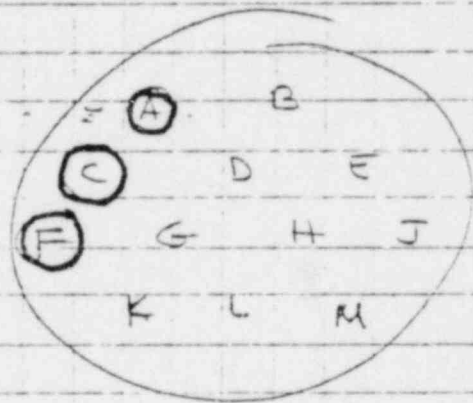
GP 2

SHORT
(END OF TEST - LOW IR IN MODULE)

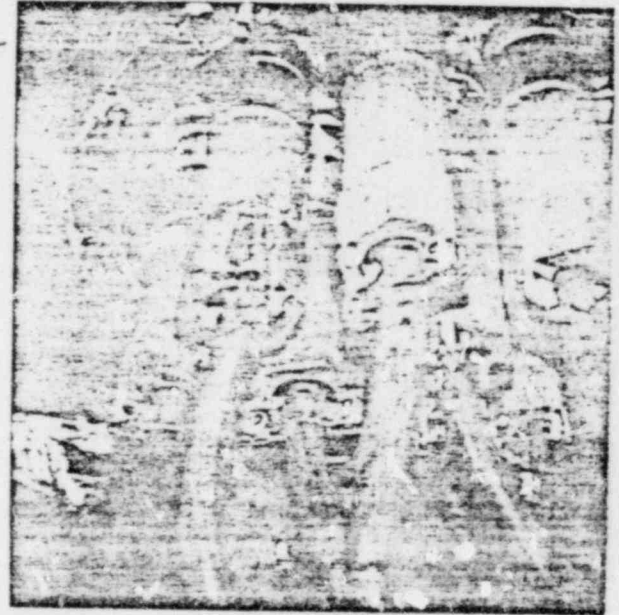
④

IN BOARD junction
removed

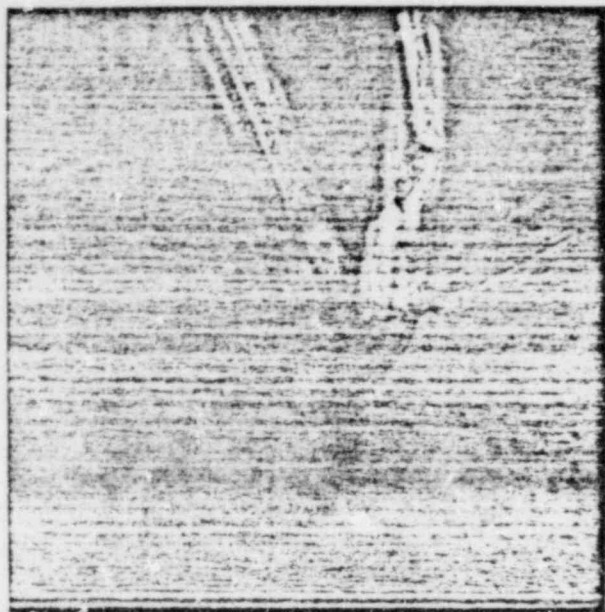
⑤

in loose state of cable
in contact with level
