SSINS No.: 6820
Accession No.
8011040288
IEC 81-06

IE Circular 81-06: POTENTIAL DEFICIENCY AFFECTING CERTAIN FOXBORO 10 to 50
MILLIAMPERE TRANSMITTERS

Subject: Potential Deficiency Affecting Foxboro Transmitters,
Model Numbers N-E11, N-E13 or E11, E13 with suffix
Codes /MCA, /MCA/RRW, or /MCA/RR

Series E10 Force-Balance Transmitters (10 to 50 mA Signal)

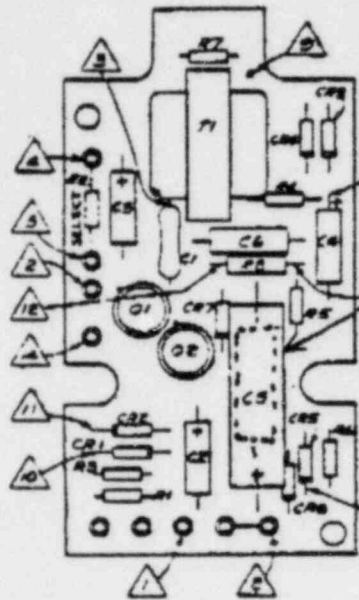
Amplifier Assembly

Capacitor
Look for Cornell-Dubilier;
smaller than component
shown. Identified by
code in form TX-65-XXXX,
07.

To determine if this capacitor is present requires a visual inspection of the amplifier which can be accomplished as described above for the insulating sleeving inspection. The recommended corrective action should the above described capacitor be present is to replace the amplifier (Foxboro P/N N0148PW) although it is possible to replace the capacitor with a Foxboro provided substitute. Use of Foxboro Service personnel to perform the inspection and replacement, if necessary, can be arranged at standard service rates as described above.

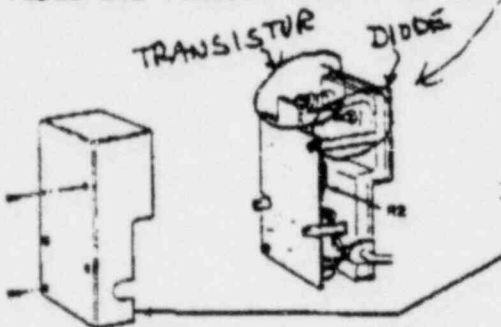
Transistor and diode check leads for insulation. If color is clear or single layer white, it is teflon and should be replaced.

If white cover over a braid, if it is polysulfone, the correct material.

If improper insulation is present, then the corrective action is to replace the amplifier (Foxboro P/N N0148PW). Replacement amplifiers can be purchased from your local Foxboro Sales or Service Representatives. If you prefer to have Foxboro Service Personnel inspect the equipment and, if necessary, replace the amplifier, this can be arranged at standard service rates.
