MISSISSIPPI POWER & LIGHT COMPANY

SUBJECT: Grand Gulf Nuclear Station
Units 1 and 2
Docket Nos. 50-416 and 50-417
File 0260/0272/L-344.0
Human Factors Engineering Review
AECM-81/267

HUMAN FACTORS ENGINEERING
CONTROL ROOM DESIGN REVIEW FINAL REPORT
GRAND GULF NUCLEAR STATION
MISSISSIPPI POWER AND LIGHT COMPANY

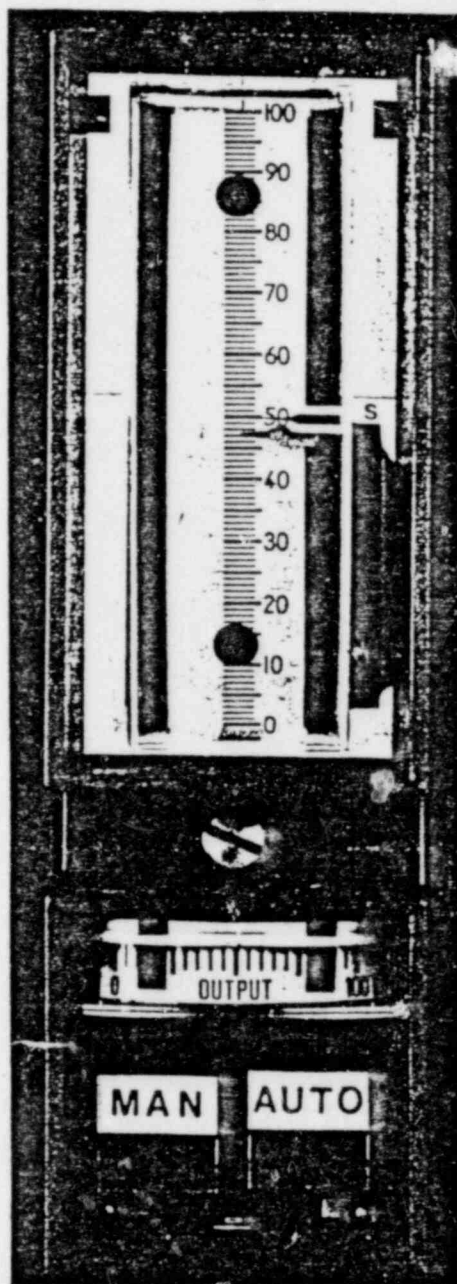
FIGURE 2: STATUS LIGHTS, PUSHBUTTONS AND
REACTOR WATER LEVEL ANNUNCIATORS

LABELS TO DISTINGUISH DIFFERENT
REACTOR WATER LEVELS
(NOT TO SCALE)
