U.S. NUCLEAR REGULATORY COMMISSION
OFFICE OF INSPECTION AND ENFORCEMENT

Report No. 50-368/81-17

Facility Name: Arkansas Nuclear One - Unit 2

Inspection Conducted: Special Announced, May 14-16, 1981

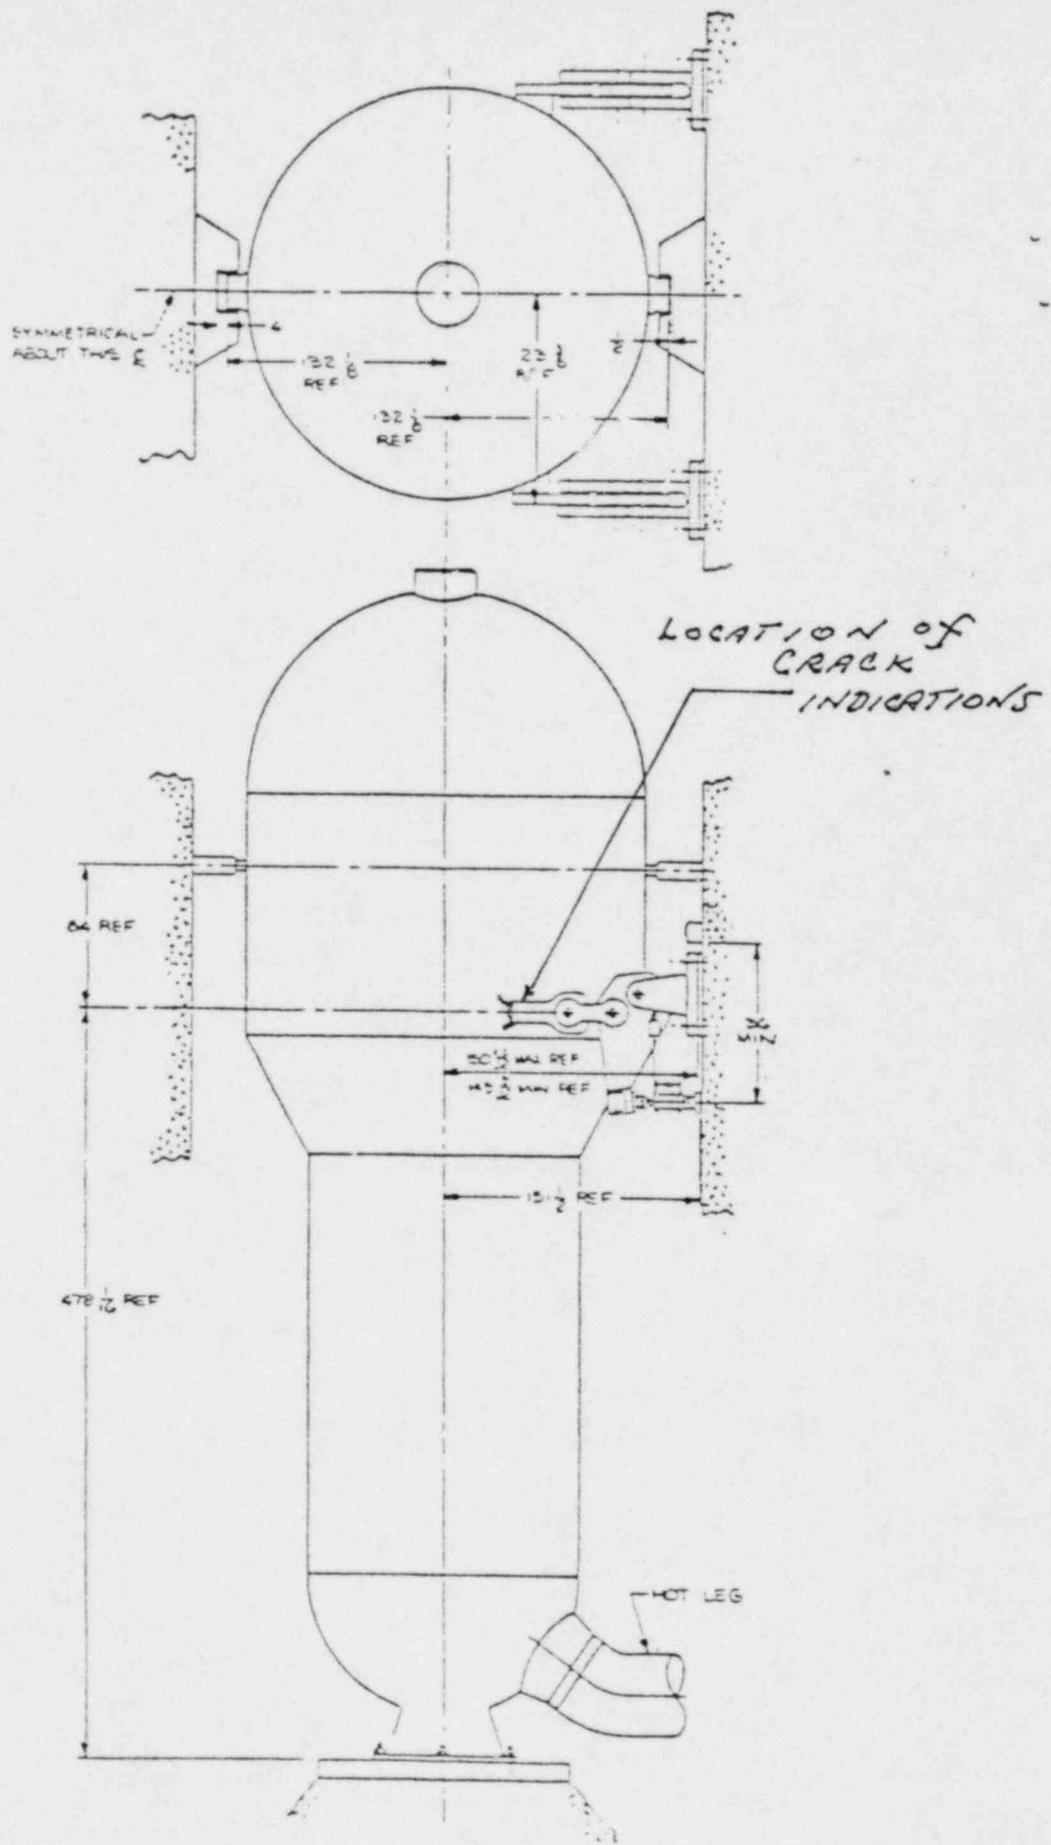
FIGURE 2

Following the above discussion AP&L further informed the staff that a LPT examination had also disclosed crack indications in an upper-side weld of a snubber lug forming an intergrally welded support to steam generator 2,

as shown in Figure 2. These indications were intermittently disposed linearly, ranging from 1/6" to 3/16" in length, along the edge of the weld to the vessel. At this time AP&L indicated a relief request would be submitted to change from a portion of the presently applicable ASME Section XI ISI Code (1974 Edition and Summer 1975 Addenda) to the later approved 1977 Edition and Addenda of the Code. Specifically, to permit use of the more definitive ISI acceptance criteria of the latter, as it relates to intergrally welded supports in evaluation of the snubber lug indications. On May 13, 1981 AP&L submitted their formal request for relief on this matter for staff consideration.

6. An investigation of the snubber lug welds also showed the reported "crack indications" were of similar characteristics as the pump welds; engendered by the welding process during installation on the vessel. These were removed by blend grinding and PT cleared.

Upon completion of the above investigation, a close visual examination (optically aided) of the reported snubber lug crack indications was made by the inspector. It was determined these indications were in fact due to (1) Partial weld bead foldover in making the final weld pass at the vessel shell and (2) shallow fusion craters in weld bead start and stop points, that were not entirely removed following welding of the lug to vessel shell.

All linear indications on the "A" and "B" RCP safe end welds and snubber lug were effectively removed by the modified grinding techniques. The existing cavities on the "A" pump welds were blended to surrounding surfaces to eliminate stress concentration effects. The depth of grinding for removal of indications was minimal (cosmetic) and did not violate the design minimum wall thickness. The entire welds were PT examined following repairs and found acceptable. A photographic record was made of the "B" pump welds and snubber lug conditions and of the repairs as required.
