UNITED STATES
NUCLEAR REGULATORY COMMISSION
WASHINGTON, D. C. 20555

This is in final response to your letters of June 28, 1979, June 9, 1980, and June 23, 1980, regarding the embedded steel anchor plates at the Callaway Nuclear Power Plant. Previous NRC letters that were sent to you on this subject were dated October 30, 1979 and July 8, 1980. In addition, a copy of IE Report 50-483/80-14, dated September 16, 1980, was also sent to you. A final review of this matter by NRC Headquarters staff has now been completed. While that review was underway the Atomic Safety and Licensing Board for the OL proceeding issued a Special Prehearing Conference Order (dated April 21, 1981). That Order outlines the petitions submitted, defines the intervenors and describes the contentions that have been admitted for the hearing. Joint Intervenors' Contention 1A stating that, "inadequate and incomplete inspection and testing on embedded plates were performed during the plant's construction" has been admitted. This contention will assure Board review of the resolution of the matter of embedded plates.

SPECIFIC RESPONSES

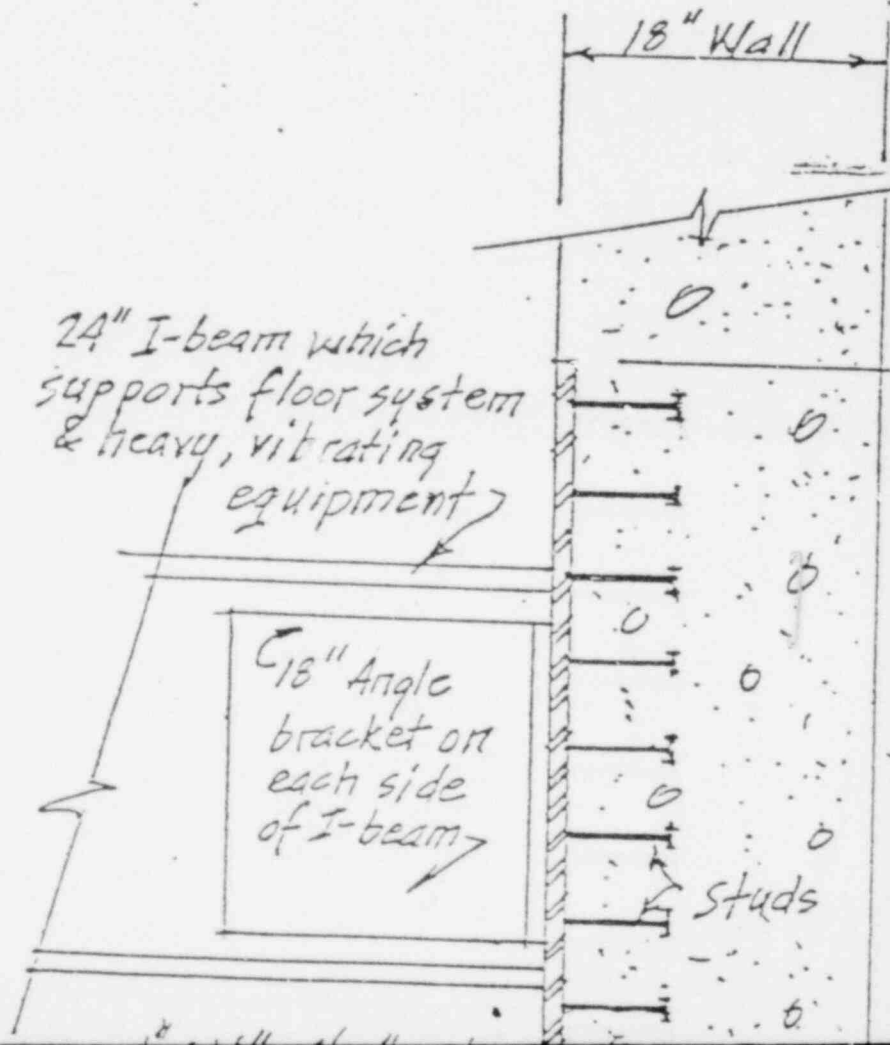
24" I-beam which
supports floor system
& heavy, vibrating
equipment

18" Angle
bracket on
each side
of I-beam

studs

18" Wall

On many embeds at Callaway 15% of the welds were defective; on some embeds, 85%. Some studs broke off when merely kicked. Others fell off without apparent cause, such as from a 7 ft. high embed that was being installed in February or March 1977 as part of a door frame

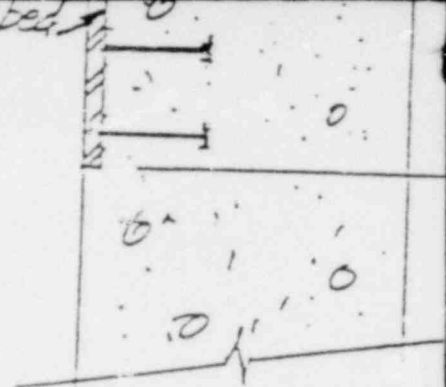
1 X 14 X 4-0 Embed

The average size of a steel embed at Callaway is 14" wide, 4 feet long, and one inch thick — with two rows of studs, ten in each row.

A stud weld should be strong enough to survive being thrown from an airplane. Traditionally ironworkers hammer-test every stud weld, and reweld every defective one. If the welds are not repairable, the plate is rejected.
