UNITED STATES OF AMERICA  
NUCLEAR REGULATORY COMMISSION

CONSOLIDATED EDISON COMPANY OF )  
NEW YORK, INC. (Indian Point )  
Unit No. 2) )

Docket No. 50-247

CONSOLIDATED EDISON'S  
ANSWER TO NOTICE OF PROPOSED  
IMPOSITION OF CIVIL PENALTY

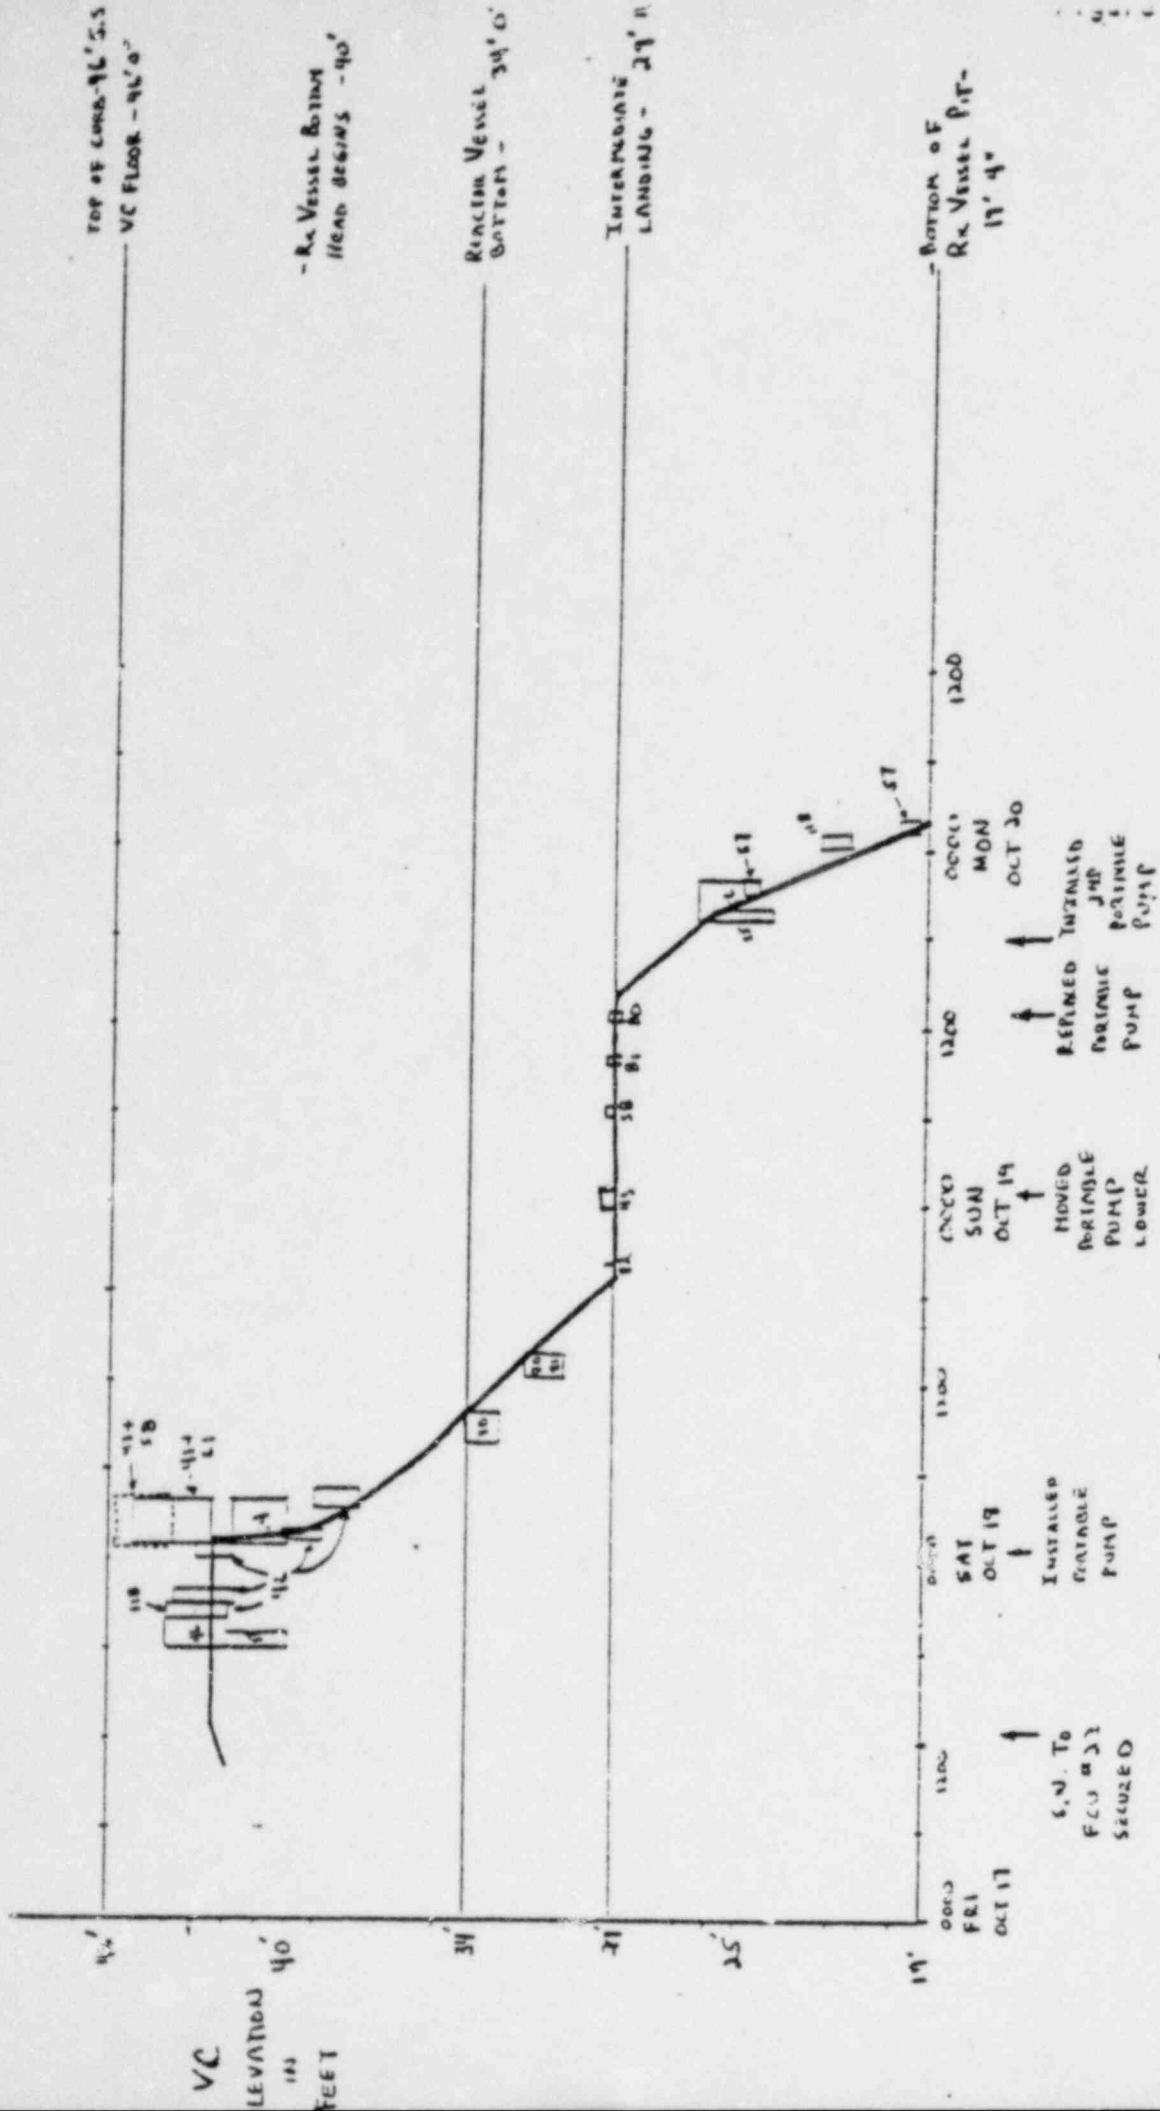
PLOT OF BEST ESTIMATE OF WATER LEVEL IN REACTOR VESSEL PIT VERSUS TIME  
BASED ON ACTUAL WATER LEVEL OBSERVATIONS

Note: The rectangles around individual observations represent the uncertainty associated with that observation.

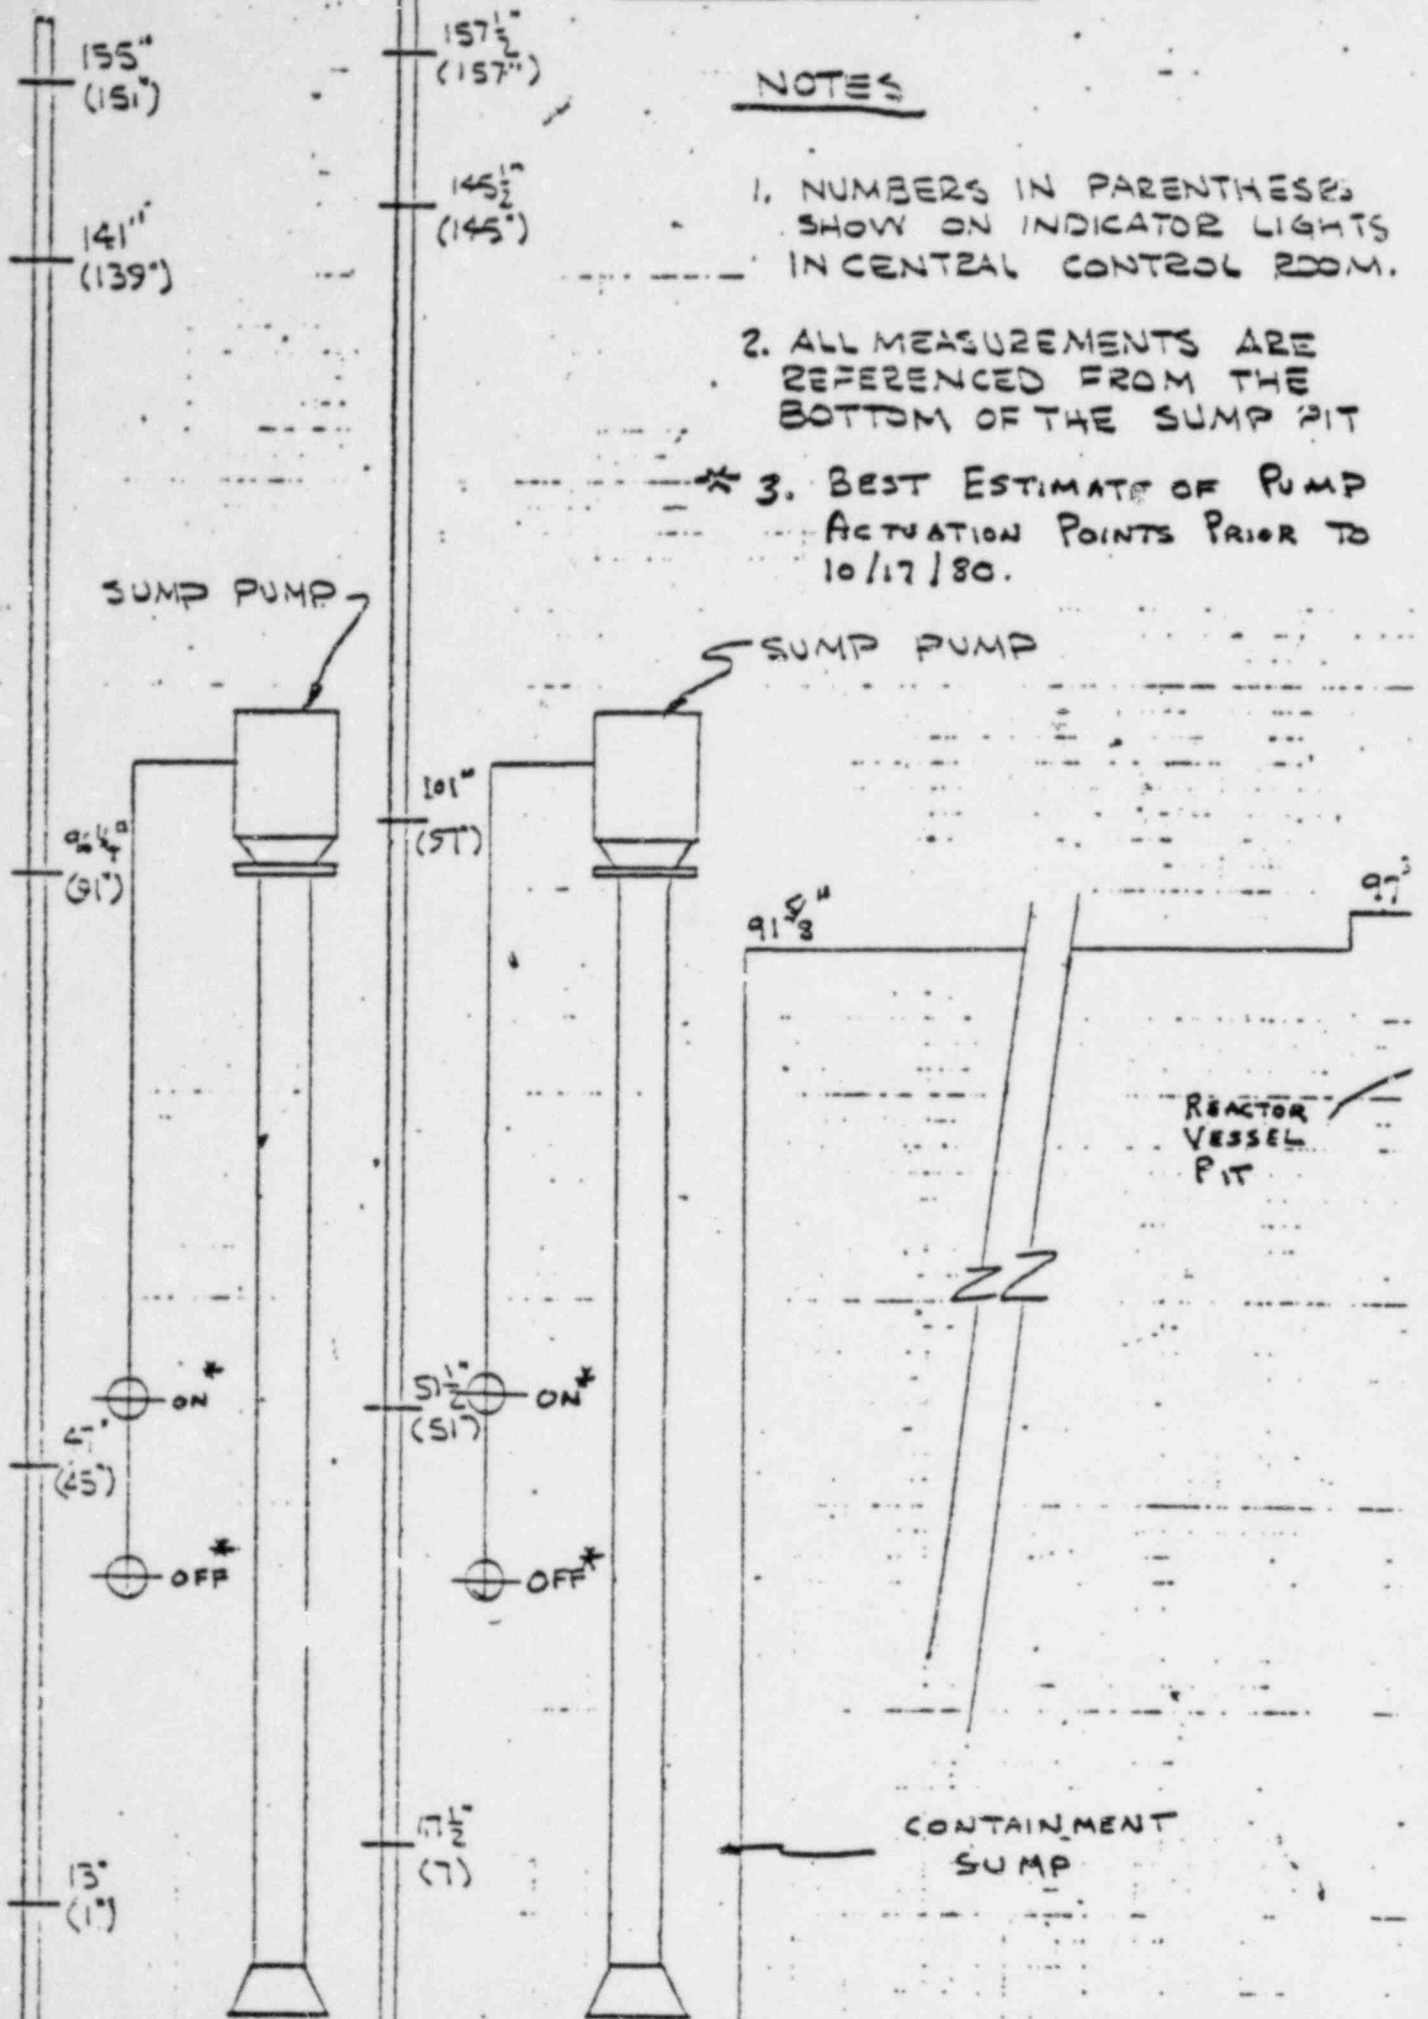
# EXISTING CONTAINMENT SUMP AND REACTOR CAVITY

1. NUMBERS IN PARENTHESES SHOW ON INDICATOR LIGHTS IN CENTRAL CONTROL ROOM.
2. ALL MEASUREMENTS ARE REFERENCED FROM THE BOTTOM OF THE SUMP PIT
- \* 3. BEST ESTIMATE OF PUMP ACTIVATION POINTS PRIOR TO 10/17/80.

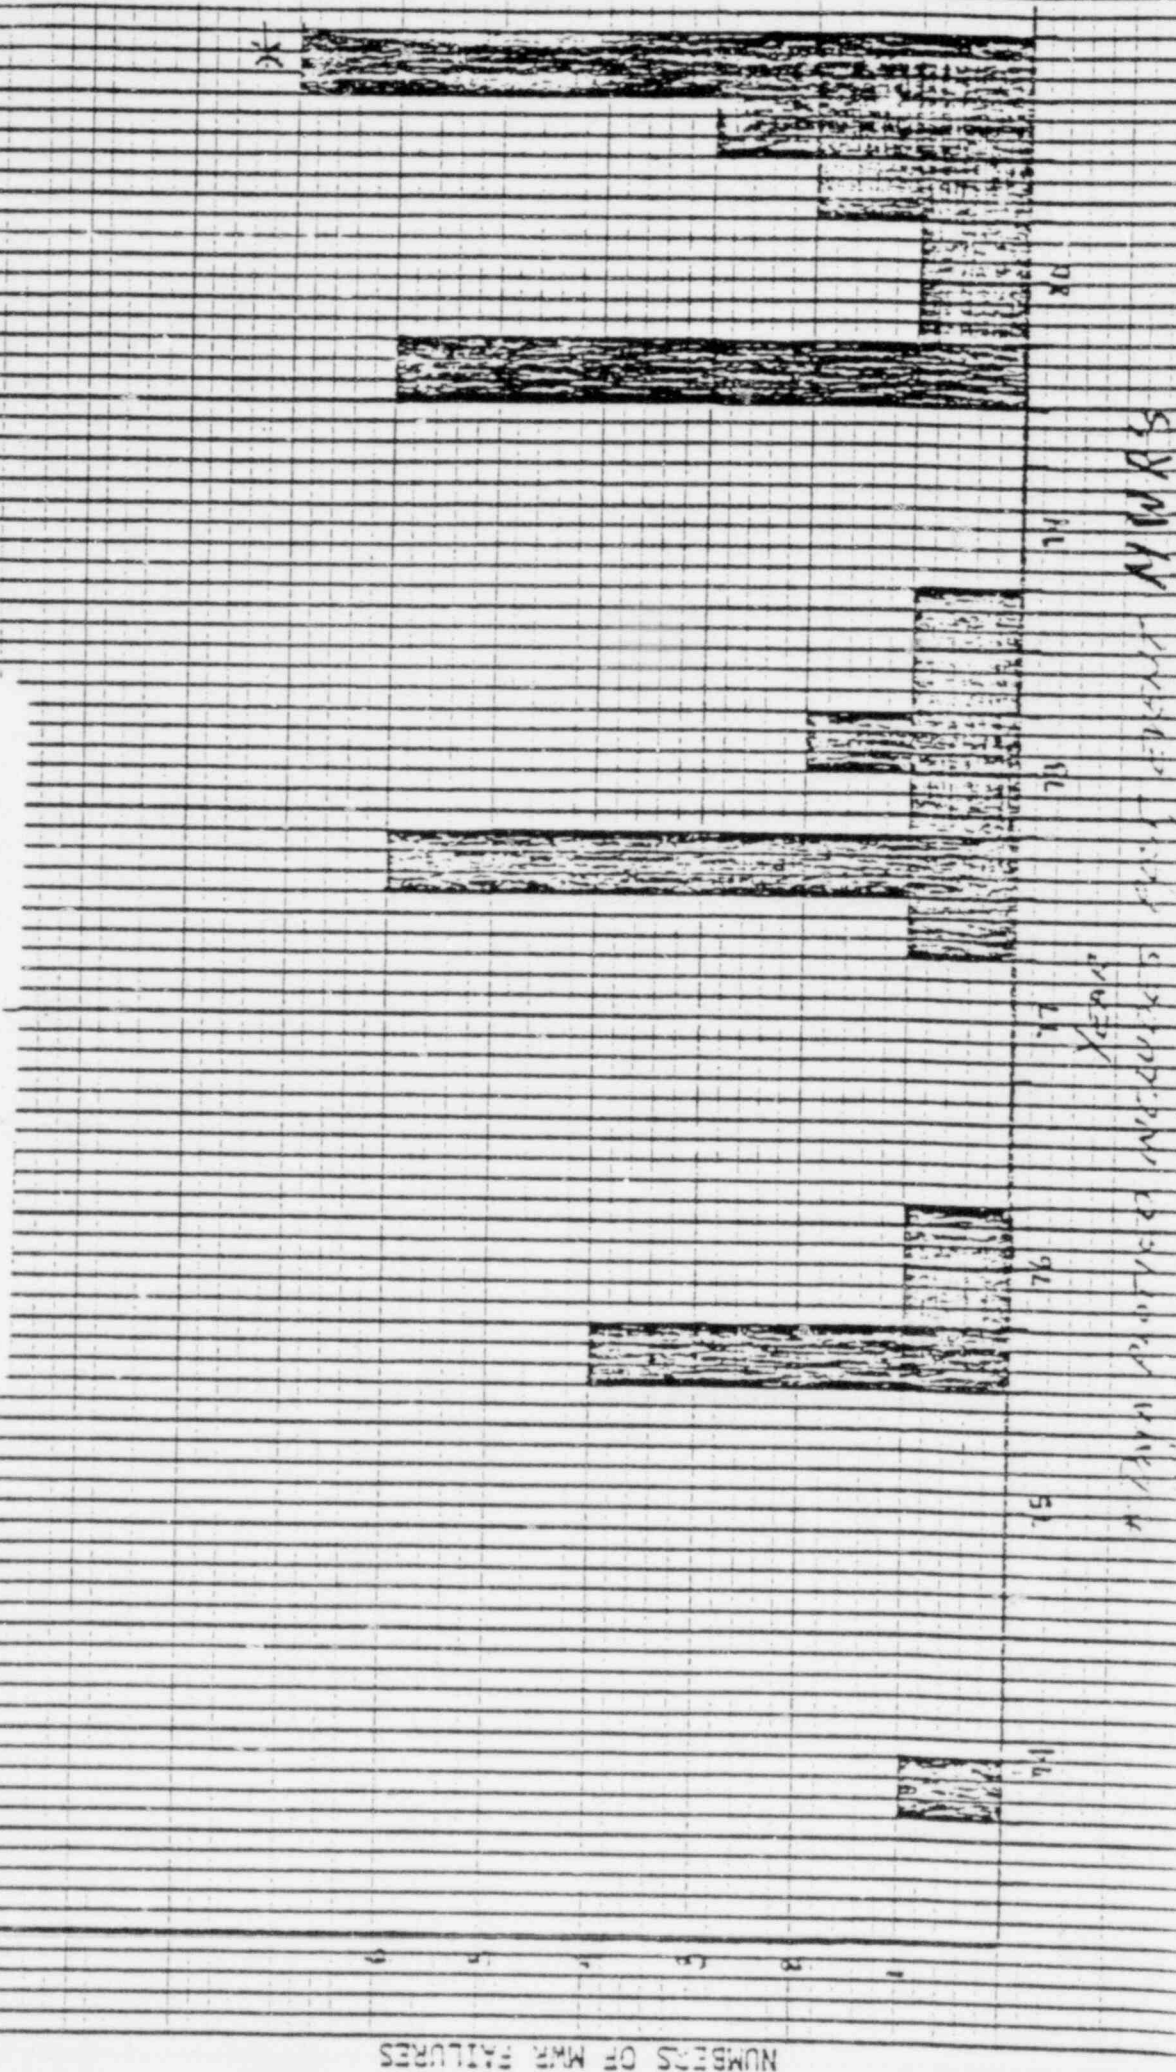
NRC SUMMARY  
TOTAL NUMBER OF MWR'S ISSUED  
FOR FAN COOLER UNIT AND RELATED  
SERVICE WATER PIPING LEAK  
REPAIRS BY YEARLY QUARTERS

PAN COOLER UNIT		TUBE FAILURE		WELD FAILURE		CORROSION AND JOINING FAILURE	
21	2	21	1	21	1	21	1
22	1	22	1	22	1	22	1
23	1	23	1	23	1	23	1
24	1	24	1	24	1	24	1
25	3	25	3	25	3	25	3
TOTAL	8	TOTAL	8	TOTAL	8	TOTAL	8

NOTE (1) MEASURES OF TUBE FAILURES IN ONE TUBE AS AILED FAILURE
