U.S. NUCLEAR REGULATORY COMMISSION
OFFICE OF INSPECTION AND ENFORCEMENT

Report No. 50-346/81-13

Facility Name: Davis-Besse Nuclear Power Station, Unit 1

Inspection on July 1-31, 1981 (Report No. 50-346/81-13)

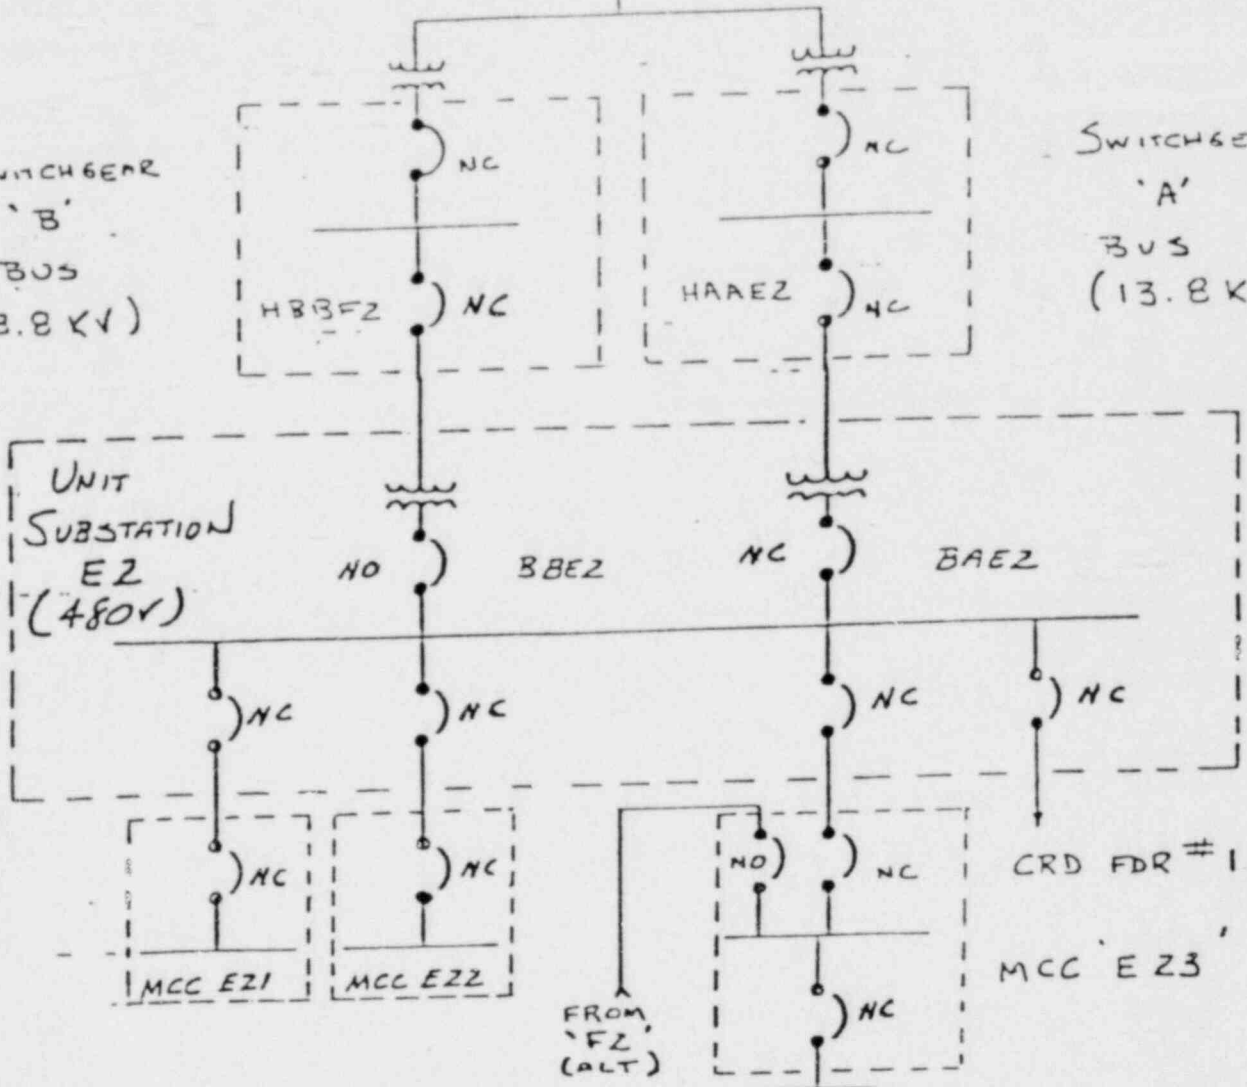
FIGURE 1

At approximately 1:27 p.m., construction personnel erecting scaffolding for Facility Change 80-137, inadvertently caused a mechanical shock to nonessential breaker NAAE2. The mechanical shock caused the ground fault relay to activate and trip the breaker.

The loss of E2 bus deenergized the power supply, E23, to the borated instrumentation distribution panel YAR which is the alternate supply to uninterruptible instrument power panel YAU. Since YAU was on its alternate supply, YAU was also deenergized.

The loss of power to YAU resulted in a loss of station annunciators, computer peripherals, both saturation meters, No. 2 bus for the control rod drive breakers, the diesel fire pump control panel and AC power to "Y" bus of non-nuclear instrumentation. The loss of power to the control rod drive breaker resulted in a reactor scram.

The loss of control room annunciators hindered the response to the transient. The station annunciators are per initial design powered only from YAU. YBU is a backup supply to the audible signal (horn) only. The licensee has implemented Facility Change 81-188 which provides power to the control room annunciators from YAU and YBU. The modification provides an automatic transfer from the primary source (YAU) to the backup source (YBU). The inspector witnessed the acceptance test conducted for this modification. This modification will alleviate the loss of assessment condition experienced during the June 24 event.
