UNITED STATES OF AMERICA
NUCLEAR REGULATORY COMMISSION

In the Matter of }
UNION ELECTRIC COMPANY }
(Callaway Plant, Unit 1) } Docket Nos. 50-483 OL

AFFIDAVIT OF EUGENE J. GALLAGHER IN SUPPORT OF
NRC STAFF MOTION FOR SUMMARY DISPOSITION ON THE
ISSUE OF JOINT INTERVENORS'S CONTENTION I-A

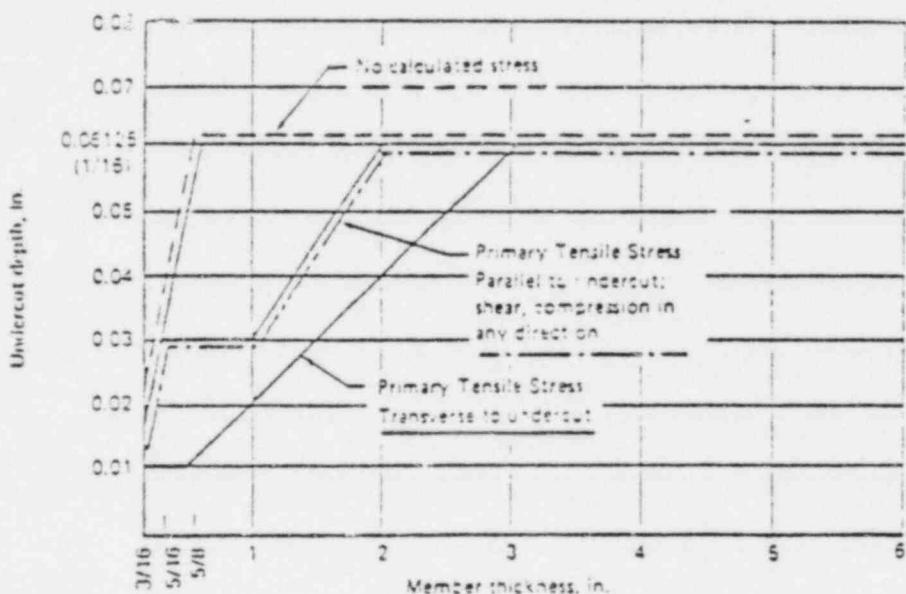
Fig. 8.15.1.5 — Permissible undercut values for buildings

4. NRC noted that current (1980) AWS D1.1 section 8.15 does not allow 1/16" undercut.
