October 22, 1981
Fort St. Vrain
Unit No. 1
P-81253

REPORTABLE OCCURRENCE 81-060

FORT ST. VRAIN NUCLEAR GENERATING STATION
PUBLIC SERVICE COMPANY OF COLORADO
16805 WELD COUNTY ROAD 19 1/2
PLATTEVILLE, COLORADO 80651-9298

REPORT NO. 50-267/81-060/03-L-0

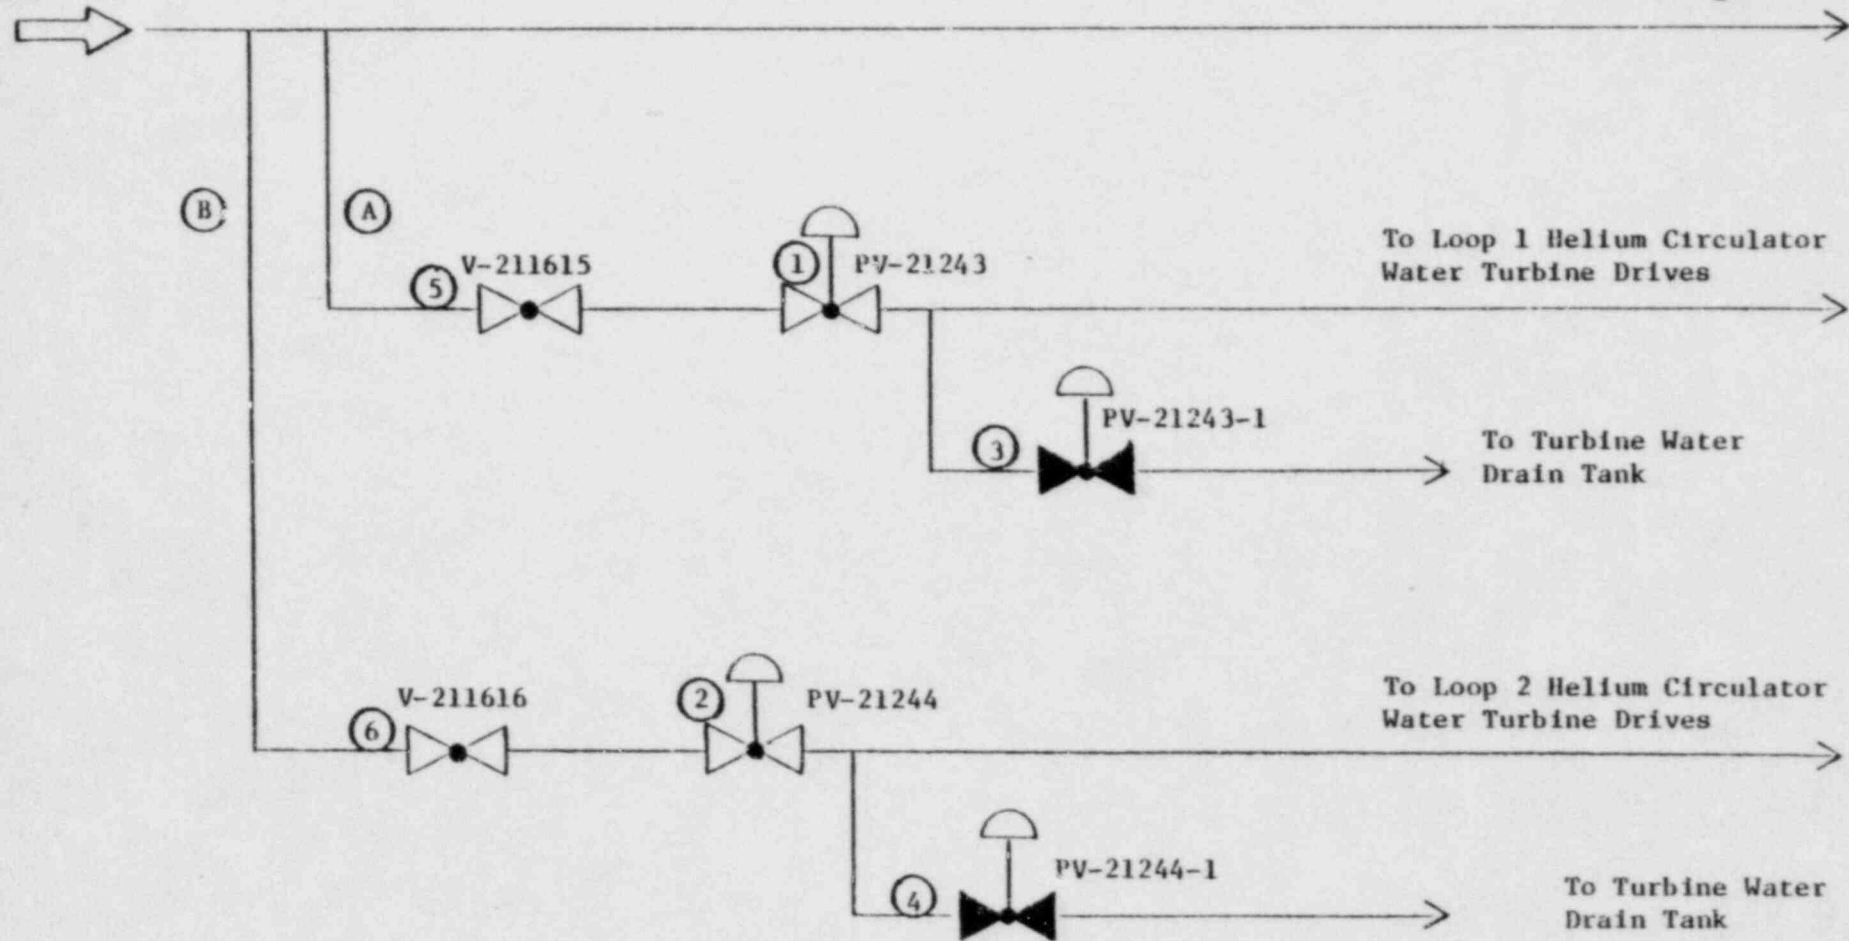
FIGURE 1

On September 22, 1981, with the plant operating at 70% thermal power and 243 MWe, excessive leakage through PV-21243 necessitated isolation of emergency feedwater to Loop 1 helium circulator water turbine drives to effect repairs. Refer to Figure 1 for simplified diagram of this system. A pressure control system is provided to control emergency feedwater flow to each of the circulator pelton wheel supply headers (A) and (B) under flow and no-flow conditions. Under flow conditions, PV-21243 (1) controls supply header pressure. Under no-flow conditions, PV-21243-1 (3) is provided to relieve excess header pressure to the turbine water drain tank in the event PV-21243 leaks through. In this instance, leakage through PV-21243 was in excess of the capabilities of PV-21243-1, and increased Loop 1 supply header pressure. This did not, in itself, render the emergency feedwater to Loop 1 circulators inoperable. A Plant Trouble Report was initiated, and the emergency feedwater was isolated ahead of PV-21243 (5) at 0010 hours on September 22, 1981. Repairs were made to PV-21243, and pelton drive water system was restored to service at 2140 hours on September 22, 1981.

Excessive leakage through PV-21243 required isolation of emergency feedwater to Loop 1 helium circulators to effect repairs. The leakage was due to wear on the gasket surface between the seat ring and the valve body.

The gasket surface in the valve body of PV-21243 was built up by applying devcon compound to eliminate leakage. The valve was re-assembled, and the system returned to service.

The valve stroke was lengthened.

The valve disc and seat ring were replaced. The valve was re-assembled and returned to service.

A Plant Trouble Report has been written to have this valve rebuilt during the upcoming maintenance shutdown.
