SUBJECT: EVALUATION OF JUSTIFICATION FOR CONTINUED OPERATION OF  
DIABLO CANYON UNIT 1 (TAC NO. 69826)

### DIABLO CANYON UNIT 1

#### EVALUATION OF LICENSEE'S PROPOSED JUSTIFICATION FOR CONTINUED OPERATION OF UNIT 1

Re: Docket No. 50-323, OL-DPR-82 Docket No. 50-275, OL-DPR-80  
Diablo Canyon Units 1 and 2  
Licensee Event Report 2-88-014-00 - Voluntary  
Anchor Darling Check Valve Retaining Block Stud Breakage Due To  
Intergranular Stress Corrosion Cracking

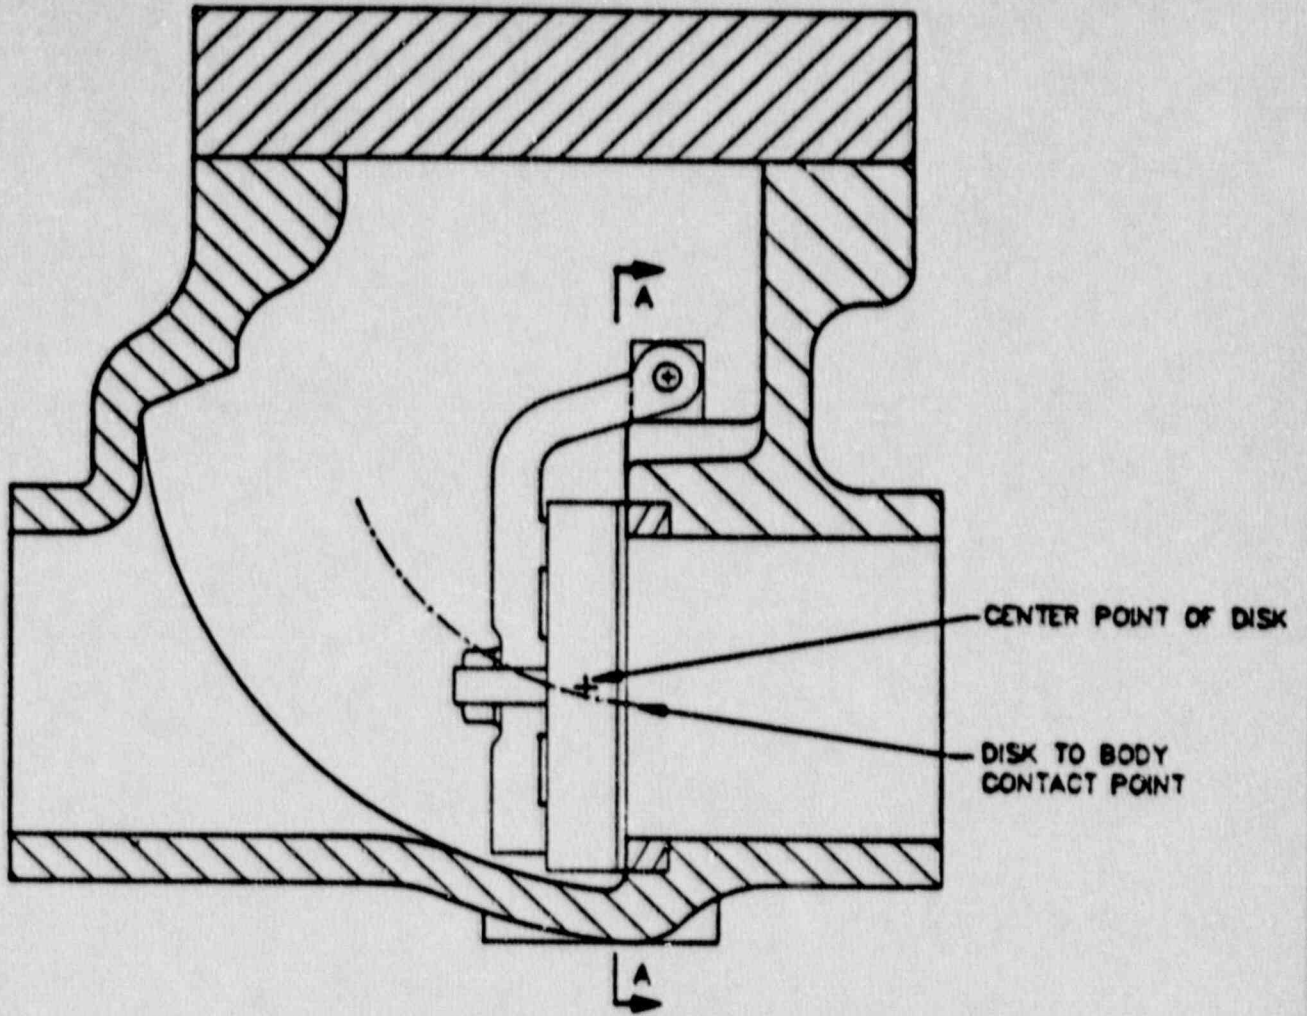
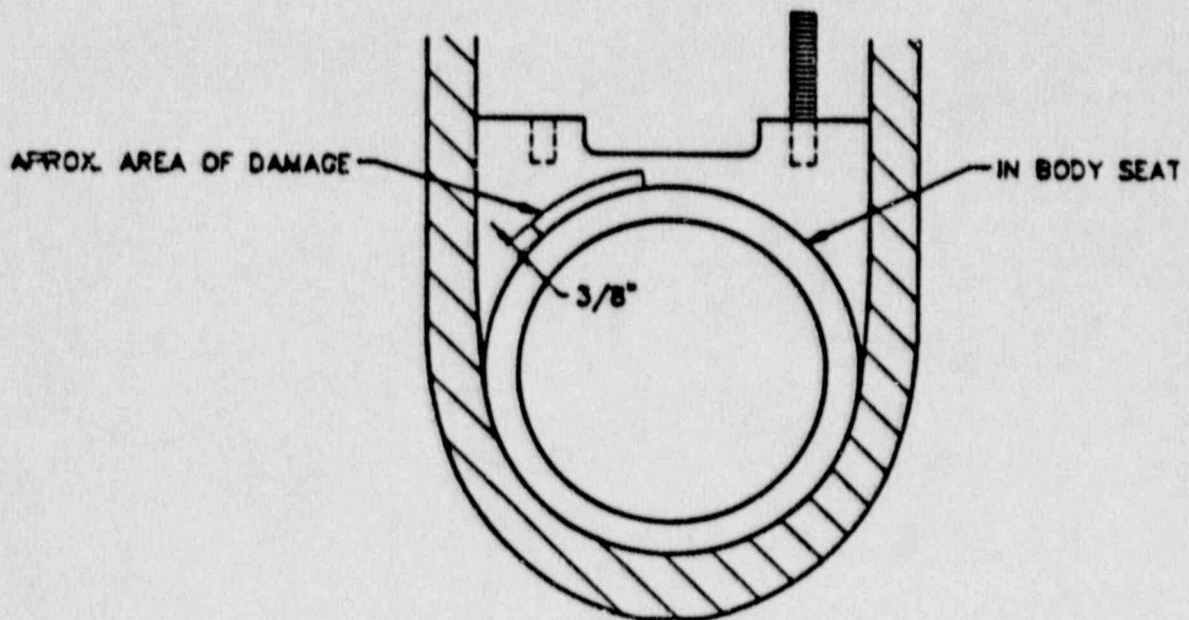
ANCHOR DARLING CHECK VALVE

On October 9, 1988, during a Unit 2 refueling outage valve inspection, two broken retaining block studs were found in check valve RHR-2-8740A. The broken studs were found after the valve had been manually cycled through its travel arc twice with no apparent problems. One stud was severed flush with the valve body while the other stud had a stub extending about 1-9/16 inches into the retaining block. Four alignment guide pins were observed to be in place and intact in the retaining block to valve body mating surface. The studs were made of ASTM A193 B6 type 410 stainless steel (SS).

The only abnormalities noted were in the 10 to 12 o'clock position (facing the valve seat from downstream) outside the in-body seat area, and consisted of wear marks 3/8 inches wide and estimated to be 1/32 to 1/16 of an inch deep (see drawing: Attachment 1). Precise measurements were not possible due to radiological clothing interference and difficult accessibility. The wear marks could have been caused by disc-to-body contact. The mechanic noted that the retaining block studs had significant corrosion product buildup.

IGSCC caused retaining block studs to fail in service.

The manufacturer's incorrect heat treatment of the check valve retaining block studs caused susceptibility to IGSCC. This was determined by material analysis, hardness testing, and microscopic section examination of the studs in a materials laboratory.

All Unit 2 Anchor Darling check valve retaining block studs have been replaced with studs made of vendor recommended ASTM A564 type 630-1100 material.

All Unit 1 Anchor Darling check valve retaining block studs will be replaced with studs made of vendor recommended ASTM A564 type 630-1100 material before the end of the next refueling outage.

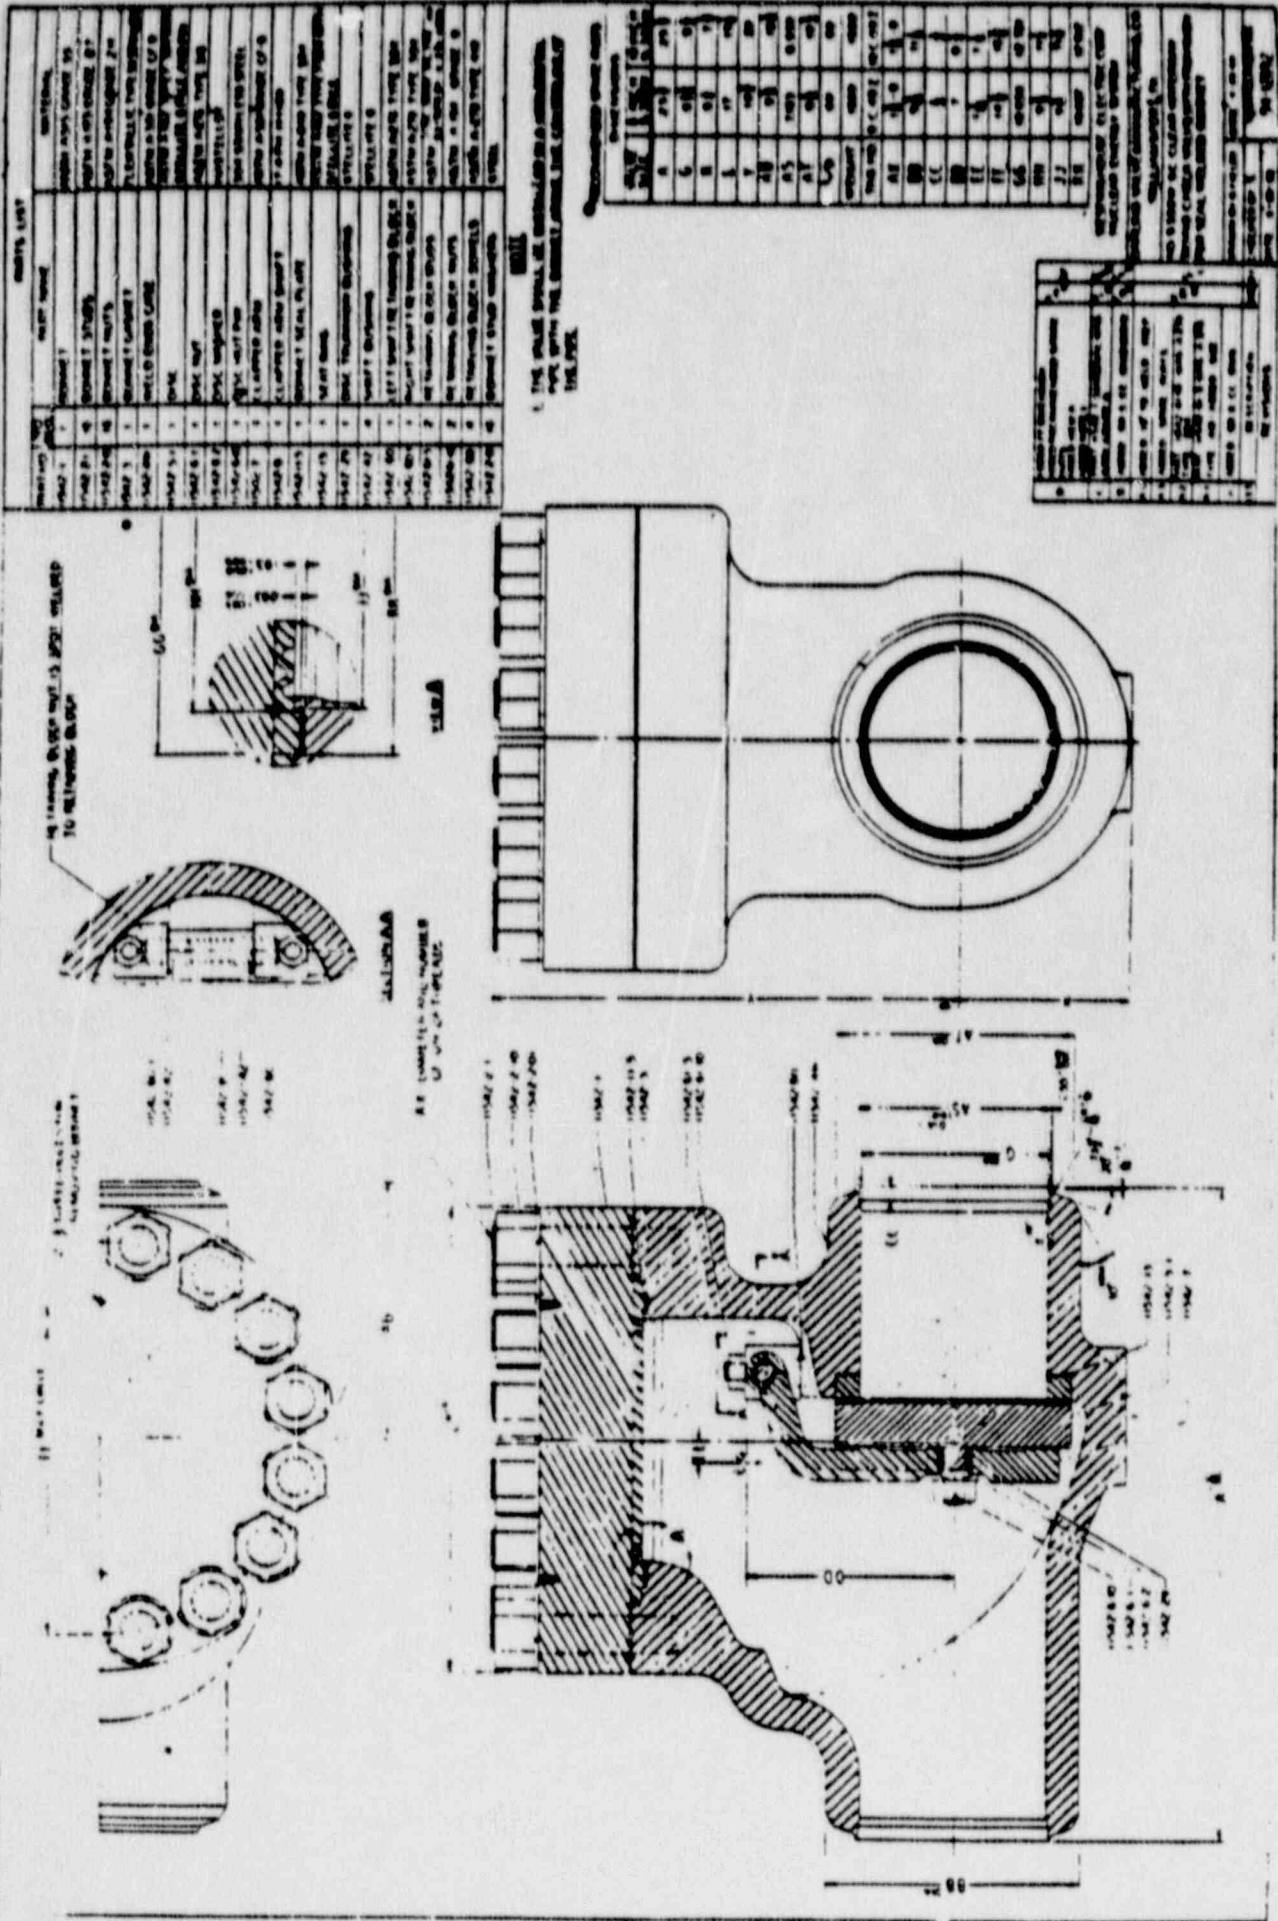
FIGURE 1: DARLING CLEAR WATERWAY CHECK VALVE

In conjunction with the performance of other maintenance on 8" Darling Clear Waterway swing check valve (2-SI-151W) installed in the low pressure emergency core cooling system (ECCS), an inspection of the valve internals was performed in accordance with the maintenance program that we established in response to INPO SOER 86-03. During this inspection, one of the two retaining block studs was found broken and the other cracked. A diagram of the valve type in question is provided in Figure 1. The retaining block studs (Part No. 11542-61-5) retain the blocks (Part Nos. 11542-60/60-1) that hold the valve disc assembly in place. As a result of this finding, the corresponding check valve (2-SI-151E) in the redundant low pressure ECCS train was

inspected. Again, one of the two retaining block studs was found broken and the other cracked. Discovery of this second instance prompted the expansion of the inspection to all Unit 2 Darling check valves of the same design as those in which the degraded studs were found. There are 12 valves of this design installed in the ECCS and RHR systems in each unit at Cook Nuclear Plant. All of these valves are classified as pressure isolation valves (PIVs) and leak tested in accordance with our IST valve program. They are:

The continuing Unit 2 inspections identified one additional check valve with one cracked stud (2-SI-166L4), and one valve (2-SI-166L1) in which, although the studs were intact, the stud material did not have the appearance typical of Type 410 stainless steel, the material specified on the valve drawing for the retaining block studs. Both valves are located on the accumulator outlet. A summary of inspection results for the valves inspected in both Unit 1 and Unit 2 is provided in Table 1.

Type 410 stainless steel were replaced with A-193 Grade B8 stud material. This new stud material is recommended by the valve manufacturer for this application. In addition, maintenance job orders were initiated to replace all A-193 Grade B6 Type 410 stainless steel studs with the new A-193 Grade B8 material regardless of whether any degradation is currently evident. This action is also in accordance with the valve manufacturer's recommendation. To date, retaining block studs in 10 of the 12 Unit 2 check valves and 4 of the 12 Unit 1 check valves have been replaced with the new A-193 Grade B8 stud material. The studs in the remaining Unit 2 check valves will be replaced during the current steam generator repair project outage. The studs in the remaining Unit 1 check valves are to be replaced during the next scheduled outage, with the possible exception of those installed in the low pressure injection lines to the cold legs (1-SI-170L1, L2, L3 and L4). Service conditions for these valves may not be conducive to the type of stud degradation observed in the other systems inspected. Westinghouse, who supplied the check valves under the original NSSS contract, and Darling, the valve manufacturer, were advised of the inspection findings discussed above. Westinghouse is conducting metallurgical evaluations to determine the root cause of the stud degradation.
