Public Service Electric and Gas Company P.O. Box 236i Hancocks Bridge, New Jersey 08038  
Salem Generating Station

SALEM GENERATING STATION  
LICENSE NO. DPR-75  
DOCKET NO. 50-311  
UNIT NO. 2  
LICENSEE EVENT REPORT 89-022-00

TITLE (4)  
**Tech. Spec. Action Statement 3.0.3 Entry; SJ49 Valves Do Not Meet Design Basis Req'ts.**

Technical Specification Action Statement 3.0.3 entered; 21(22)SJ49 valves do not meet design basis requirements

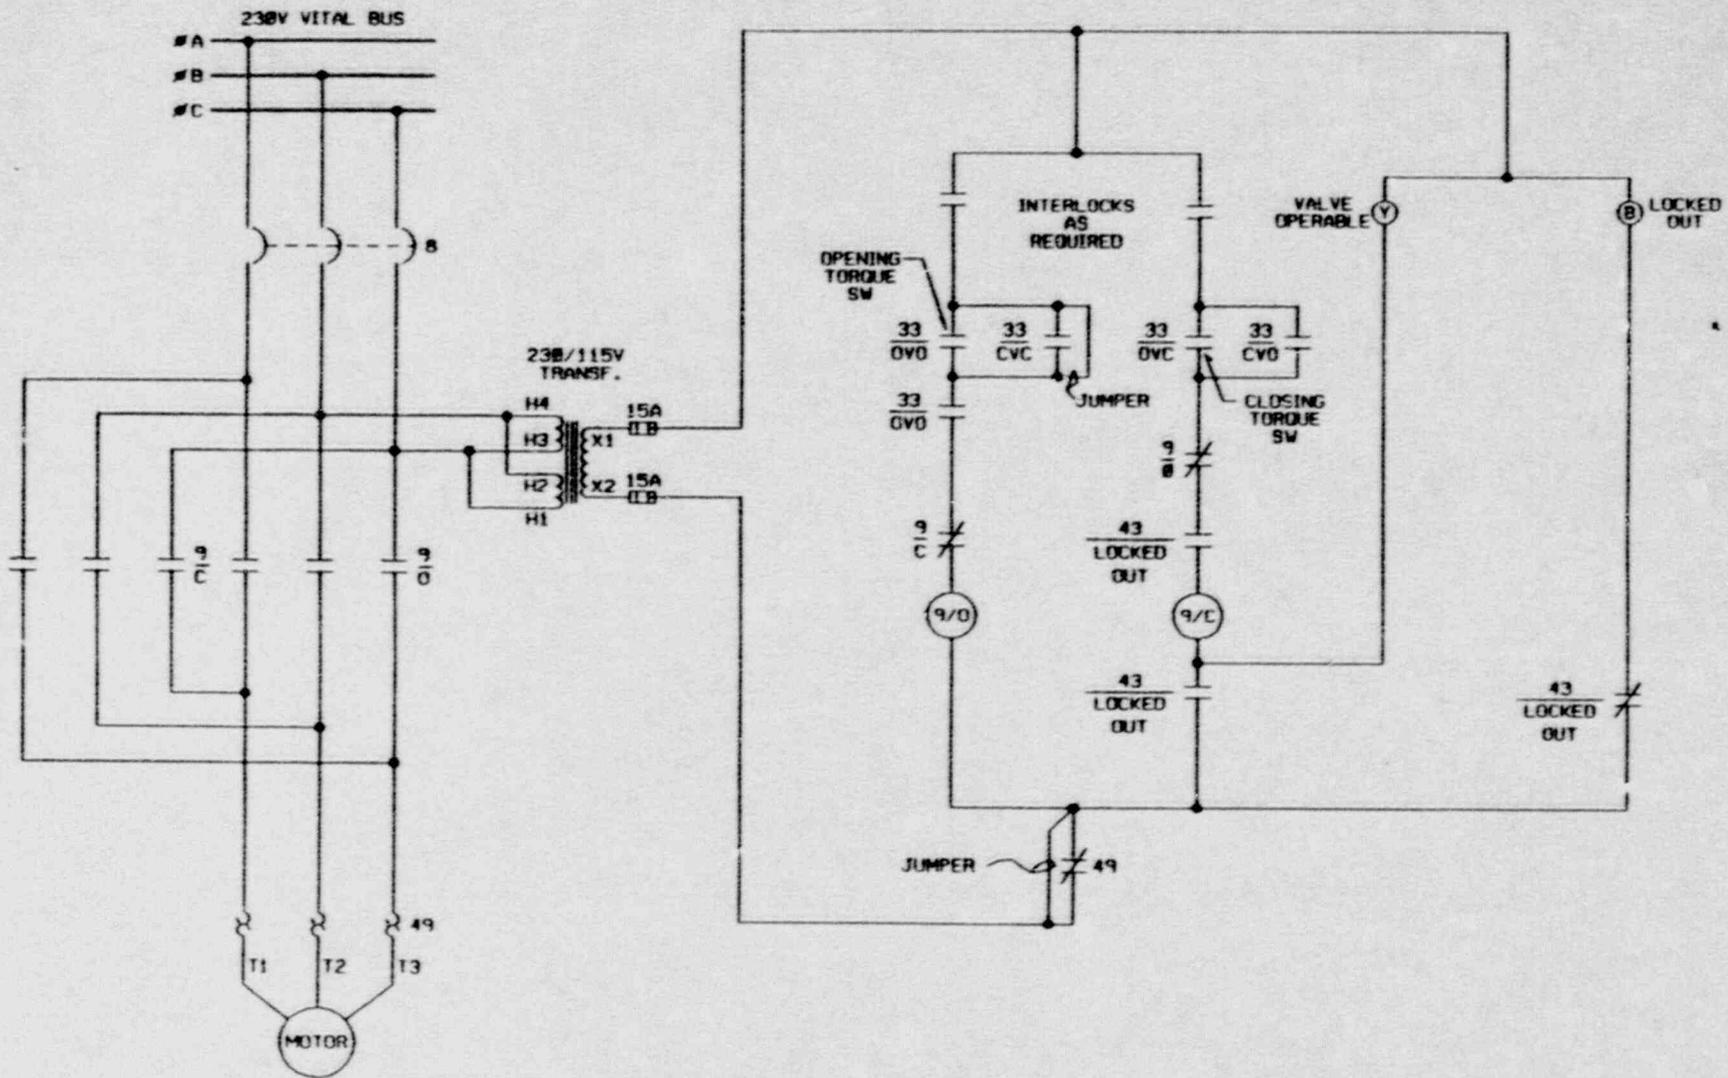
UPDATED FSAR FIGURE 7.3-3

The control power lockout design included a power lockout switch which isolated the closing coil of the motor starter. This design would then require two (2) distinct operator actions to close the valve; removal of the power lockout and pushing the CLOSE pushbutton. The design also precluded a single active failure from causing the valve to inadvertently close. The switch is monitored in the Control Room on panel RP4 by separate lights which would indicate a failure of the lockout circuit to provide the required isolation and also provide indication that the valve control circuit has been made operable by removal of the lockout. The control power lockout circuit is described in the Updated Final Safety Analysis Report (UFSAR) section 7.3.2.6 and Figure 7.3-3.

# LICENSED DESIGN

TYPICAL MOV 230V POWER LOCKOUT

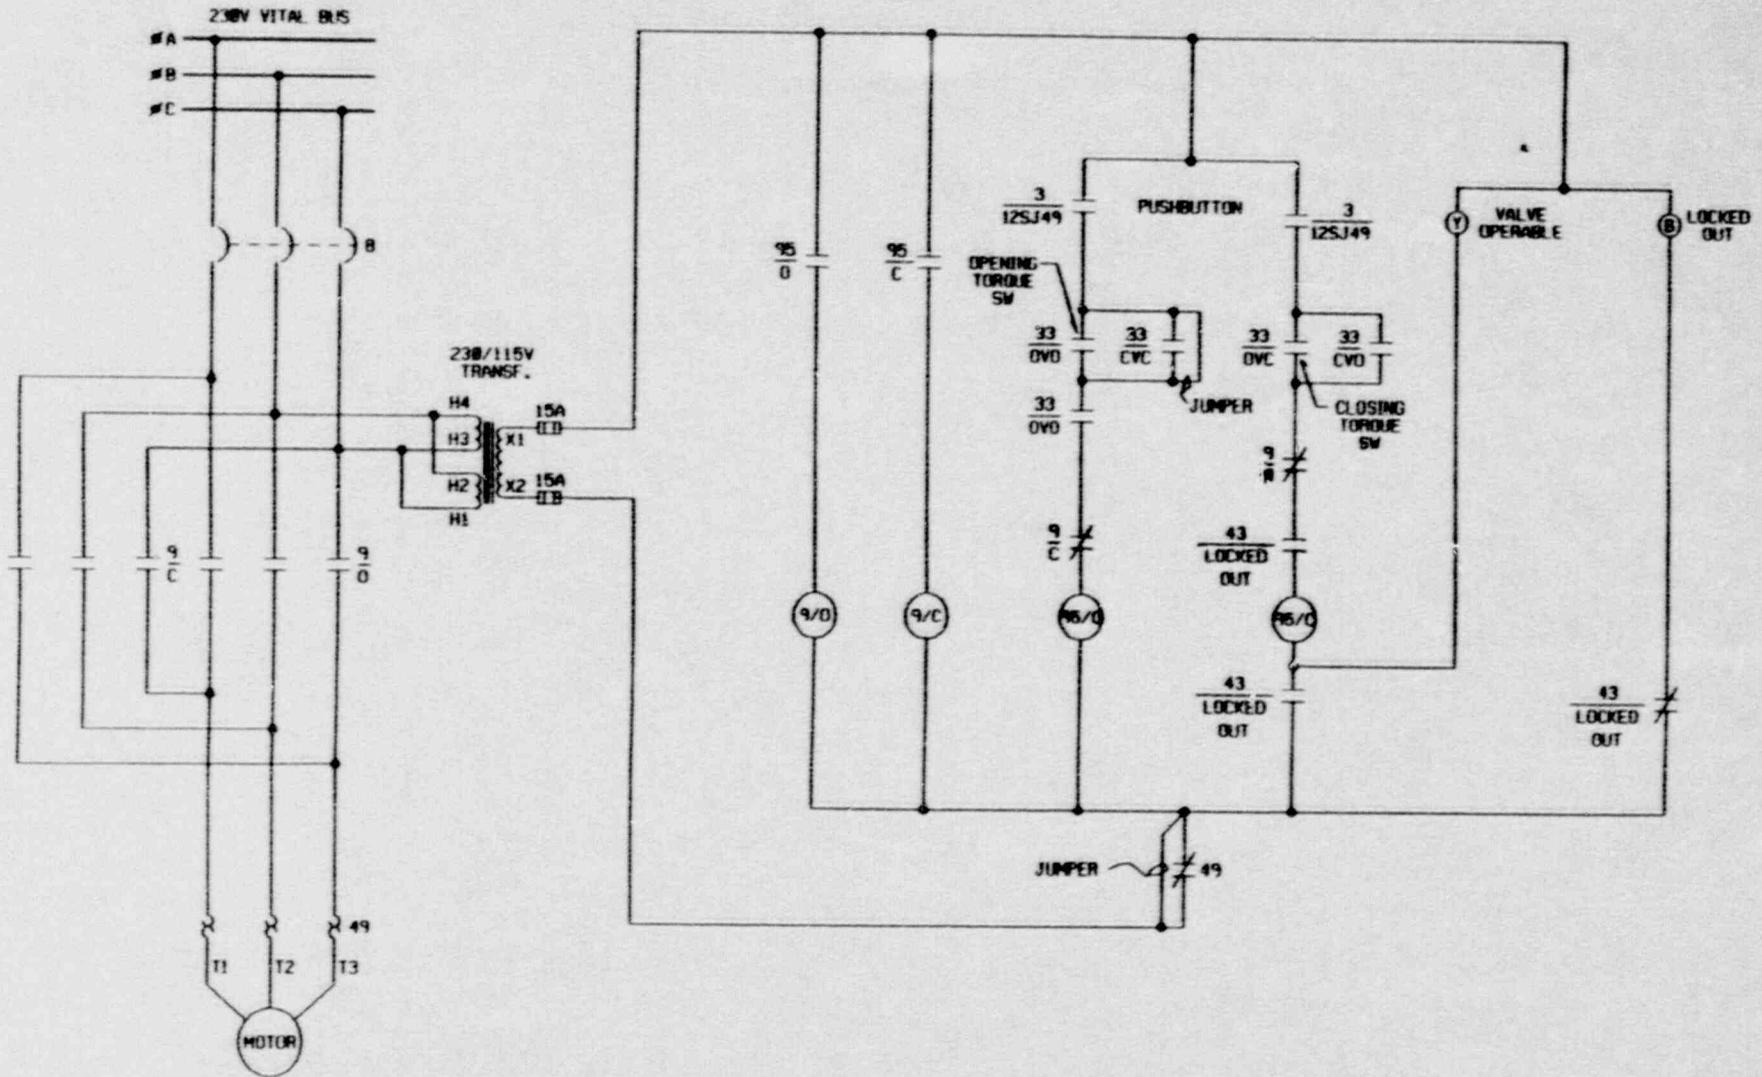
SJ49 MOV 230V POWER LOCKOUT

In December 1987 a design change was completed for both Units (reference DCP's 1(2)EC-2295) which alleviated the concern that a large voltage drop, caused by a large in-rush current, could potentially prevent the closing coil from picking up thereby preventing a required SJ49 valve closure. These DCPs added a low power interposing relay (95/C) locally at the Motor Control Center (MCC), thereby eliminating the long cable runs from the control room to the MCC for the motor starter closing coil, 9/C (see attached drawings). This significantly reduced the voltage drop associated with the high power starter closing coil. The new design placed the motor starter closing coil, 9/C, in series with a single contact off the interposing relay. This new configuration no longer provided for a completely isolated closing coil or the monitoring of the power lockout to the closing coil as described in the Updated Final Safety Analysis Report (UFSAR) section 7.3.2.6 and Figure 7.3-3. Therefore, the single failure of the 95/C interposing relay contact would both restore power to the 9/C closing coil and result in an undesirable closure of the valve.

This installation was judged by the NRC to be acceptable as it met the NRC staff review criteria of Branch Technical Position EICSB-18, Application of the Single Failure Criterion to Manually-Controlled Electrically-Operated Valves. However, as discussed in the Apparent Cause of Occurrence section, December 1987 design modifications to the SJ49 circuitry created a condition in which a single failure of the new interposing relay contact could restore power to the SJ49 circuit closing coil resulting in undesirable closure of the valve.

# CURRENT INSTALLATION

SJ49 circuitry design modifications will be completed during the next refueling outage for each Unit.
