Subject: Catawba Nuclear Station
Docket No. 50-414
LER 414/89-20

LICENSEE EVENT REPORT (LER)

TITLE (4) Technical Specification 3.0.3 Entry and Five Month Auxiliary Building Ventilation System Inoperability Due to a Clogged Air Flow Monitor Causing Reduced Flow

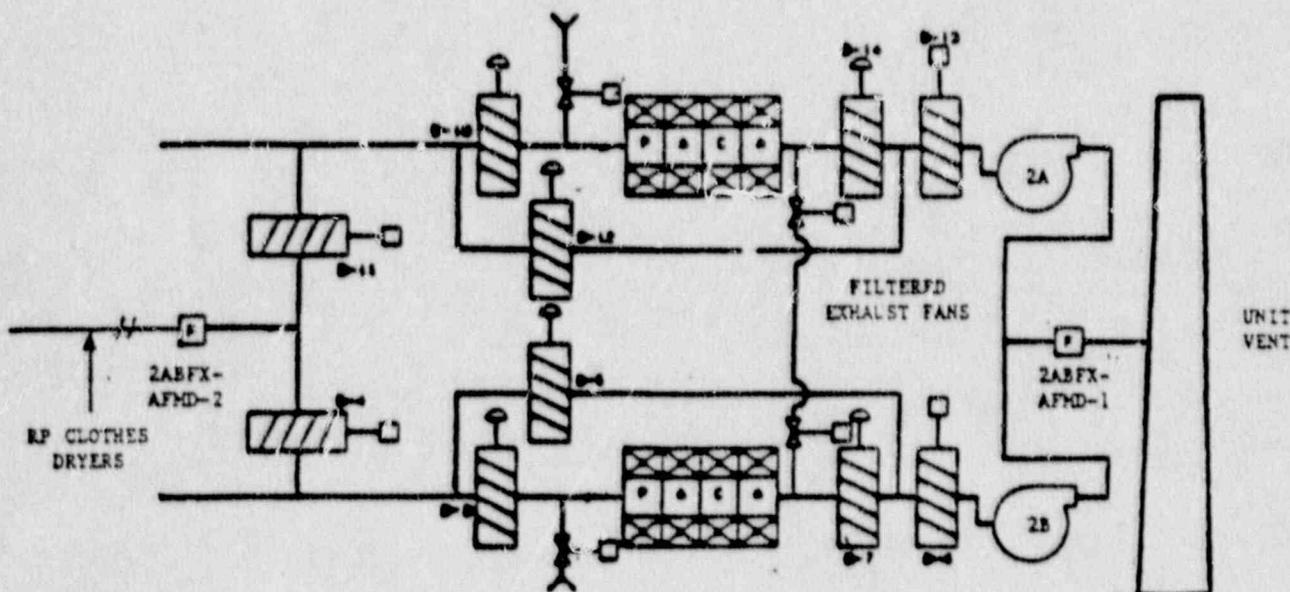
FIGURE 1

The Auxiliary Building Ventilation [EIIS:VF] (VA) System is designed to provide a suitable environment for equipment operation and personnel access during both normal and accident conditions. The Auxiliary Building Filtered Exhaust (ABFX) Subsystem consists of two exhaust trains per Unit with associated fans [EIIS:BLO] (ABFXF-1A, 1B and ABFXF-2A, 2B), filters [EIIS:FLT] and duct. An Air Flow Monitor Device (AFMD) (1ABFX-AFMD-1 and 2ABFX-AFMD-1) is located in the common duct downstream of each Unit's ABFX Subsystem and measures the combined flow of each Unit's filtered exhaust trains on the way to the respective Unit vent. There is also a second AFMD (1ABFX-AFMD-2, 2ABFX-AFMD-2) located upstream of each Unit's filters which is used during the flow balance testing (see Figure 1). The VA filters are bypassed during normal operation.

SCHEMATIC OF UNIT 2 FILTERED EXHAUST
