Subject: Pilgrim Nuclear Power Station Revised Operability
Evaluation of Installed Salt Service Water Pumps

BOSTON EDISON COMPANY
OPERABILITY EVALUATION

Revision 1

Salt Service Water Pumps (P208B, C, D, E)

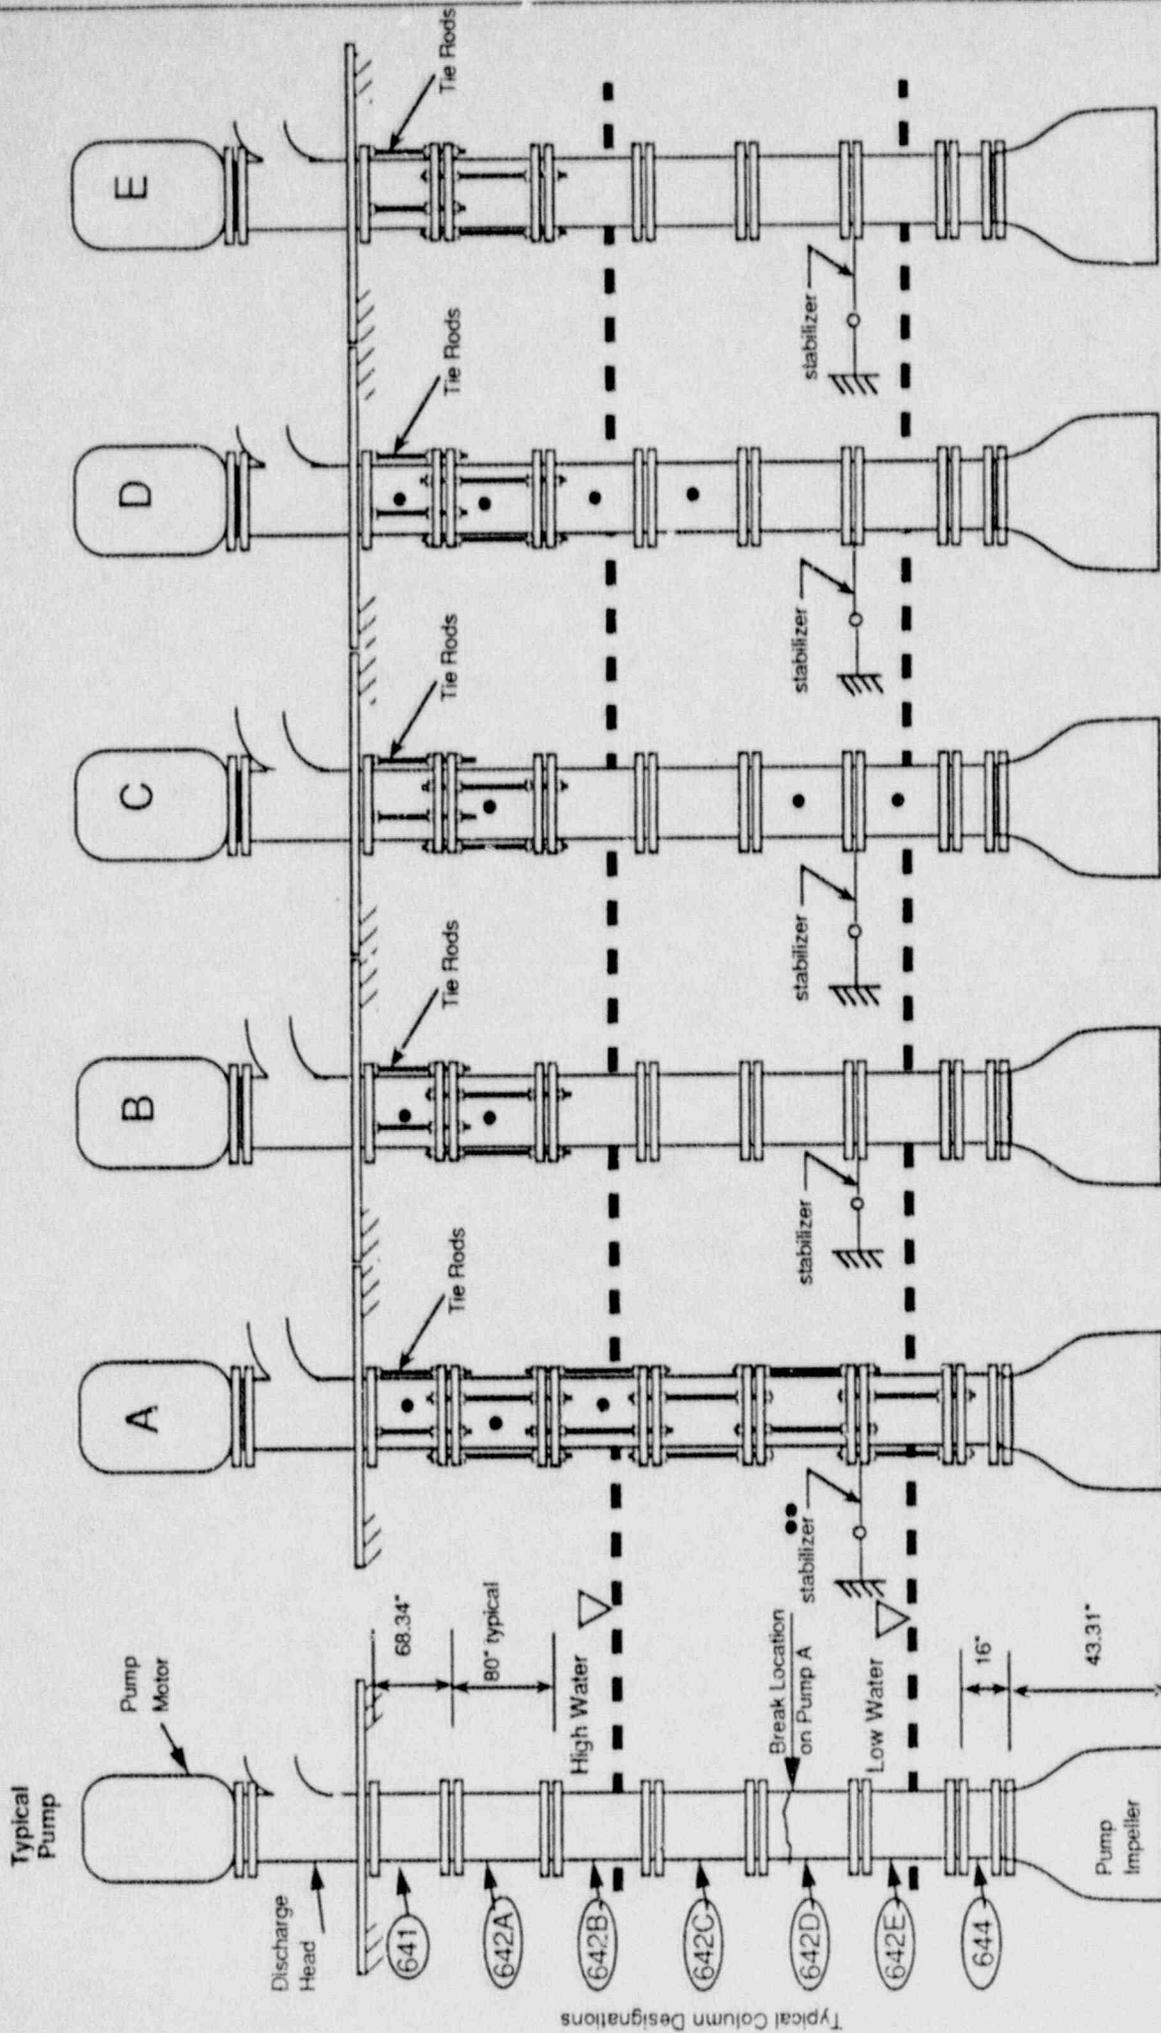
Figure 1

Improvements have been made in the manufacture of replacement column types 641 and 642 (See Figure 1). These columns are centrifugally cast versus the sand casting used in the failed column. Also, these columns are cast in two smaller pieces which allows for more uniform cooling and reduces shrinkage and porosity concerns that can result from a single piece casting. The two castings are then joined by a circumferential weld at the centerline to provide the finished product. Pumps B, C and D have some columns which have been manufactured using the improved processes. The pump manufacturer knows of no inservice failures of this new design. This better quality casting is recognizable by the circumferential weld at its centerline. These columns were visually verified to be installed in pumps B, C and D as indicated by dots (•) on Figure 1. Heat treating and controlled cooling of the castings will reduce the potential for significantly interconnected eutectoid formation in both centrifugal and sand castings. These treatments have been specified for the new replacement columns.

Key to Pump Column Designations & Pump Column Layouts

- Indicates columns installed since 1987
- Pump A Stabilizer: 2 of 3 legs are currently installed but are not credited in analyses because they are only fully effective for all loading directions if all 3 legs are installed.
