PHILADELPHIA ELECTRIC COMPANY

LIMERICK GENERATING STATION

SUBJECT: Licensee Event Report
Limerick Generating Station - Units 1 and 2

Reference:	Docket Nos. 50-352 50-353
Report Number:	1-90-002
Revision Number:	00
Event Date:	January 25, 1990
Report Date:	February 26, 1990
Facility:	Limerick Generating Station P.O. Box A, Sanatoga, PA 19464

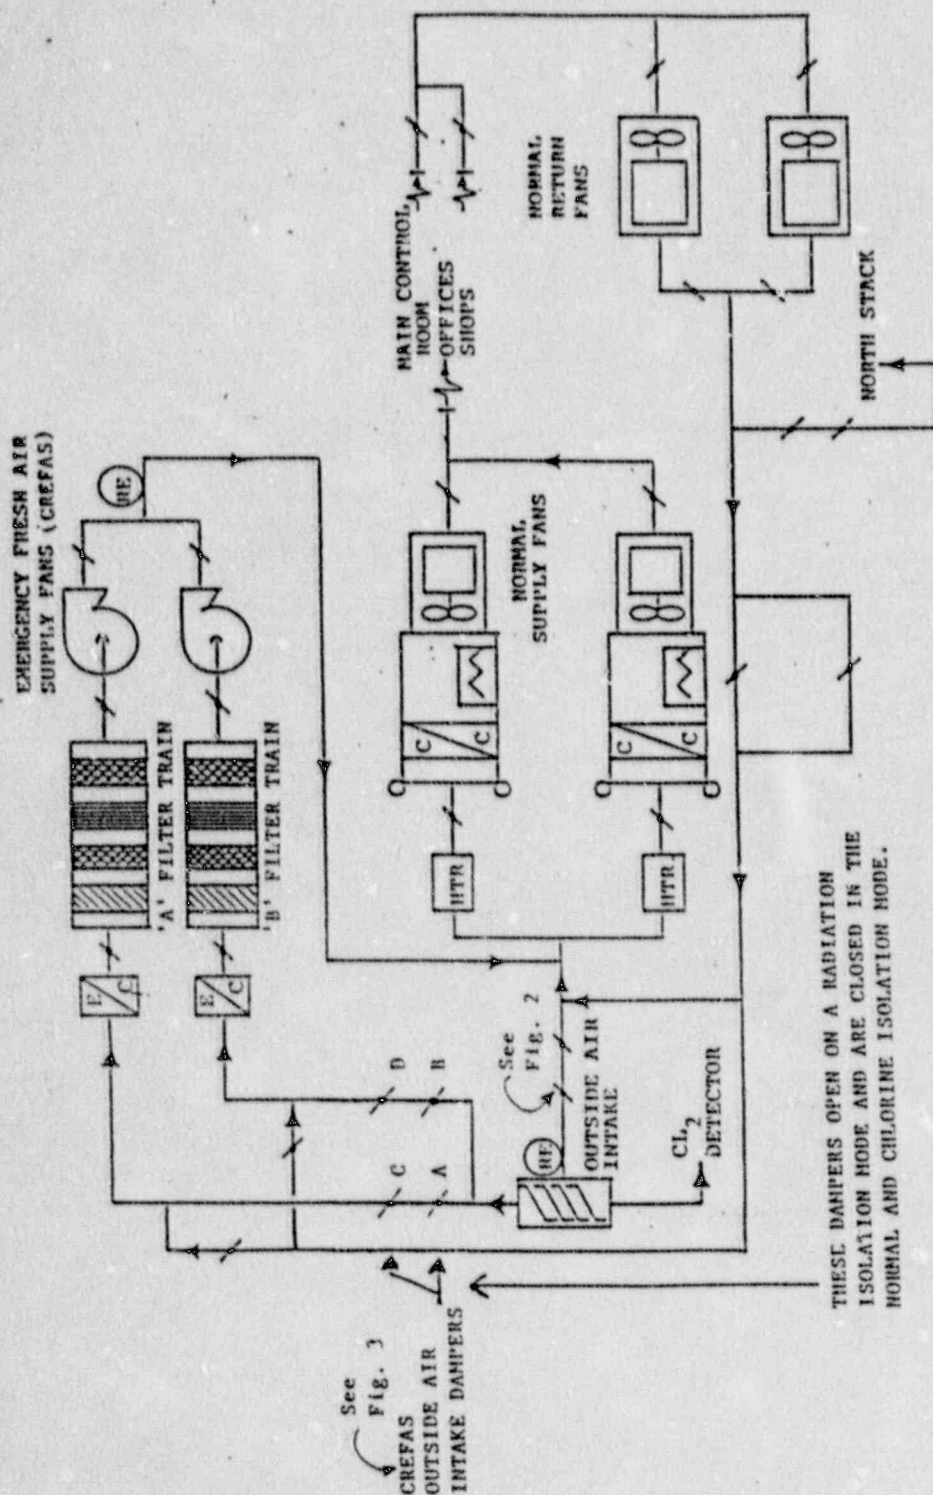
FIGURE 1

The Limerick Generating Station (LGS), Units 1 and 2, Main Control Room (MCR) Heating, Ventilation, and Air Conditioning (HVAC) system (EHS:VI) has several modes of operation (see Figure 1). There is a normal mode where outside air is circulated through the MCR and maintains it at a slight positive pressure. In the normal mode, the normal outside air intake isolation dampers are open and the Control Room Emergency Fresh Air Supply (CREFAS) System outside air intake dampers are closed. In the event of the presence of radiation in the normal outside air intake plenum, the normal MCR HVAC supply and exhaust flow paths are isolated from outside air and the CREFAS System is operated in the radiation isolation mode. The radiation isolation mode is a partial recirculation mode with the normal outside air intake isolation dampers closed and a maximum of 525 scfm of filtered outside air that enters the MCR through the CREFAS outside air intake dampers to maintain the positive pressure. In the event of the presence of chlorine or other toxic gases in the normal outside air intake plenum, the normal MCR HVAC system supply and exhaust flow paths are isolated from outside air and the CREFAS system is operated in the chlorine isolation mode. The chlorine isolation mode is a full recirculation mode with no outside air entering the MCR. In this mode, the positive pressure in the MCR decays to atmospheric pressure due to exfiltration. In both isolation modes, the recirculated or outside air flows through charcoal and High Efficiency Particulate Air (HEPA) filters.

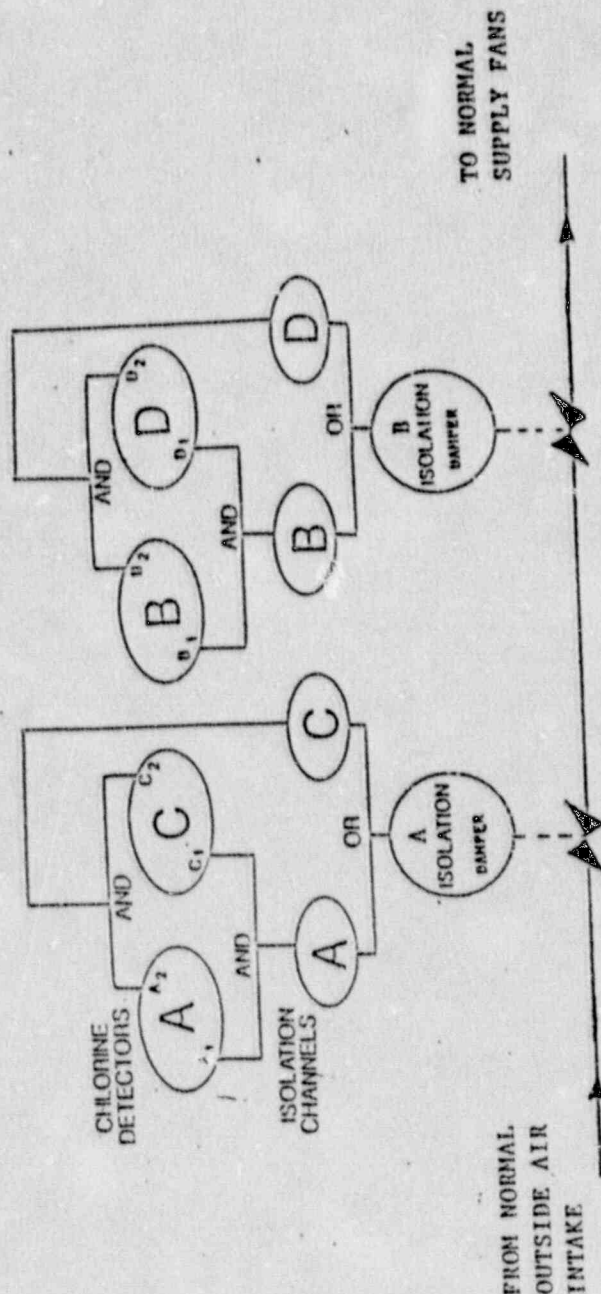
FIGURE 2

The chlorine isolation logic for the normal outside air intake isolation dampers is shown on Figure 2. Two chlorine detectors must detect chlorine to actuate the isolation logic resulting in closure of one of the two series normal outside air intake isolation valves.

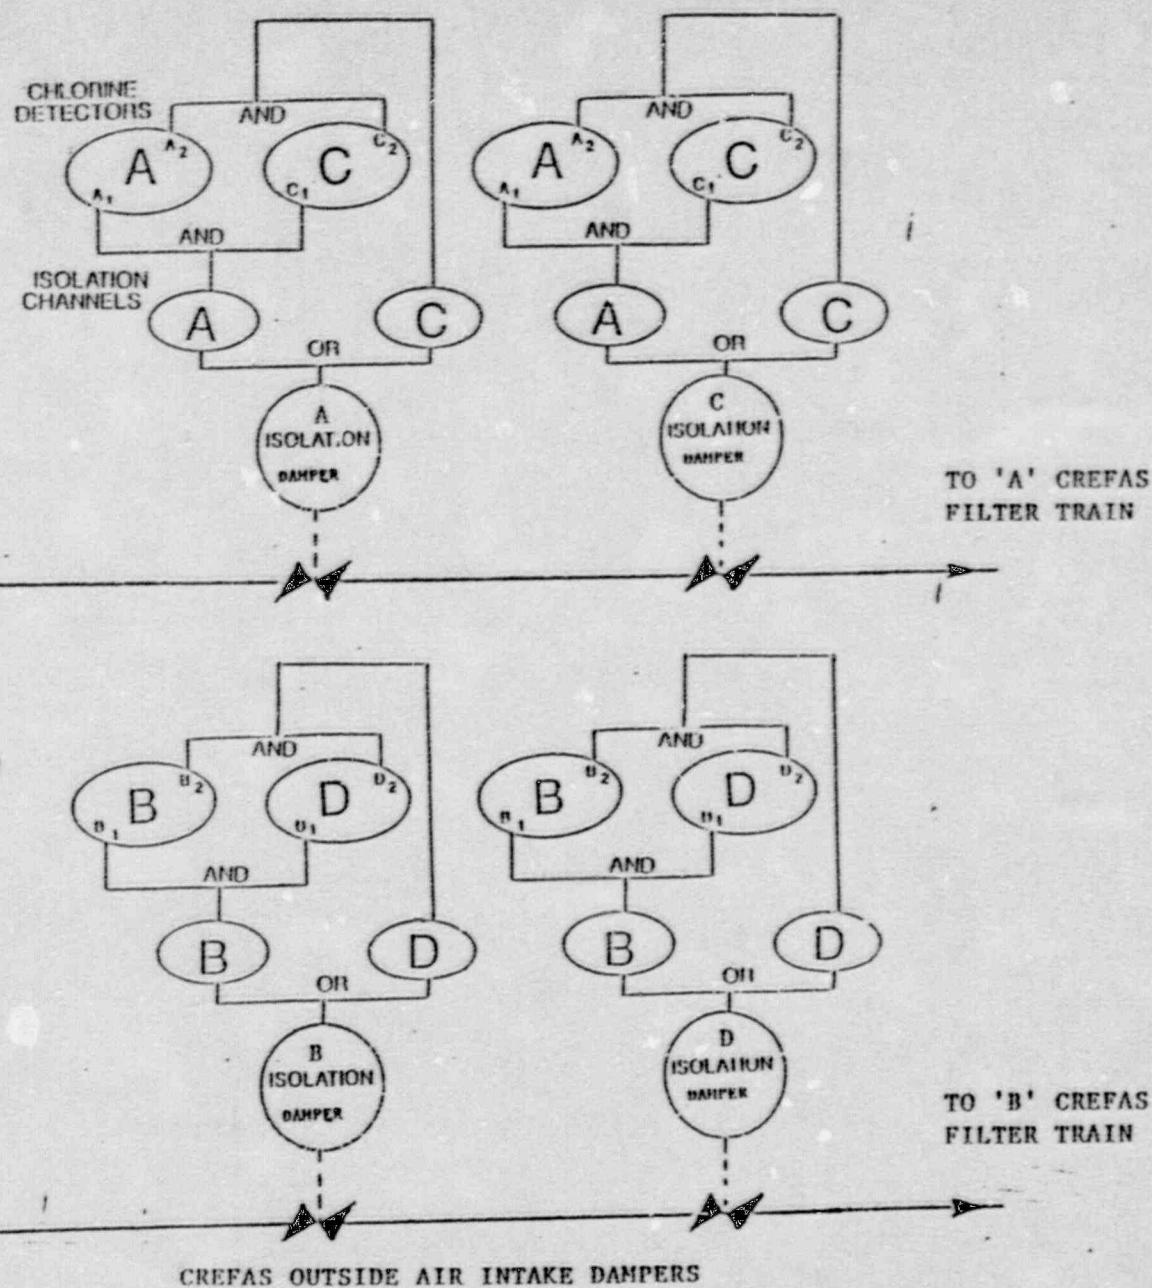
FIGURE 3

dampers. These isolation dampers only open in the radiation isolation mode and are closed in the normal and chlorine isolation modes. Following a modification on this system, the new chlorine isolation logic for the CREFAS system outside air intake dampers is shown as on Figure 3. Presently, all four chlorine detectors must detect chlorine to actuate the isolation logic to close the CREFAS outside air intake dampers in both filter train supply lines.

The configuration of the CREFAS system filtered outside air intake dampers and the associated chlorine logic was originally designed to conform with single failure proof criteria when the system is in the radiation isolation mode.

On January 25, 1990, it was determined that, if the MCR HVAC system is in the radiation isolation mode and an automatic chlorine mode isolation is required due to the presence of chlorine, a single failure in the chlorine isolation logic could prevent the CREFAS outside air intake isolation dampers from closing and completing the chlorine mode isolation. The possible single failures that could occur are a chlorine detector probe failure or a relay failure in the isolation logic. This is contrary to the description in the Final Safety Analysis Report (FSAR) sections 6.4.1.j and 7.3.2.10, which describe the MCR habitability system and indicate that the chlorine isolation design meets the single failure criteria.

A revision to the FSAR will be developed to further explain the design when the ambiguities of the design basis for the various isolation modes are resolved. The FSAR revision will provide sufficient information of the system design basis to prevent misinterpretation in the future.
