**DUKE POWER**

Subject: Catawba Nuclear Station  
Docket No. 50-413  
LER 413/90-08

Attached is Licensee Event Report 413/90-08, concerning TECHNICAL SPECIFICATION VIOLATION FOR INOPERABILITY OF A FIRE BARRIER PENETRATION DUE TO DESIGN OVERSIGHT.

TITLE (4) Technical Specification Violation For Inoperability Of A Fire Barrier Penetration Due To Design Oversight

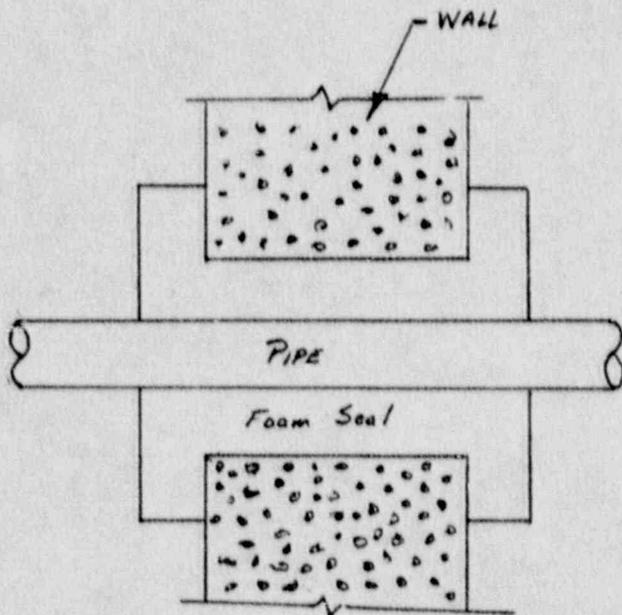
FIGURE 1

Firestop C-AX-217-F-26 is located in the floor/ceiling fire boundary between the Unit 1 Auxiliary Feedwater (CA) [EIIS:BA] Pump [EIIS:P] Room and the Auxiliary Feedwater Pump Turbine [EIIS:TRB] (CAPT) #1 Pit. Firestop C-AX-200-W-33 is located in the fire barrier wall between the Unit 1 Mechanical Penetration Room and the Unit 1 CA Pump Room. These firestops allow penetration of the Main Steam to Auxiliary Equipment [EIIS:SA] (SA) System piping to the CAPT #1. The CAPT is a part of the Emergency Core Cooling System to supply sufficient feedwater to the Steam Generators [EIIS:HX] to maintain decay heat removal to place the plant in shutdown conditions following loss of normal feedwater and essential power to the Motor [EIIS:MO] Driven CA pumps. The SA lines to the CAPT are insulated and equipped with Electrical Heat Trace [EIIS:FD] (EHT) elements arranged 90 degrees apart on the outside of the SA pipe under the insulation. The purpose of the EHT is to prevent condensate accumulation in the

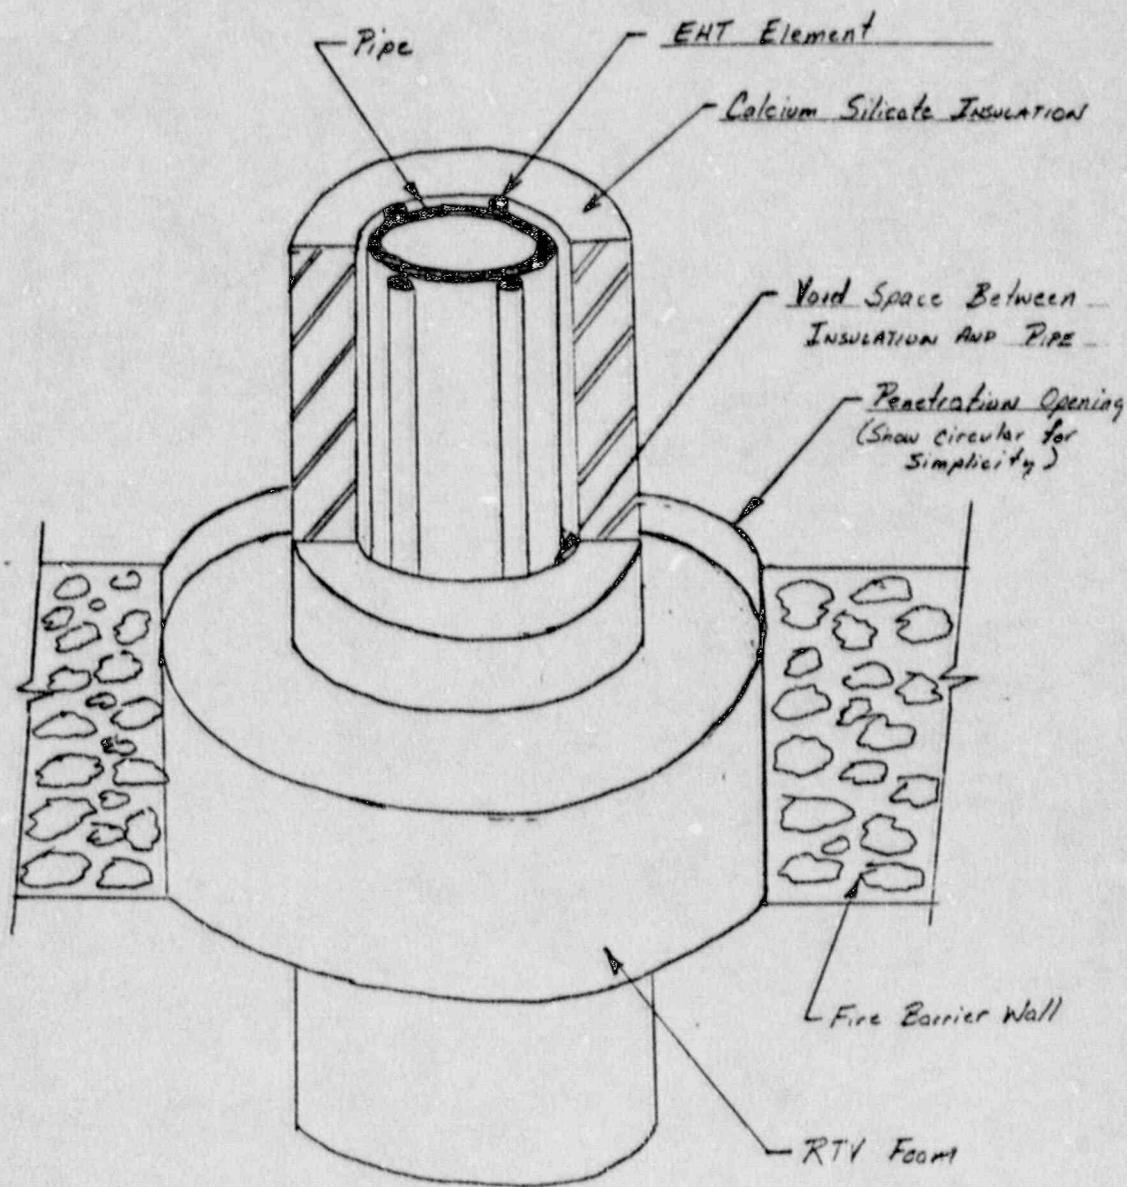
FIGURE 2

On February 3, 1990, at 1130 hours, with Unit 1 in Mode 5, firestop technicians working in the CA Pump Room noticed that insulation had been removed from the SA piping and that there was a 3/4 inch annular gap between the SA pipe and the calcium silicate insulation installed in the firestop. The firestop technicians recognized the fire barrier penetration as inoperable and promptly installed cerafiber bulk in the opening per Work Request 4859 SWR to return the fire barrier to operable status. The fire barrier was subsequently removed and reinstalled on February 14, 1990, to facilitate the replacement of the EHT element. During the reinstallation, cerafiber bulk was installed between the insulation and the SA pipe to prevent recurrence of the problem due to insulation removal. This problem was documented on PIR 1-C90-0041 on February 9, 1990, and was evaluated to be reportable to the NRC since a fire watch was not established when the insulation was removed.

In addition to the original Design oversight involving the long term temperature limits of the RTV Silicone foam material, Design oversight was involved in the subsequent alteration on August 24, 1988, of the fire barrier to correct the temperature problem at firestop C-AX-217-F-26. The annular space between the calcium silicate insulation and the SA line, which was caused by the interference of the EHT elements, was not recognized by DE or MES Production Specialist A as a potential problem if the insulation was removed adjacent to the firestop. This discrepancy was also not noted by the firestop technicians since after vendor insulation personnel insulated the line through the penetration the discrepancy was not visible when the firestop was sealed with foam. The Firestop Installation Specification and/or the Firestop Maintenance Procedure will be revised to specifically address the installation of insulated pipes through firestops. Also, other penetrations had not been identified as having the potential for high, long term temperature leading to degradation of sealant foam.

CUTAWAY REPRESENTATION OF  
SA Line With Insulation  
Passing Through Firestop

- 1) The discrepancy in firestop C-AX-217-F-26 was repaired using cerafiber bulk firestop material per Work Request 4859 SWR.
- 2) After the discovery of the discrepancy in firestop C-AX-200-W-33, a fire watch was established and the EHT in the penetration was insulated and the firestop was reinstalled.
- 3) The insulation supervisor discussed this incident with the insulation crew to report indication of fire barrier discrepancies and re-emphasized the need to contact MES when working around fire barrier penetrations.

- 1) All four remaining heat traced SA penetrations on Units 1 and 2 will be insulated through the penetrations to prevent sustained temperature damage.
- 2) Steam Generator Blowdown [EIIS:WI] and Nuclear Sampling [EIIS:KN] System penetrations in the Mechanical Penetration Room will be evaluated to determine if firestop temperature limitations are affecting these penetrations.
