SUBJECT: U. S. NUCLEAR REGULATORY COMMISSION REVIEW OF HOMESTAKE MINING COMPANY OF CALIFORNIA'S REPLY TO "RESPONSE TO THE HOMESTAKE MINING COMPANY OF CALIFORNIA LETTER, DATED JULY 26, 2018: PROPOSED ADJUSTMENT IN GROUNDWATER MONITORING OF THE SAN ANDRES-GLORIETA AQUIFER NEAR THE GRANTS RECLAMATION PROJECT", DATED MAY 10, 2019, DOCKET NO. 040-08903, LICENSE NO. SUA-1471

RESULTS OF U.S. NUCLEAR REGULATORY COMMISSION STAFF REVIEW OF THE MAY 10, 2019, "RESPONSE TO THE HOMESTAKE MINING COMPANY OF CALIFORNIA LETTER, DATED JULY 26, 2018: PROPOSED ADJUSTMENT IN GROUNDWATER MONITORING OF THE SAN ANDRES-GLORIETA AQUIFER NEAR THE GRANTS RECLAMATION PROJECT"

HOMESTAKE MINING COMPANY OF CALIFORNIA
GRANTS RECLAMATION PROJECT

DOCKET NO: 040-08903
LICENSE NO: SUA-1471

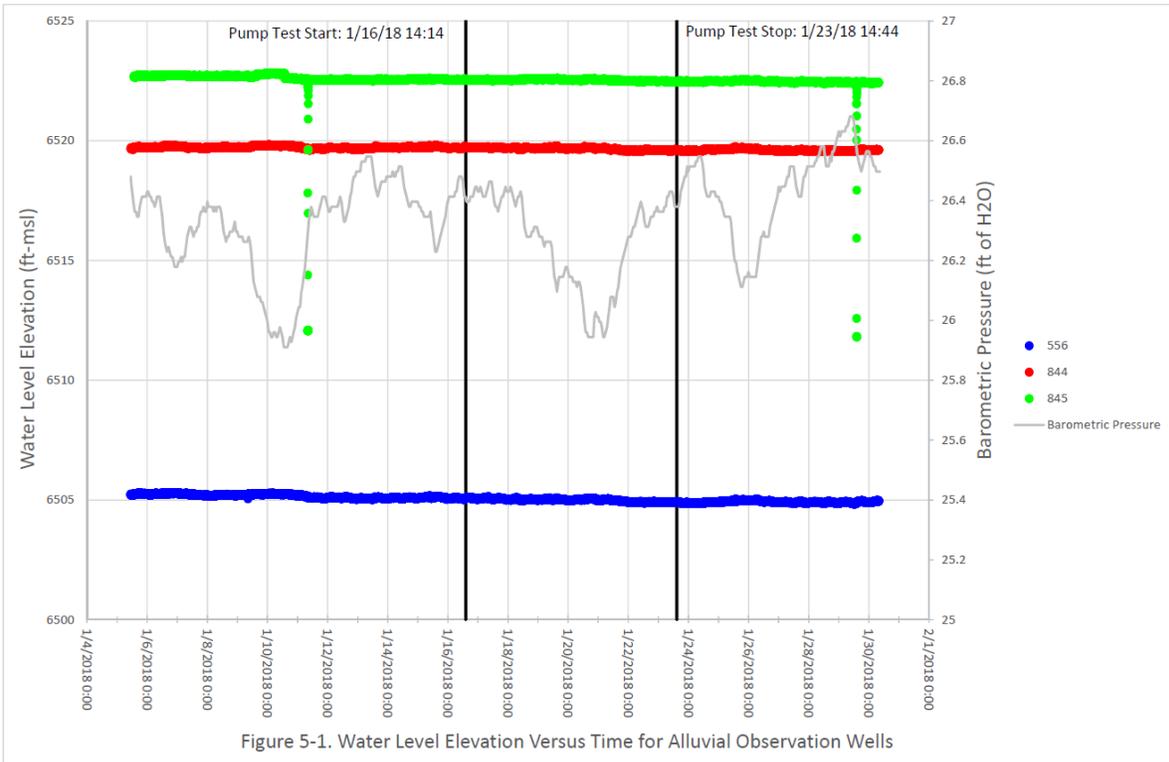
In review of any other potential sources of the contamination observed at well 943, the NRC staff, in coordination with the Agencies, reviewed additional groundwater monitoring data. Figure 1 and Figure 2 of this report show water level elevations from the April 3, 2018, Well 943 Pump Test Report for the Alluvial and Middle Chinle Aquifers, respectively. As shown in Figure 1 and Figure 2, the pump test stopped on January 23, 2018, and the well monitoring data stopped on January 30, 2018. The pump test data shown in Figure 1 and Figure 2 did not show any drawdown in the Alluvial⁸ or Middle Chinle Aquifers during the pump test. However, the water elevations measured on February 6, 2018, and shown in Figure 3 and Figure 4 of this report, which were adapted from the 2018 Annual Monitoring Report, showed drawdown for several Alluvial wells and Middle Chinle well CW76, which are in the vicinity of well 943. In addition, a similar trend in well drawdown was observed during the February 6, 2018, sampling event for several Alluvial wells located further away in the 100-Acre Center Pivot area, as shown in Figure 5 of this report. It is not clear if the drawdown in these wells was related to other HMC activities (e.g., well sampling, groundwater extraction) or if the drawdown was delayed and was related to the well 943 pump test. The NRC staff, in coordination with the Agencies, note that there is the potential for an additional source(s) of contamination into the SAG Aquifer that has

⁸ The brief drawdown events shown in Figure 1 and Figure 2 for well 845 and CW76 are due to sampling events.

Figure 1. Water level elevations for Alluvial wells 556, 844, and 845 (adapted from April 3, 2018, Well 943 Hydrologic Test Report)

1. Provide clarification as to the cause of the well drawdown observed in wells 555, 556, 844, and 845 as well as the wells located in the 100-Acre Center Pivot area (i.e., wells 881, 882, 884, 886, 893). In the 2018 Annual Monitoring Report, HMC did not discuss the decreases observed in these wells during the February 6, 2018, well sampling event. If the observed delayed well drawdown in could be related to the 943 well pump test, HMC should investigate and report on the potential pathway(s) from the Alluvial Aquifer to the SAG Aquifer during the pump test.

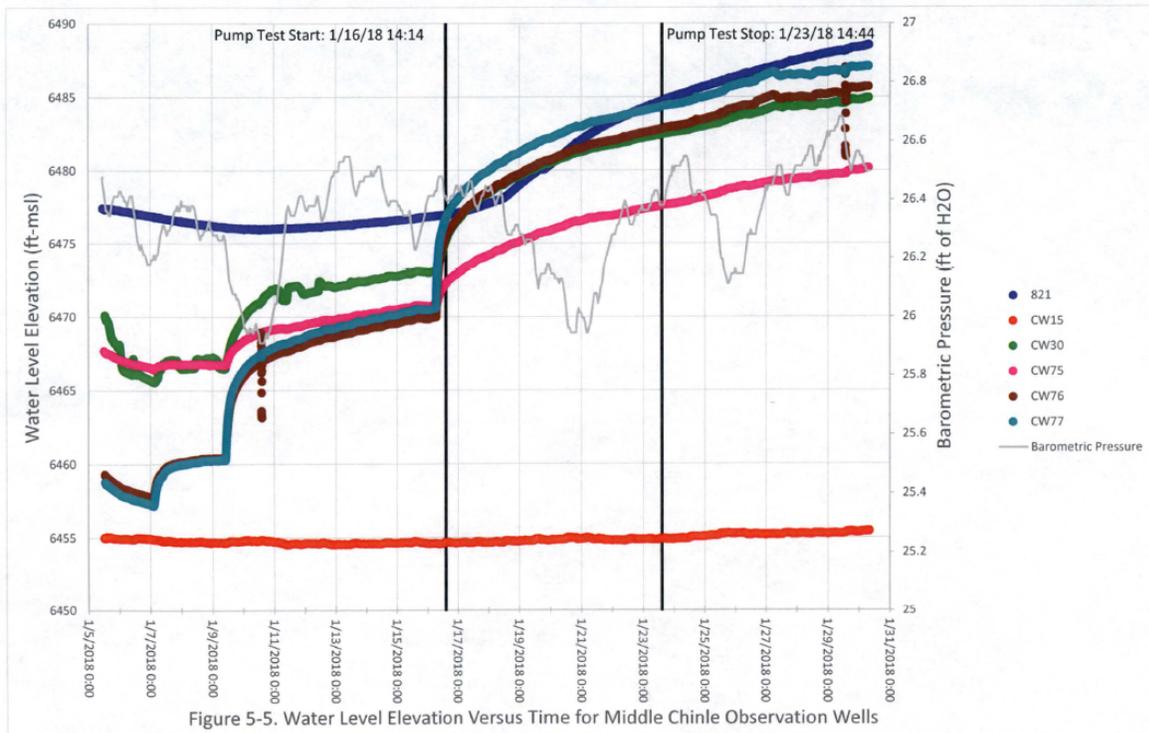
Figure 2. Water level elevations for Middle Chinle wells 821, CW15, CW30, CW75, CW76, and CW77¹¹ (adapted from April 3, 2018, Well 943 Hydrologic Test Report)

¹¹ In the report dated April 3, 2018, HMC described the rise in water level elevations for these Middle Chinle wells as being due to a series of collection wells being turned off.

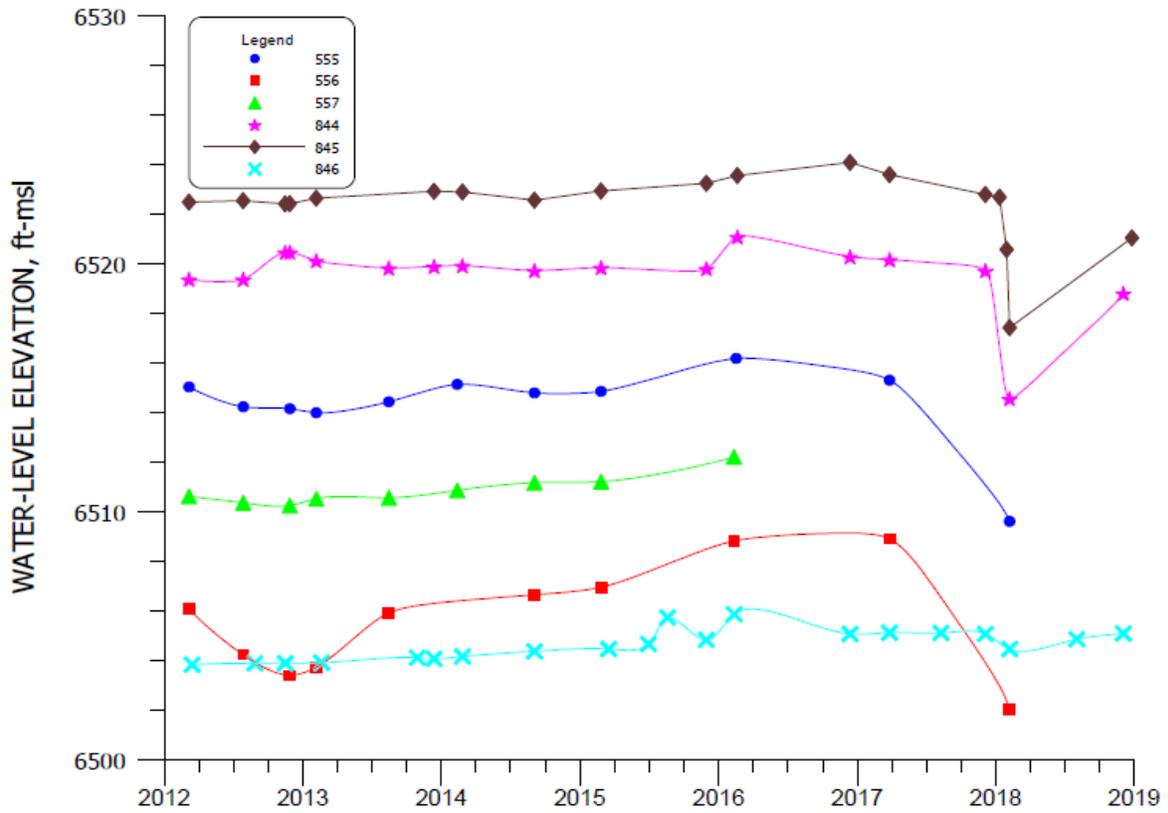
FIGURE 4.2-14. WATER-LEVEL ELEVATION FOR WELLS 555, 556, 557, 844, 845, AND 846.

Figure 3. Water level elevations for Alluvial wells (adapted from 2018 HMC Annual Monitoring Report)

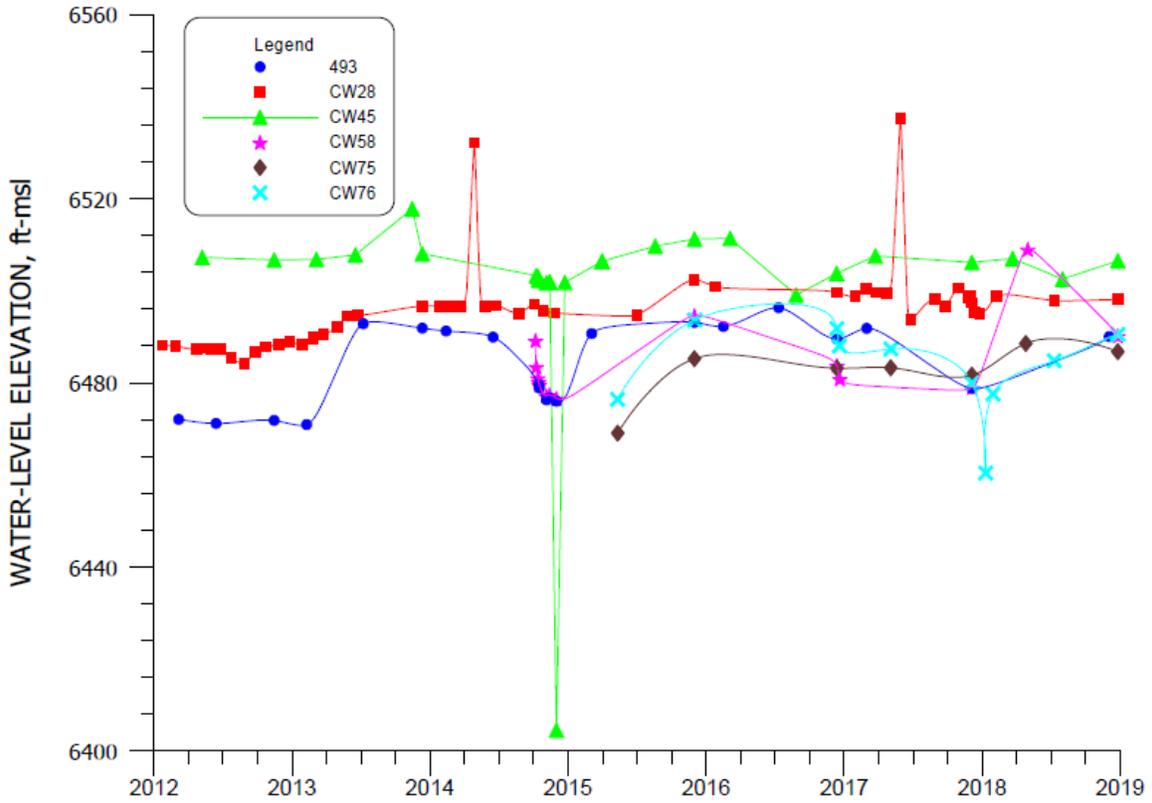
FIGURE 6.2-3. WATER-LEVEL ELEVATION FOR WELLS 493, CW28, CW45, CW58, CW75 AND CW76

Figure 4. Water level elevations for Middle Chinle wells (adapted from 2018 HMC Annual Monitoring Report)

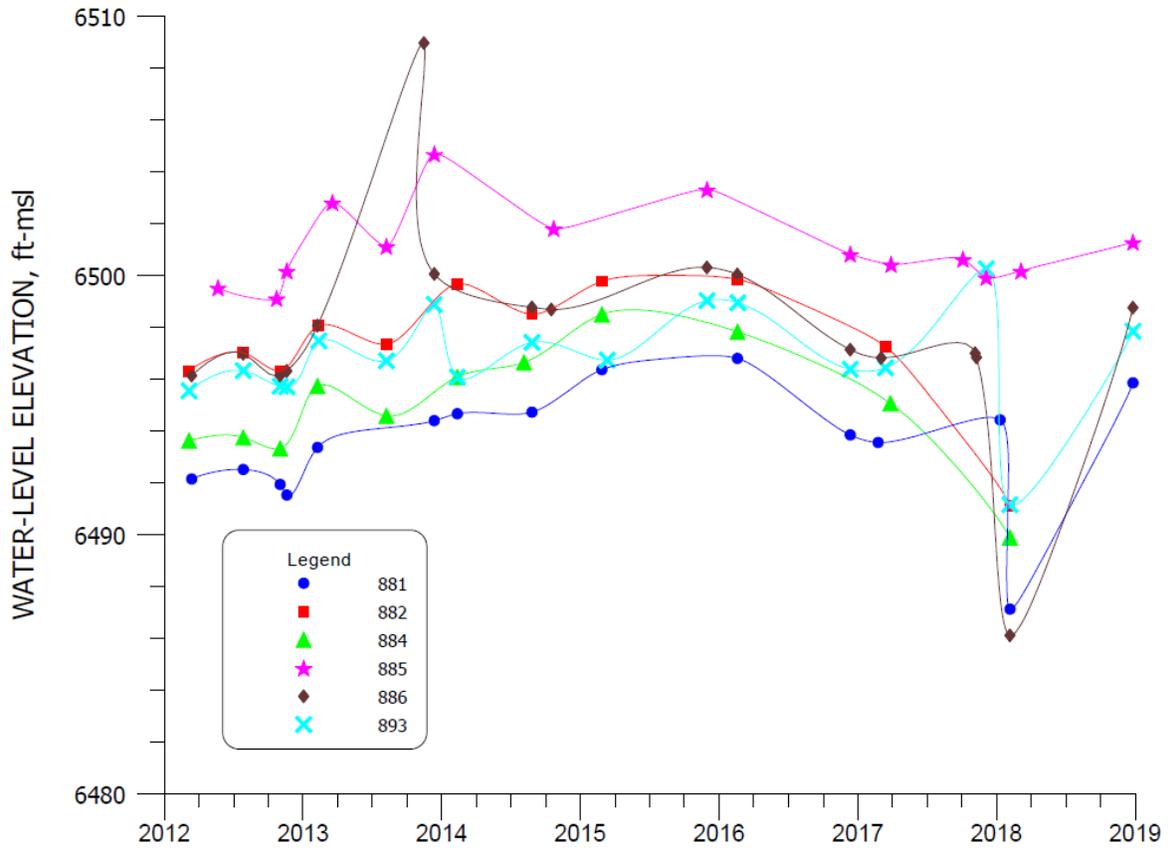
FIGURE 4.2-16. WATER-LEVEL ELEVATION FOR WELLS 881, 882, 884, 885, 886, AND 893.

Figure 5. Water level elevations for Alluvial wells (adapted from 2018 HMC Annual Monitoring Report)
