U. S. NUCLEAR REGULATORY COMMISSION  
OFFICE OF INSPECTION AND ENFORCEMENT

Report No. 50-508/83-05  
Docket No. 50-508 License No. CPPR-154 Safeguards Group \_\_\_\_\_

Facility Name: WNP-3

Inspection conducted: March 28 - April 27, 1983

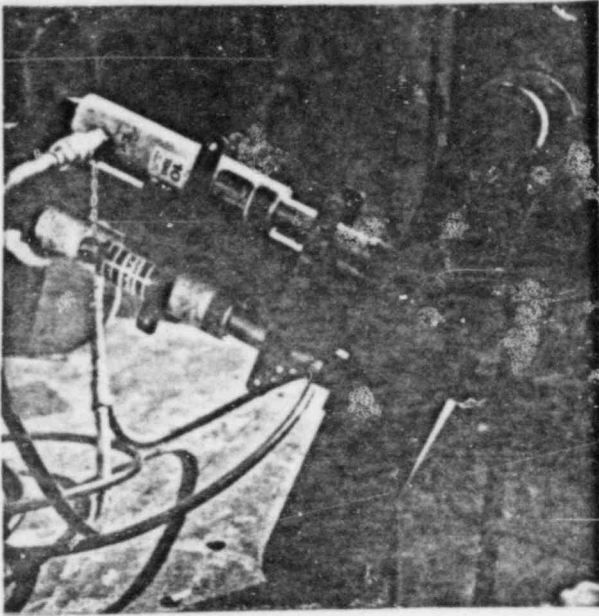
- b. Bending of reinforcing steel utilizing a bender specifically designed to be used on steel dowels in the field was examined. The qualification of the benders (one for No. 8 size bars and one for No. 11 size bars) by bench test was observed. The initial field use of the bender on No. 8 bars was also examined. No problems or items of noncompliance were observed.

Figure 1 - Bench test of rebar bender for use on partially embedded rebars of shield building.

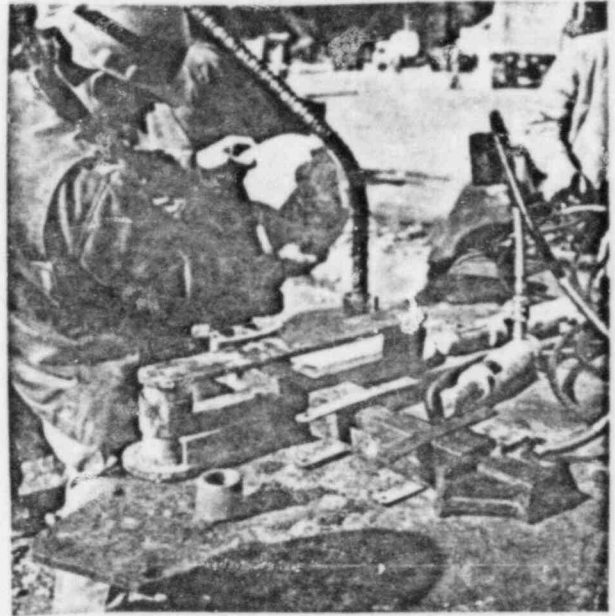
Figure 2 - Quality Control inspector uses template to examine bend radius. Bender frame in foreground.

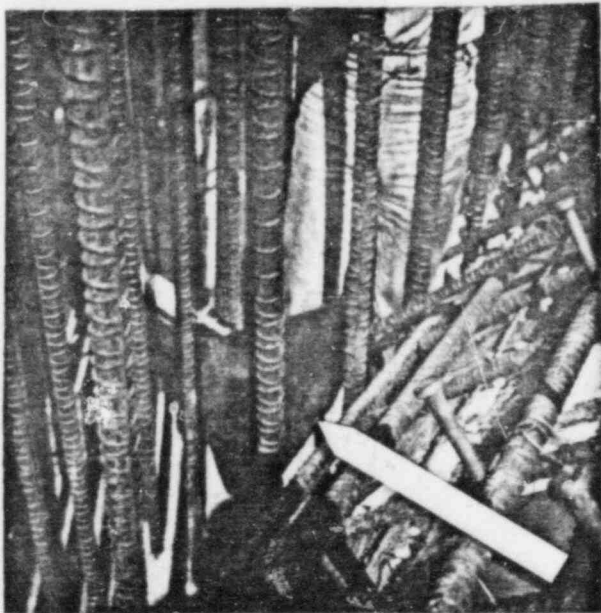
Figure 3 - Rebar bender in field use. Note heavier side plates (arrow) found to be necessary after bench test.

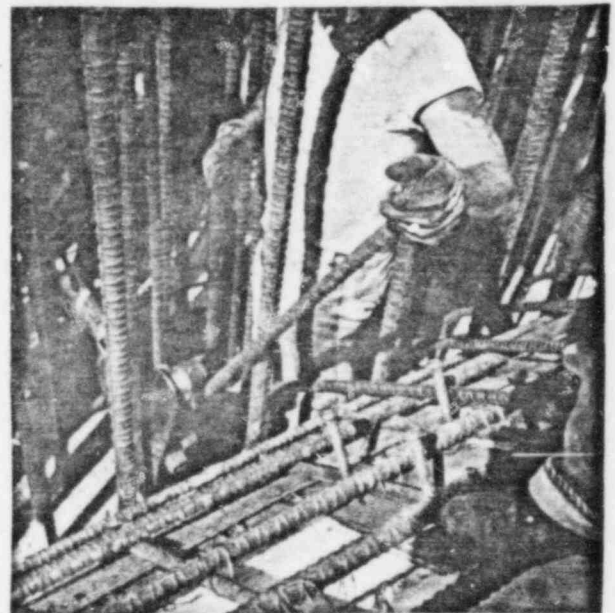
Figure 4 - Rebar being bent on the parapet of the shield building. Rebar is tied down before release of hydraulic pressure.

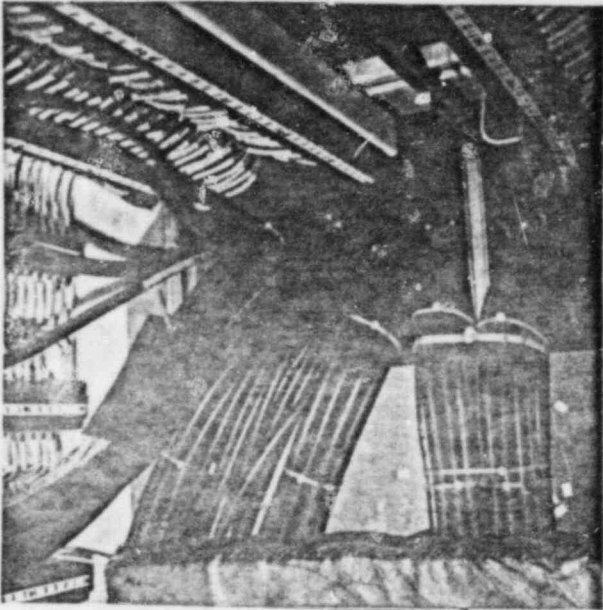
The inspector questioned the methods observed for supporting cables as they enter the bottom of the cabinets and control boards. Reliance on cable ties for vertical supports did not appear to be a sound practice in certain instances. The Licensee has stated that the concern of the NRC resident inspector is being referred to the architect-engineering design offices for review and analysis. The matter will be followed up during future inspections. This item is identified as Follow-Up Item No. 50-508/83-05/01, "Cable Bundle Supports."

Figure 5 shows an example of the inspector's concern about bundle support. Figures 6 and 7 are general views of the cable termination process which utilizes computer generated termination cards and heat shrink identification tags.

Figure 5 - Cable entry into cabinet in south relay room. Cable tie supports are in question. See text.

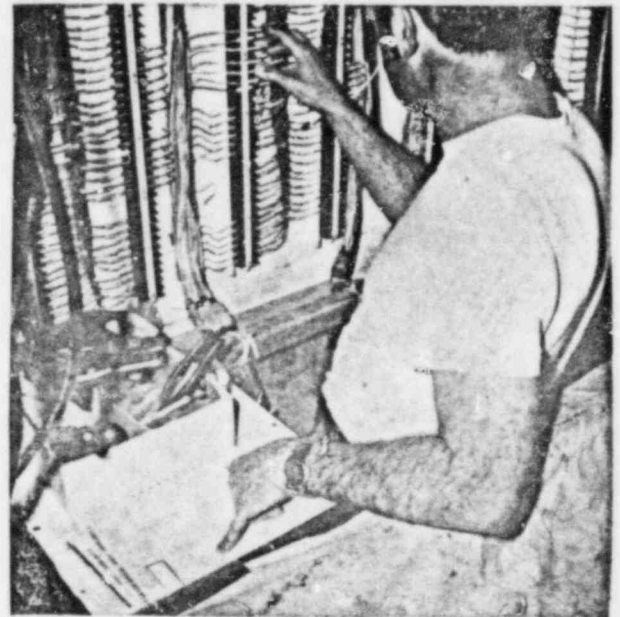
Figure 6 - Electrician terminating cables checks computer developed "termination card" against identified termination points.

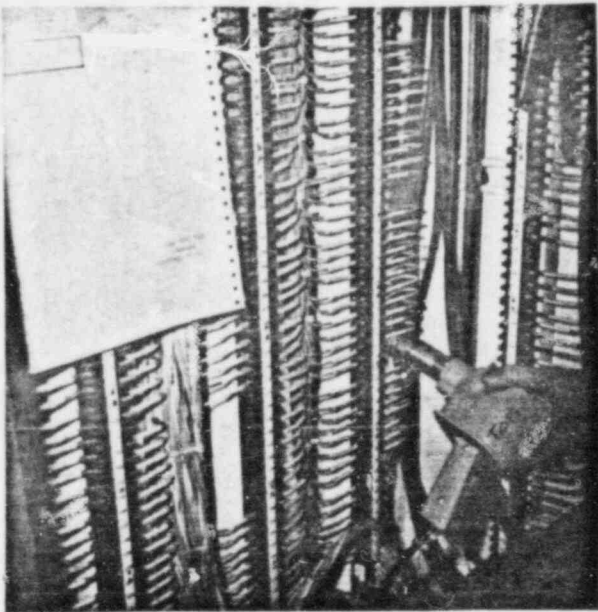
Figure 7 - Induction heating "gun" shrinks cable identifier sleeve on wire after lug has been crimped to wire.

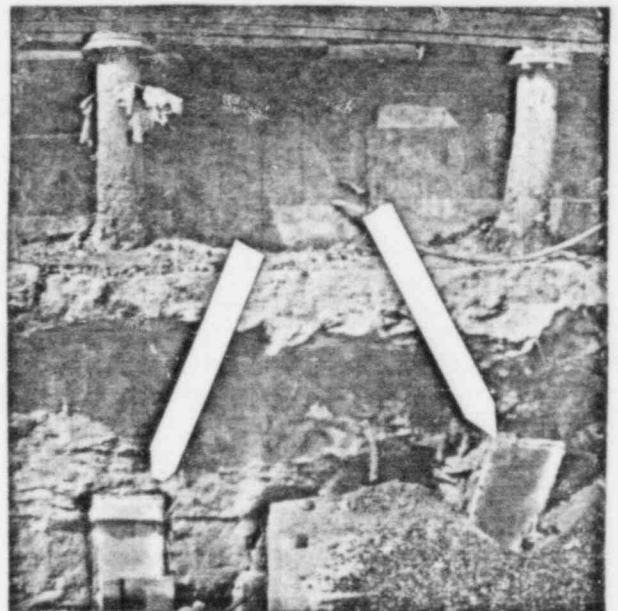
- a. LER 82-074/034-1 at Beaver Valley was found to be not applicable to WNP-3 since the same brand of check valves are not used in the charging pump outlet lines.
- b. Figure 8 shows protection provided for the half round pipes of the Ground Water Drainage System after NRC inspectors noted problems with dirt entering this system from non-safety-related work.

Figure 8 - Arrows point to metal protecting shields for half-round pipes which compose the subsurface vertical drains of the Ground Water Drainage System.
