UNITED STATES OF AMERICA  
NUCLEAR REGULATORY COMMISSION

In the Matter of )  
LONG ISLAND LIGHTING COMPANY ) Docket No. 50-322 (OL)  
(Shoreham Nuclear Power Station, )  
Unit 1) )

AFFIDAVIT OF EDWARD J. YOUNGLING

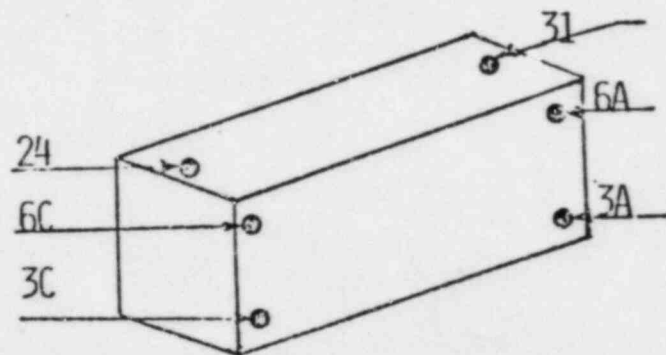
VIBRATION LEVELS  
AT FIRING FREQUENCY OF ALL CYLINDERS AT 75% LOAD  
 (UNITS: MILS PEAK TO PEAK)

14. The data in Attachments B, C and D demonstrate that vibration of Shoreham's diesel generators is comparable to and consistent with the vibration of the other two diesel generators that were studied. The amplitudes of the vibratory motions of Shoreham's diesel generators are within expected limits and are acceptable under the industry experience. In short, the generators do not experience excessive vibrations.

<u>3C</u> <u>H</u>	<u>6C</u> <u>H</u>	<u>24</u> <u>V</u>	<u>31</u> <u>V</u>	<u>6A</u> <u>H</u>	<u>3A</u> <u>H</u>	
101	-	-	0.12	1.26	3.45	0.67	(SOIL)
102	1.46	0.57	0.55	0.70	1.59	1.39	(SOIL)
103	1.70	1.52	0.44	0.28	4.67	1.65	(SOIL)
SAN	1.03	5.73	0.51	0.63	6.02	1.21	(ROCK)
1 KN	1.89	1.55	1.03	0.63	2.67	1.89	(SOIL)

SAN & LKN MACHINES ADJUSTED FOR POWER LEVEL  
 1 KN MACHINE ADJUSTED FOR ENGINE SPEED

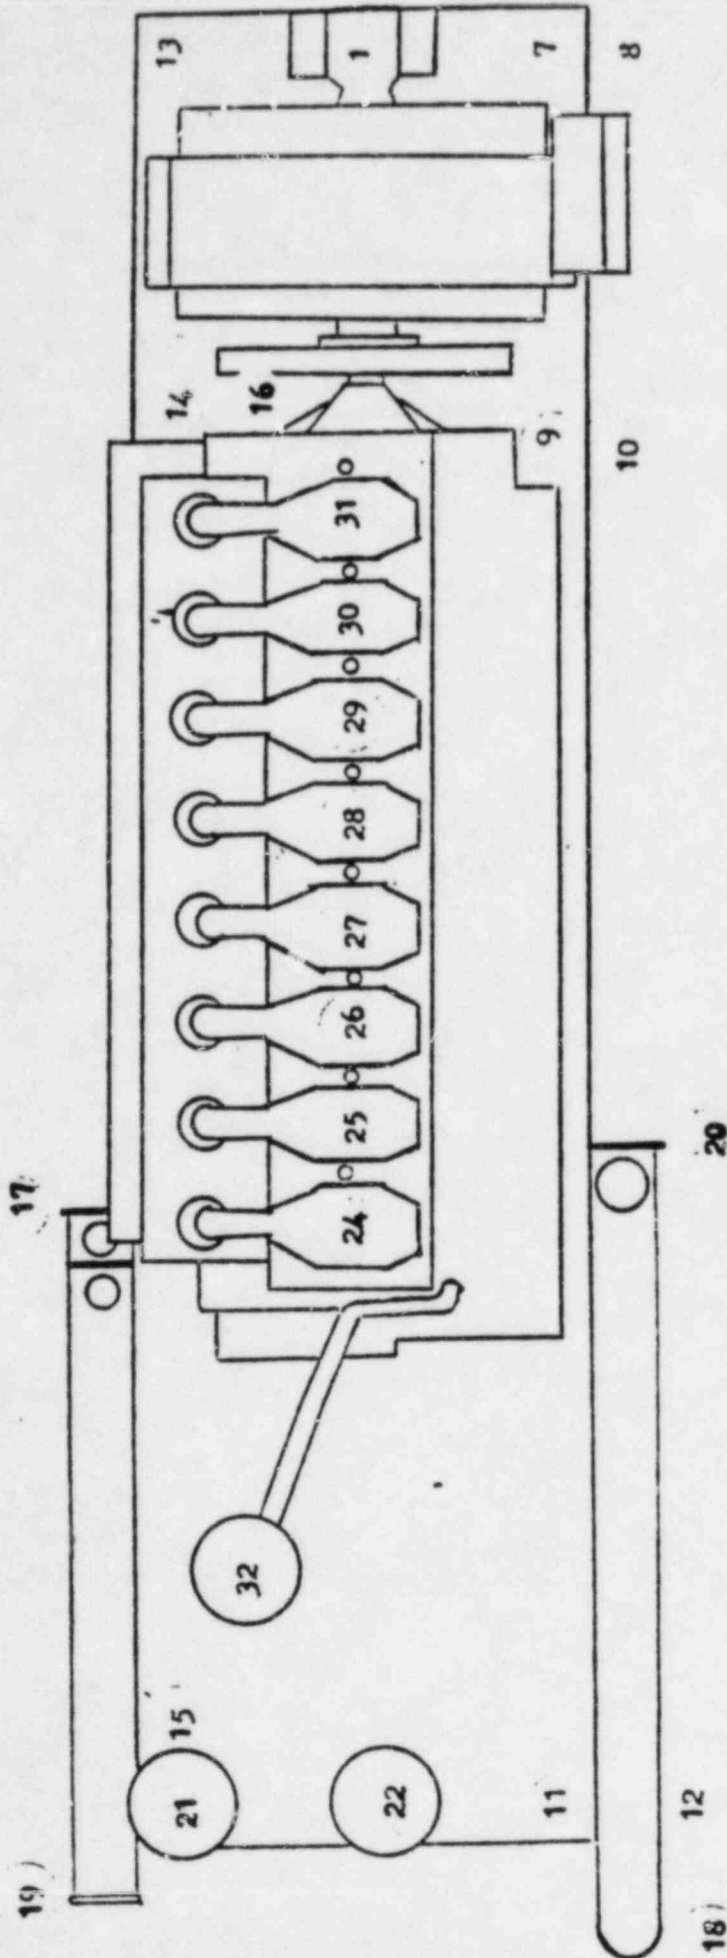
VIBRATION MEASUREMENT LOCATIONS - PLAN VIEW  
SHOREHAM NUCLEAR POWER STATION  
EMERGENCY DIESEL GENERATORS

for major components of the diesel generators, the foundation and surrounding floor area. Representative data from the study, normalized to reflect differences in power level and RPM, are presented in Attachment B. Attachments C and D show in more detail the points where the vibration measurements were taken.

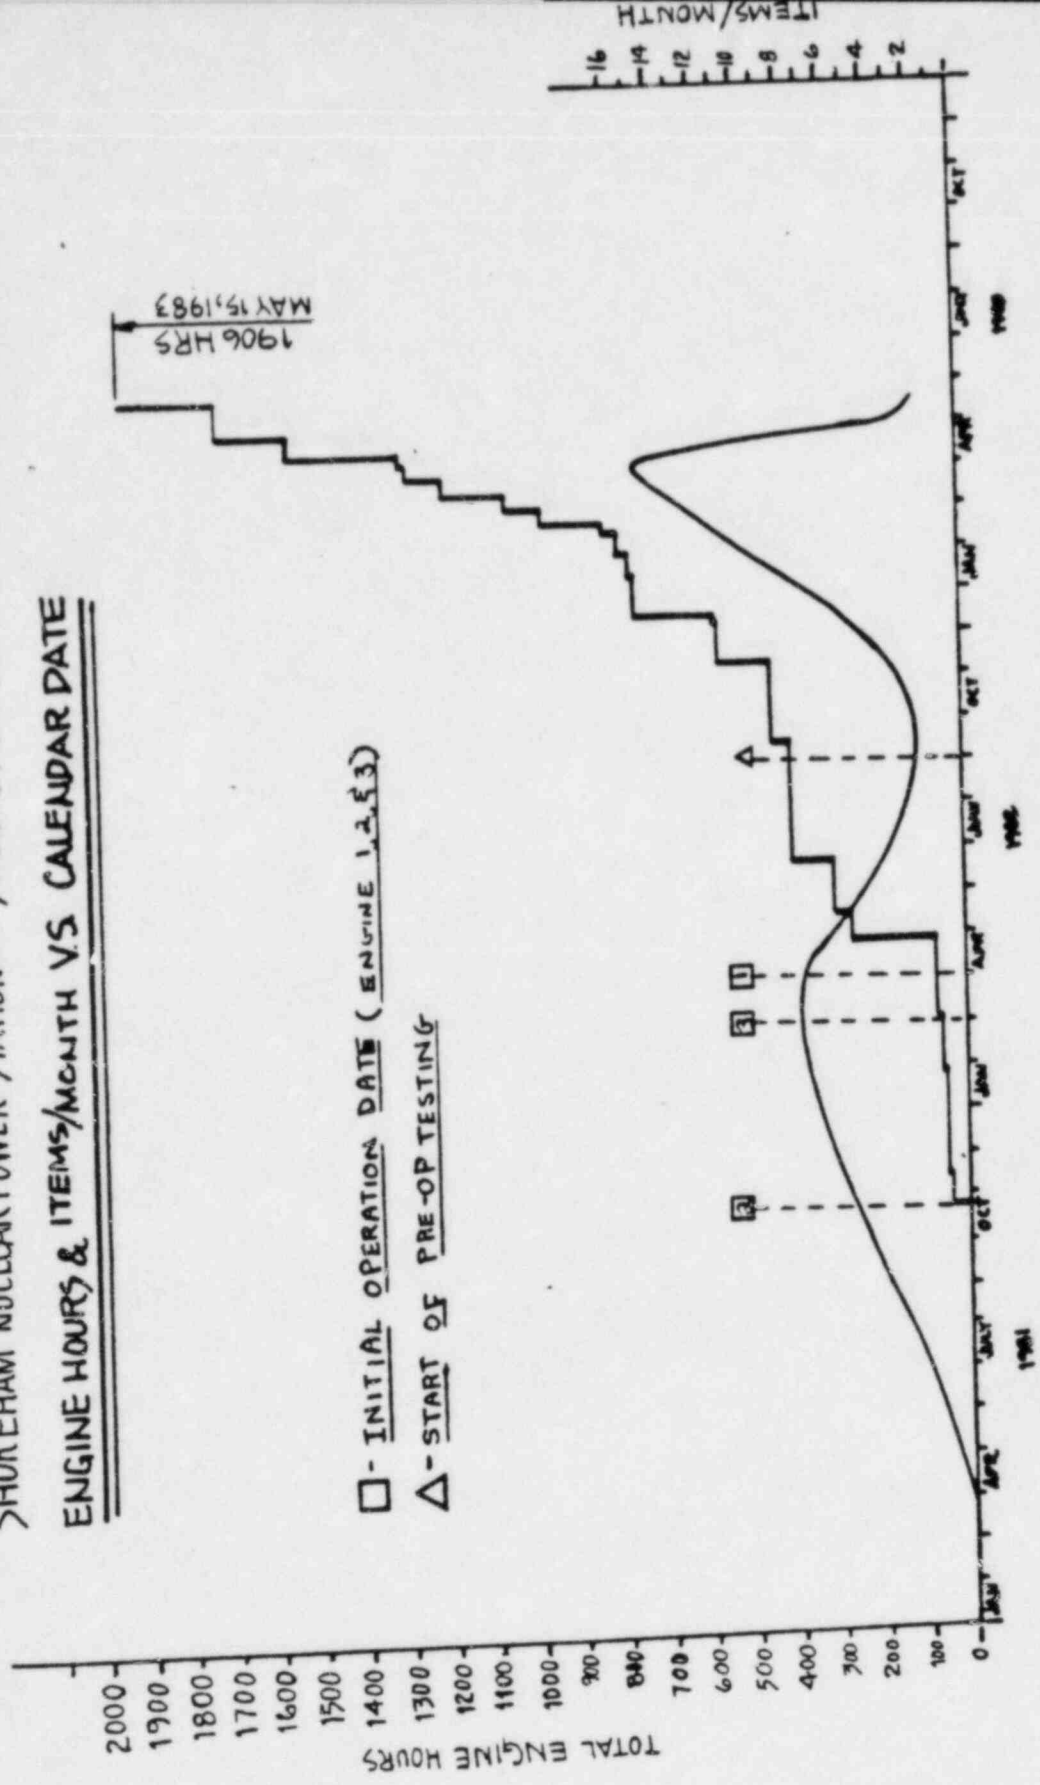
SHOREHAM NUCLEAR POWER STATION ~ STAND-BY DIESEL GENERATORS  
ENGINE HOURS & ITEMS/MONTH VS CALENDAR DATE

Items/Month vs. Calendar Date" illustrates that beginning March, 1983, although the testing of the diesels continued and hours were being accumulated rapidly, the number of items identified was sharply declining. Attachment F entitled "Items Resolved Per Month vs. Total Engine Hours" is similar to the first. It shows, even more dramatically, that the number of items identified by preoperational testing is sharply declining even though engine hours are accumulating. It is important to recognize that the initial operation of the diesel generators and the preoperational testing of the diesel generators are expected to identify items requiring resolution. The Shoreham data coincide with the expected trend. As the Attachments show, prior to and just after the initial operation of the diesels, a number of items were identified, with fewer being identified as operating hours accumulated. The start of preoperational testing in September 1982, as expected, identified a number of additional items. Again, the number of items identified declined substantially as the testing progressed and engine hours accumulated.

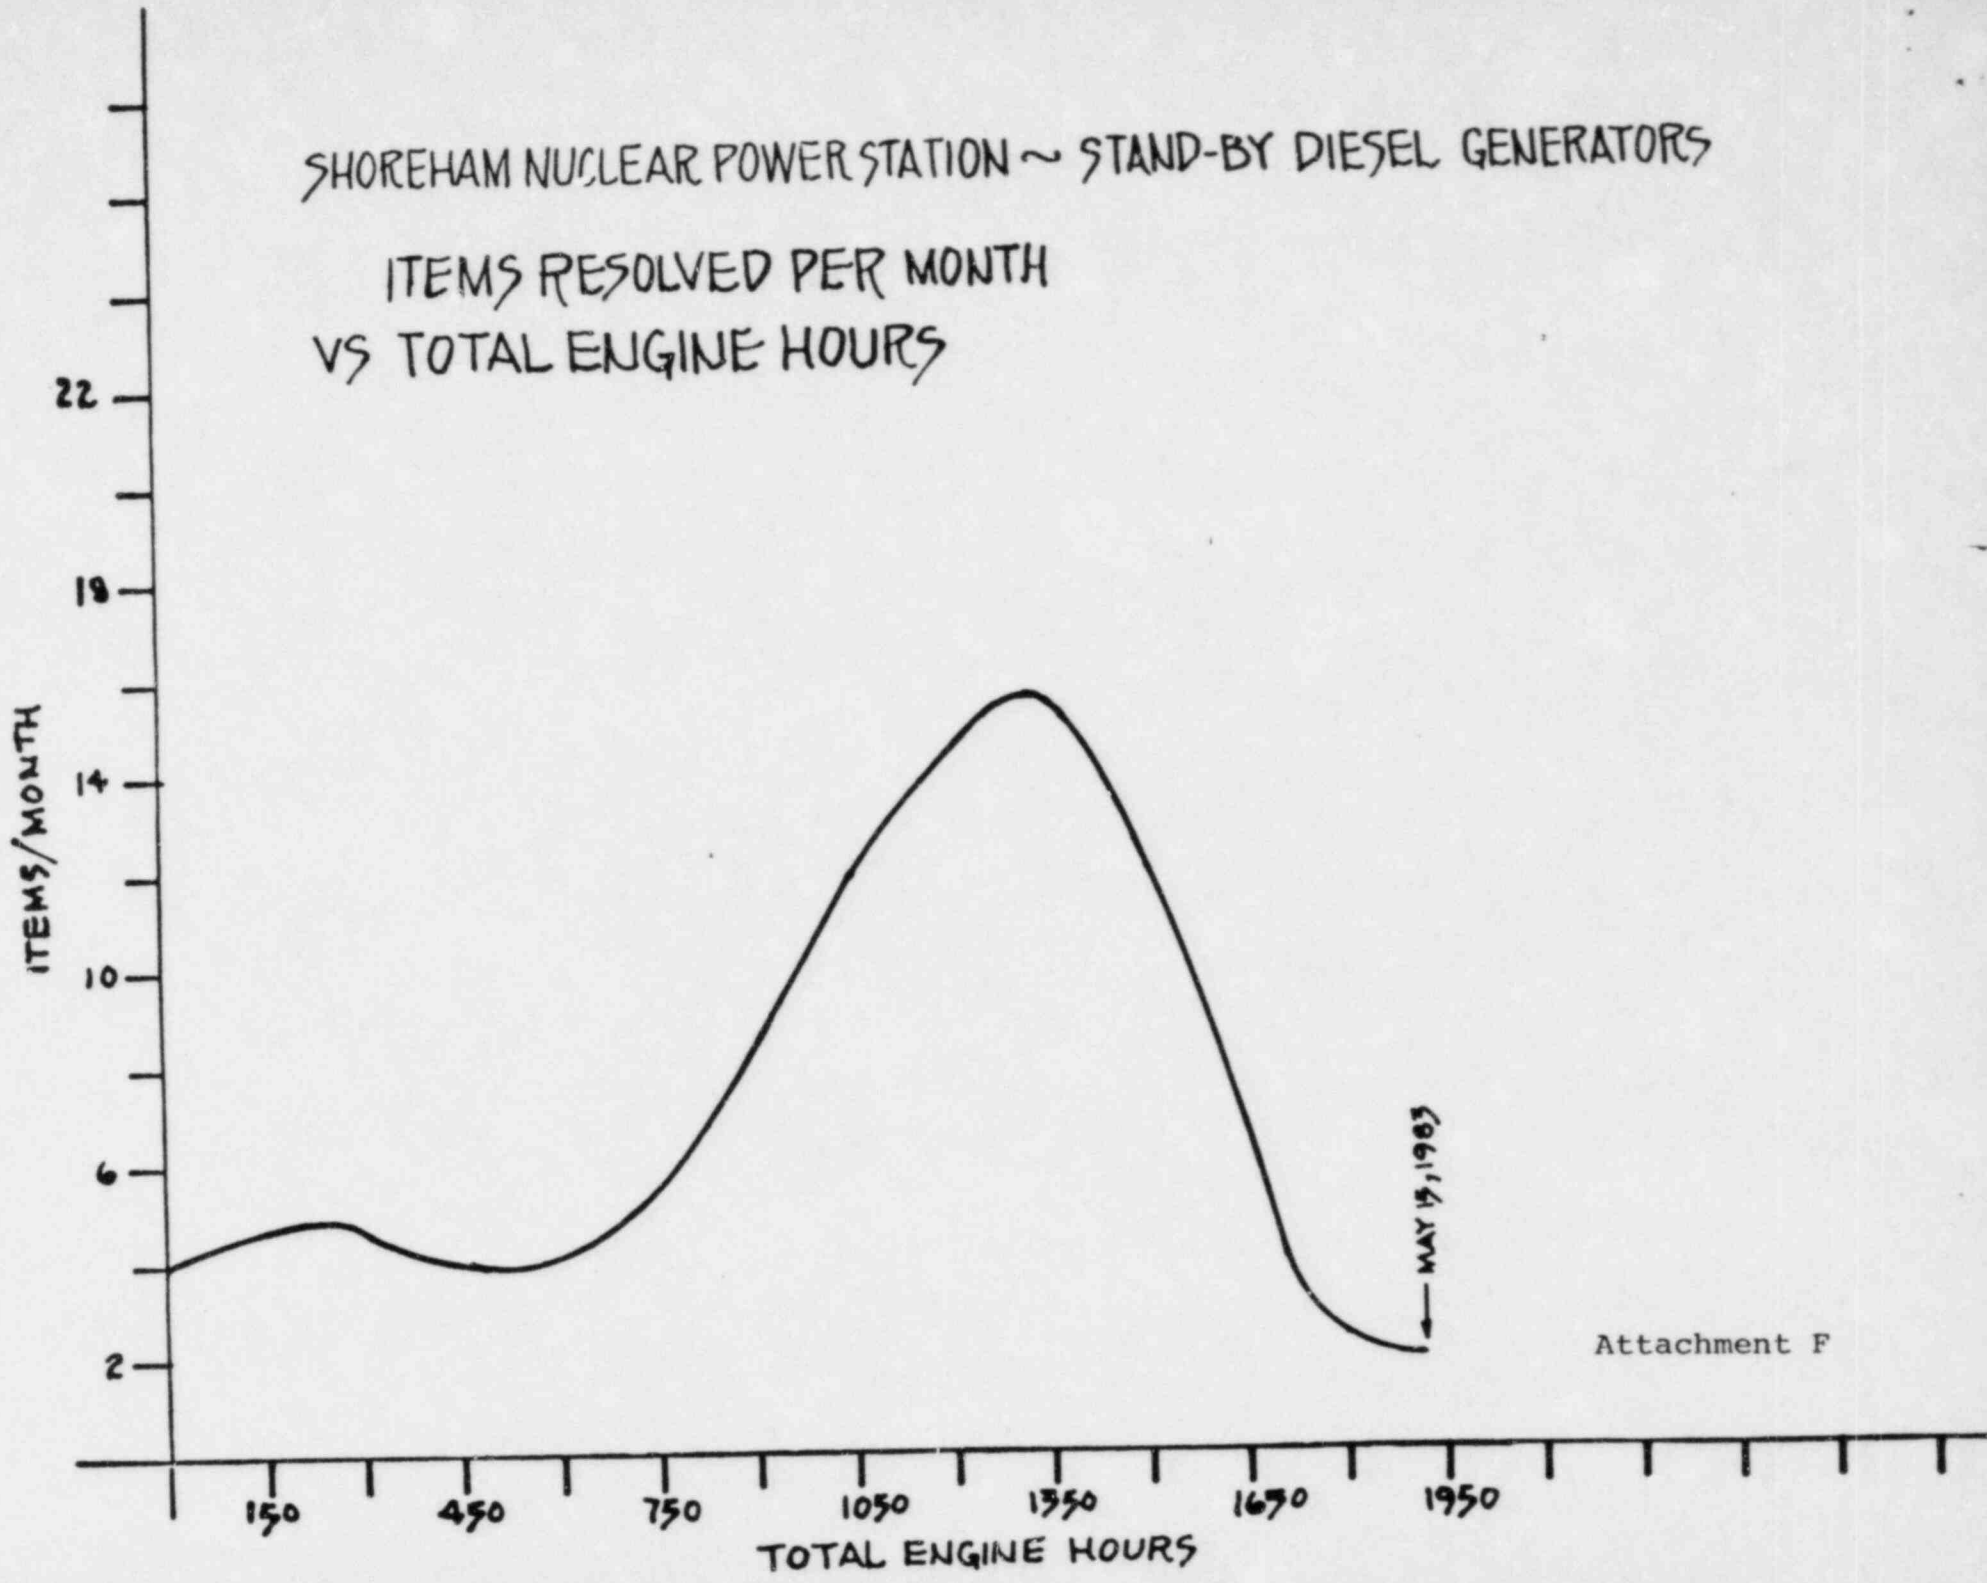
ITEMS RESOLVED PER MONTH  
VS TOTAL ENGINE HOURS

31. Attachments E and F are two graphs that show the currently declining trends of the diesel generator items to be resolved at Shoreham. Attachment E entitled "Engine Hours and
