8307070398 780629 PDR ADDCK 05000289 P HOL GPM - B/W letter-Betzl-1978

<u>#</u>	Description
REM-I-361	Periodic Incore Detector Leakage Measurements
REM-I-371	FHE Site Caution Instructions
REM-I-372	Nuclear Spare Parts Service
REM-I-391	Fuel Transfer Basket Load Distribution
REM-I-392	Fuel Transfer System Cable Takeup Reels
REM-I-393	Fuel Handling Bridge Hydraulic Hose Deterioration

Power Generation Group

Subject: Periodic Incore Detector Leskage Measurements

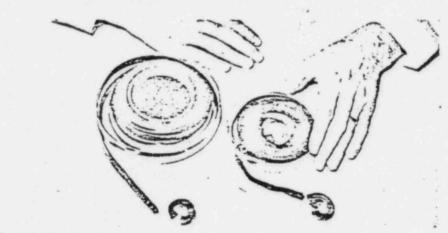
Figure 2. Graphite ribbon rings. At left is a smooth ribbon and ring; at right is the crinkled ribbon starting material and a ring made from it. Both rings have been cut open to show direction of the laminations.

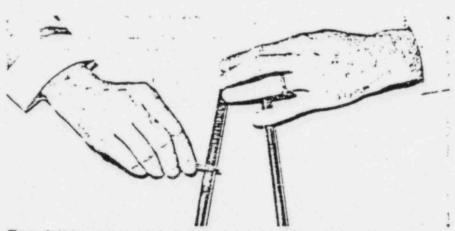
Figure 3. Valve stem on left is from a valve that had been been laboratory tested, using laminated rings. Graphite particles can be scraped off. Stem at right had been tested with the braided graphite filament/laminate graphite combination. Stem is smooth and free of particles.

effect; the graphite buildup on the stem was so thick it could be scraped off with a knife. The surface of the deposit was much rougher than the underlying stem surface—a condition which had to be conducive to wear. Further investigation revealed that both graphite ribbon-wound rings and laminated graphite rings exhibited the effect.

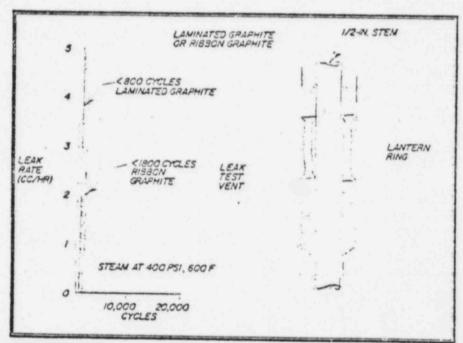
Figure 4. Plot of valve stem cycles vs leak rate through packing for laminated graphite or ribbon graphite only.
