U.S. NUCLEAR REGULATORY COMMISSION

Report Nos. 50-361/90-37, 50-362/90-37
Docket Nos. 50-361, 50-362
License Nos. NPF-10, NPF-15
Licensee: Southern California Edison Company
Irvine Operations Center
23 Parker Street
Irvine, California 92718
Facility Name: San Onofre Units 2 and 3
Inspection at: San Onofre, San Clemente, California
Inspection conducted: October 1, 1990 through November 15, 1990
Inspectors: A. L. Hon, Resident Inspector
C. W. Caldwell, Senior Resident Inspector
Approved By: P. H. Johnson 12/3/90
P. H. Johnson, Chief Date Signed
Reactor Projects Section 3

Inspection Summary

Inspection on October 1 through November 15, 1990 (Report Nos. 50-361/90-37, 50-362/90-37)

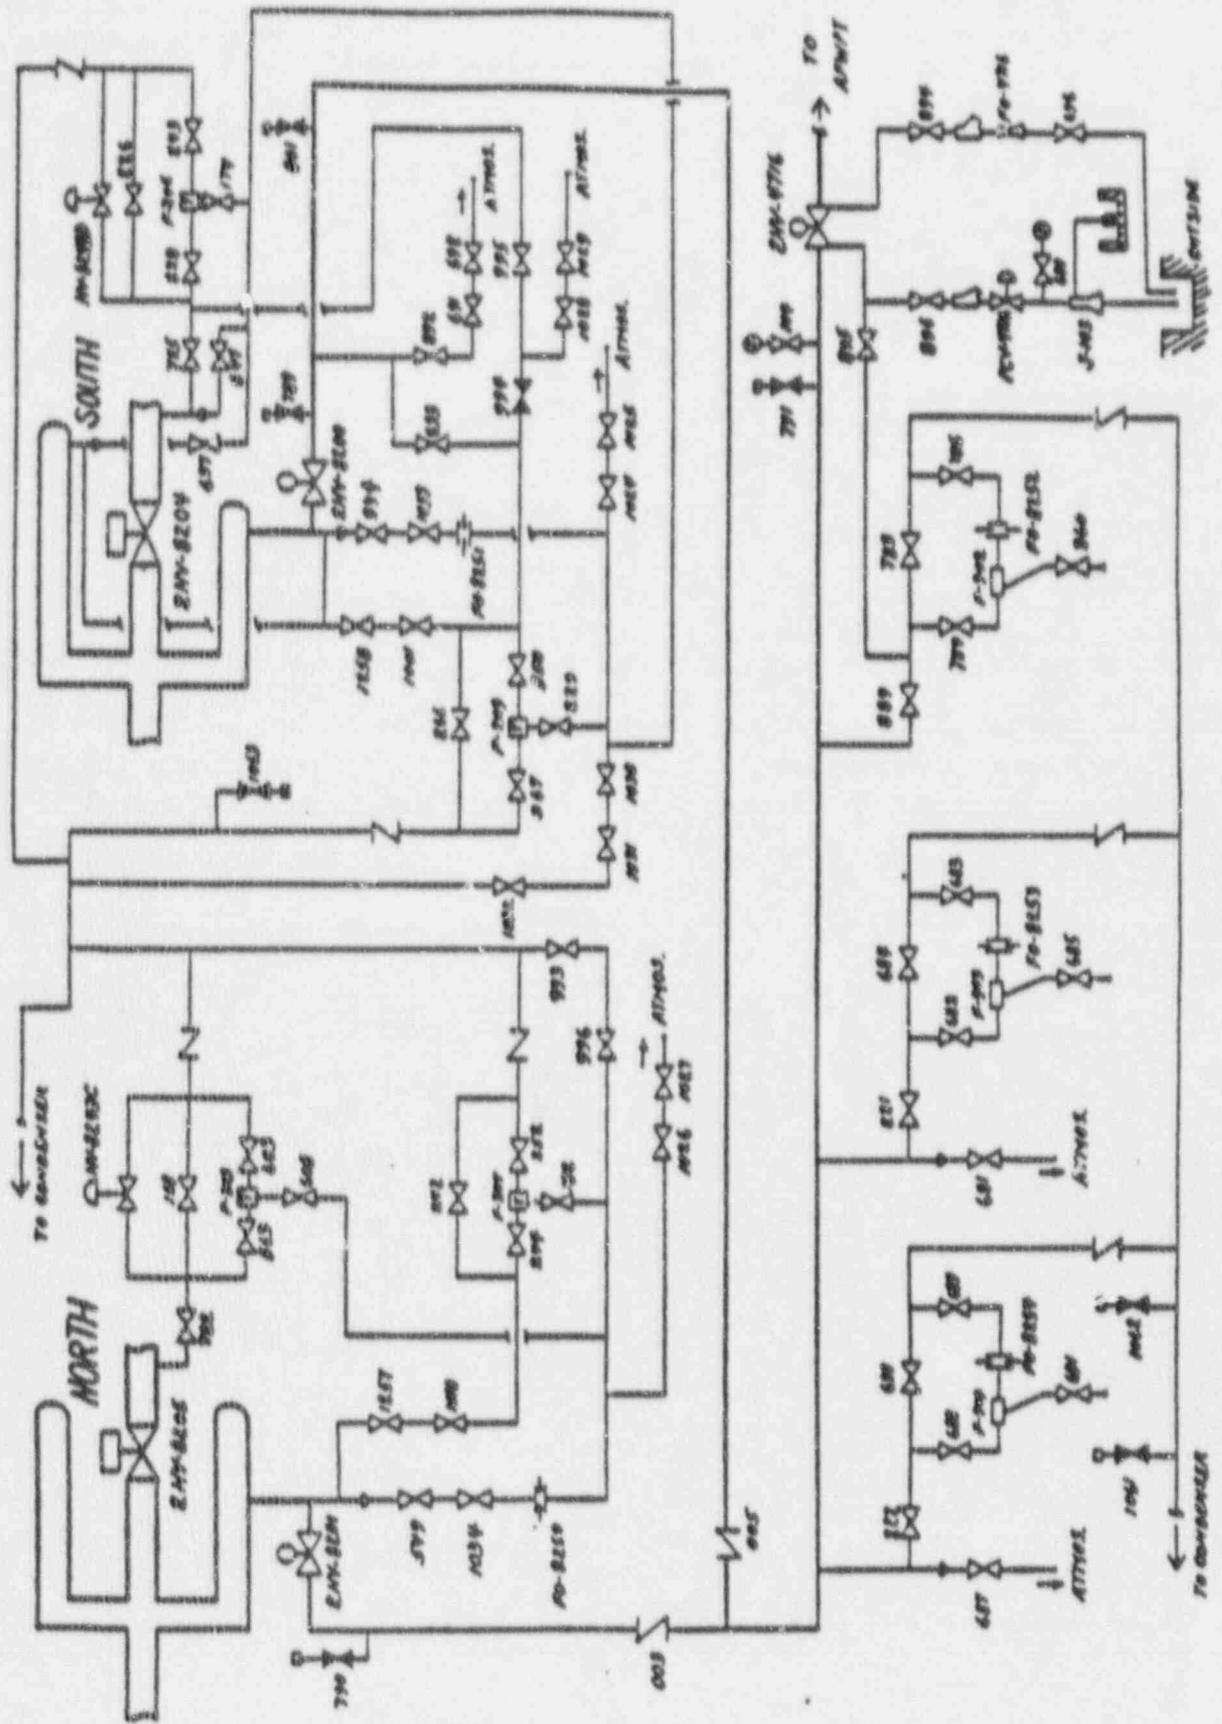
FIGURE 1

- Steam supply (from SG E-088) isolation valve 2HV-8201 is normally closed to limit wear on check valve S21301MU003, caused by pressure differential between the two steam generators. (Refer to Figure 1, enclosed with this report).
- Continuous condensate removal lines are connected upstream and downstream of steam stop valve HV-4716. (Figure 1)
- Overspeed trip was set at 110% of the 3570 RPM nominal speed.
- Applicable T.S. requirements while in Modes 1, 2, and 3:
 - 3.7.1.2, Actions a and b:
 - one pump inoperable - 72 hour shutdown
 - two pumps inoperable - 6 hour shutdown
 - 3.1.1.1, Action c.2:
 - with one EDG and P-140 Inoperable - 6 hour shutdown

- At the conclusion of the feed ring repair outage, the Unit was started up per S023-5-1.3 (TCN 13-1), "Plant Startup from Cold Shutdown to Hot Standby." As part of the startup process, to purge oxygen from the steam generators, a N2 sparge and blanket were applied twice per S023-2-18 (TCN 6-7), "Draining and Refilling of Steam Generators," Attachment 6. This involved closing steam trap isolation valves MU1257 and MU1258.

- S021-2-18, Attachment 8, "Restoration from SG Nitrogen Blanketing or Sparging," was used to secure from the N2 sparging evolution, but it did not specify that MU1257 and MU1258 be reopened. Step 2.2.3.3, "Return SG to service," of Attachments

9 and 10, "SG Removal/Return to Service," specified that MU1257 and MU1258 be opened and verified independently. Completion of this step would have reopened the steam drain isolation valves; however, the startup procedure did not direct that Attachments 9 and 10 be accomplished.

STEAM HEADER DRAINS UPSTREAM OF UNIT 2 MSIVs
