Commonwealth Edison

September 9, 1982

Subject: Byron Station Units 1 and 2
Braidwood Station Units 1 and 2
Waterhammer Prevention
NRC Docket Nos. 50-454, 50-455,
50-456 and 50-457

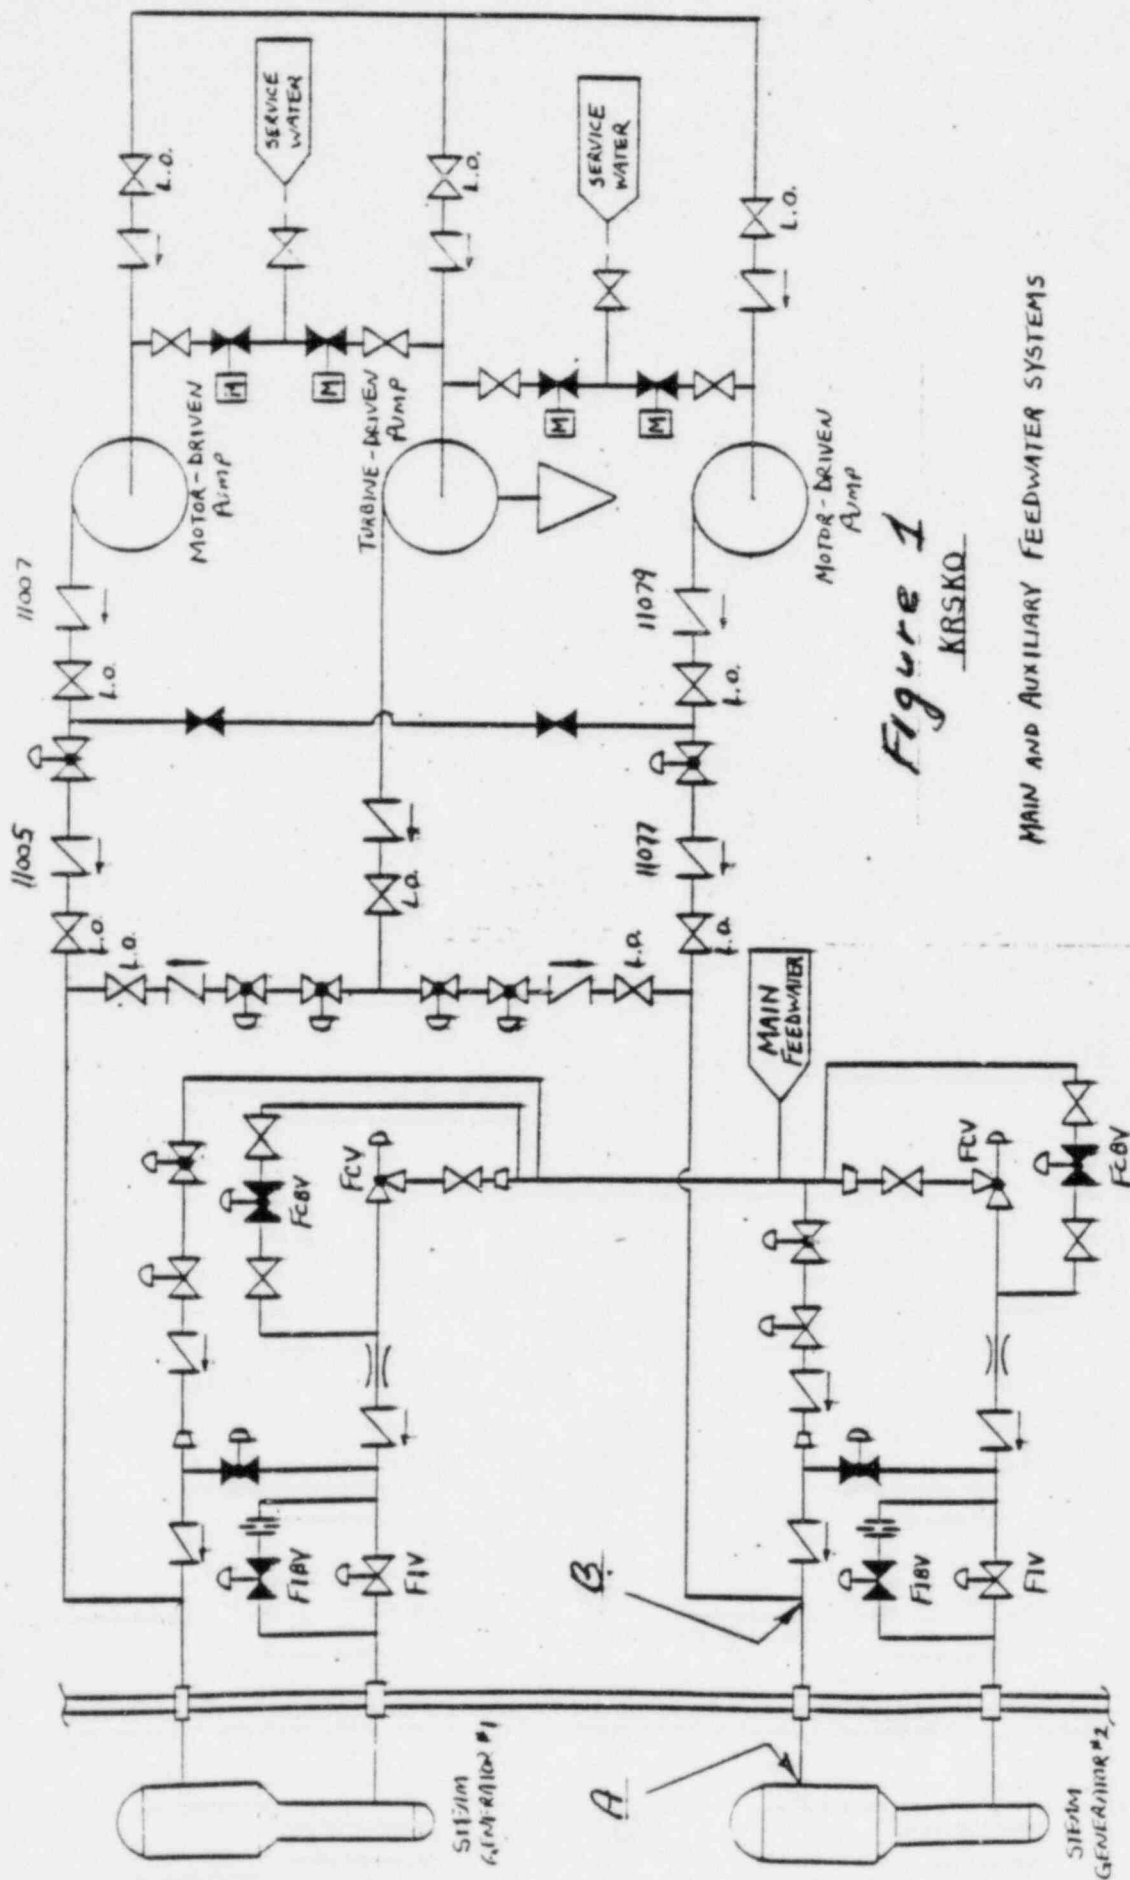
Figure 1
KRSKO

To reduce the likelihood of backleakage, the Auxiliary Feedwater System check valves which were known to leak, valves 11005, 11007, 11077 and 11079, on Figure 1 were refurbished. The check valves associated with the turbine driven AFS pump discharge were not inspected as a pyrometer check under hot condition indicated no leakage.

As discussed earlier, based on the evidence of blistered and discolored paint, hot water and/or steam leaked back from the steam generators through a section of the six inch Sch 80 bypass piping and then into the AFS. The section of loop 2 bypass piping of interest is indicated in Figure 1 as between Points A and B.

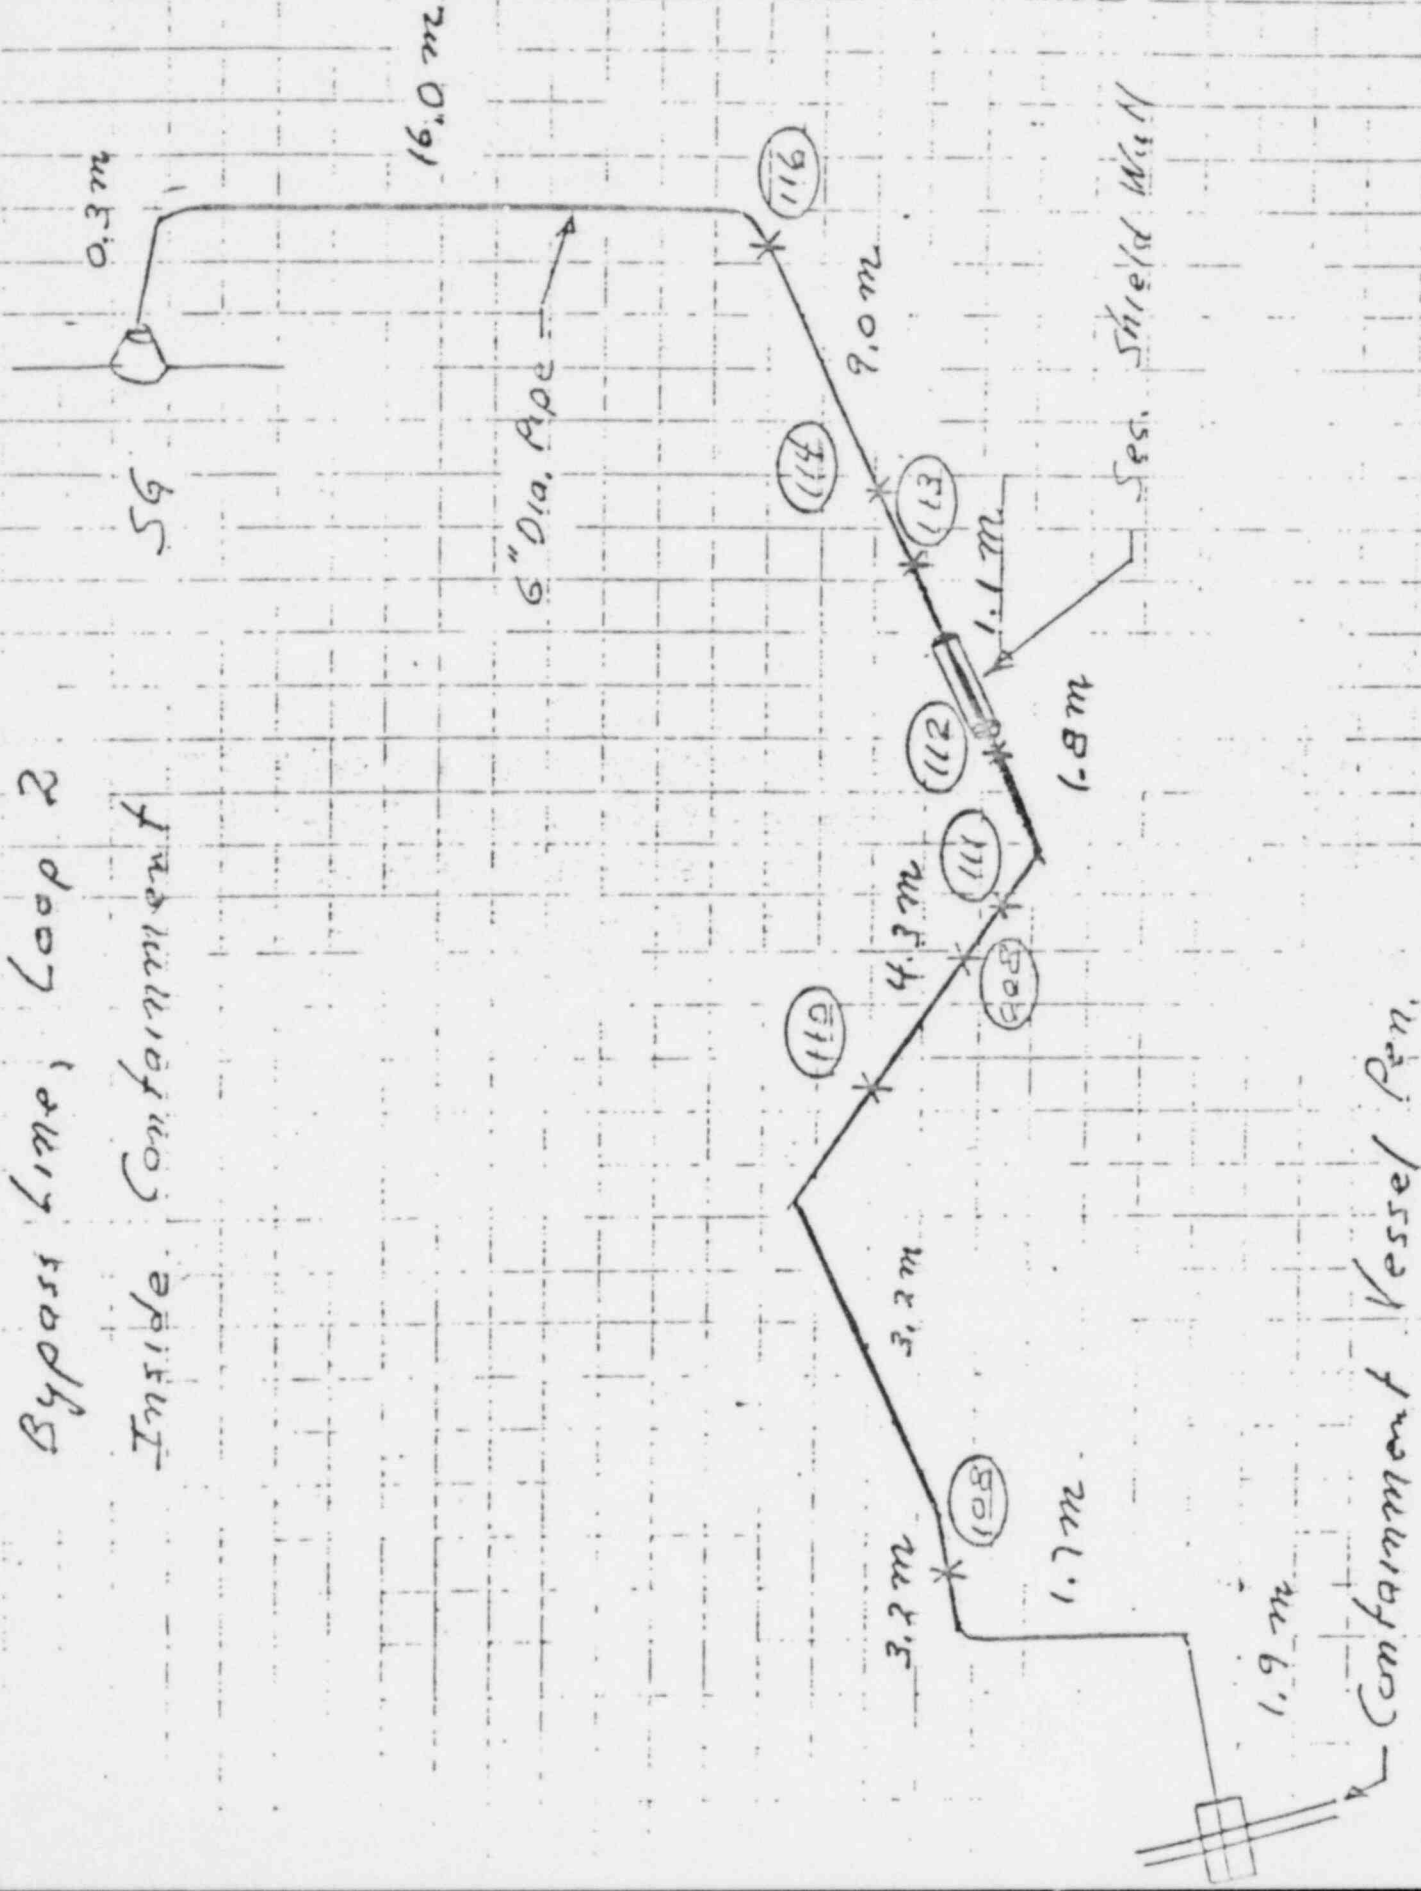
Figure 2, KRSKO

The extent of the damage to the loop 2 bypass piping inside and outside containment, is presented in Table 1. In Figure 2, the numbers in ovals identify the pipe hangers which were affected. On both Figures 2 and 3, the length in meters of the pipe sections are given. A bulge or blister was observed in the bypass piping, in the horizontal section, downstream of the secondary shield wall, approximately midway between the shield wall and elbow in Figure 2. The bulged region was approximately six to eight inches long, with the bulge located on the top side of the pipe. At the bulge, the pipe diameter was increased approximately one quarter inch.

- o EMBEDMENT PLATES MOVED, BOLTS LOOSENEED, PIPE CLAMPS LOOSENEED AND MOVED, (AFFECTED HANGERS ARE IDENTIFIED BY NUMBERS IN OVALS),
- o PIPE CHANGED LOCATION
- o PIPE BULGED 1/4 INCH NEAR SECONDARY SHIELD WALL.

With respect to KRSK0 plant repair, the section of bypass piping, containing the bulge, between and including the second and third upstream elbows was replaced. Also the hanger damage was repaired.

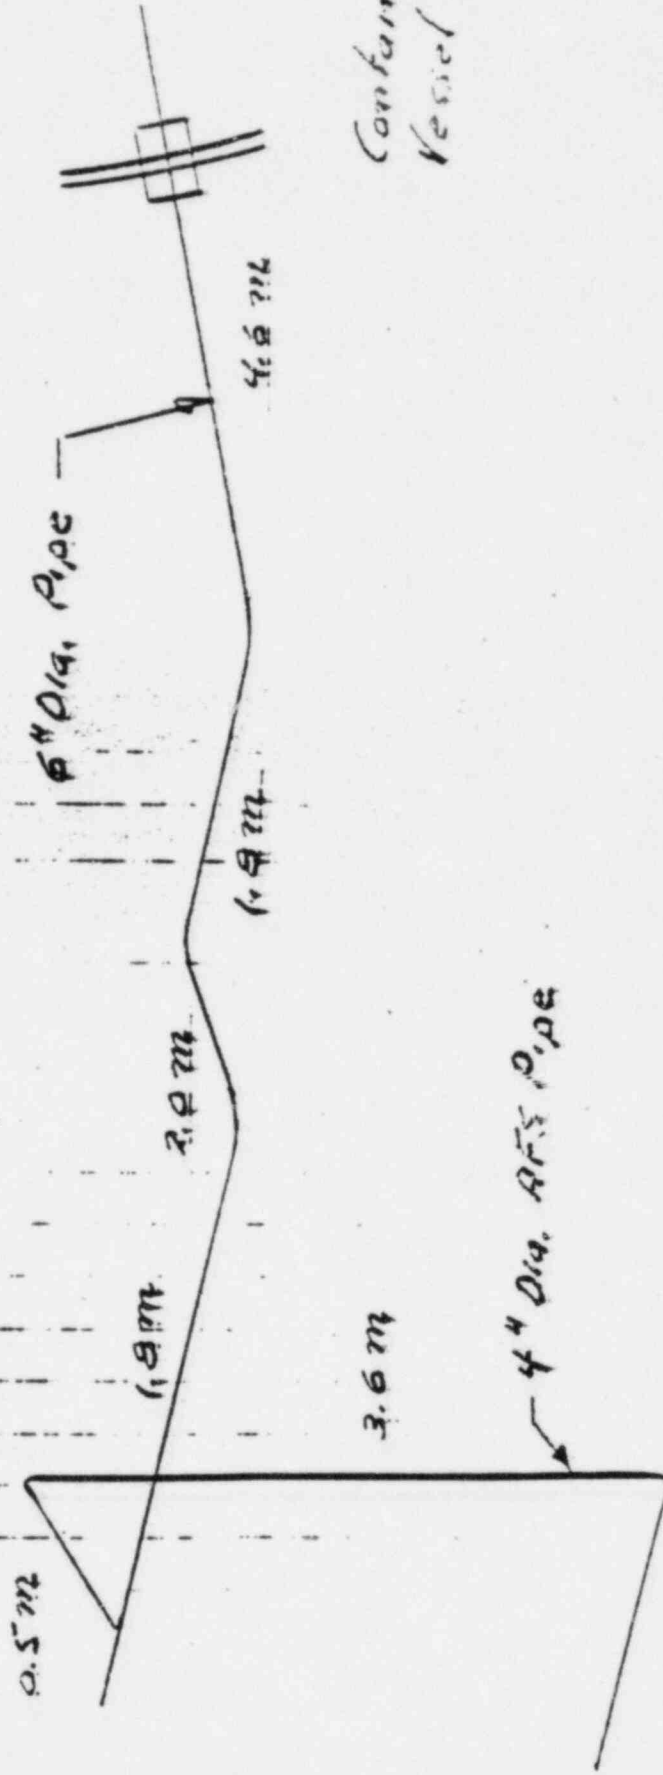
Figure 3, KR5KO

Two isometric pipe sketches of the bypass piping are presented in Figures 2 and 3. Figure 2 shows the bypass piping inside containment from the six inch auxiliary nozzle to the containment vessel penetration. Figure 3 shows the section of bypass piping from the containment penetration back to the point where the four inch Sch 80 AFS pipe connects.

- o PIPE MOVEMENT WAS NEGLIGIBLE
- o AUXILIARY PIPE PAINT WAS BLISTERED BACK TO THE MDAFS PUMPS
- o MDAFS PUMP CHECK VALVES WERE FOUND TO HAVE SOME NICKS, SCRATCHES, AND UNEVENNESS.

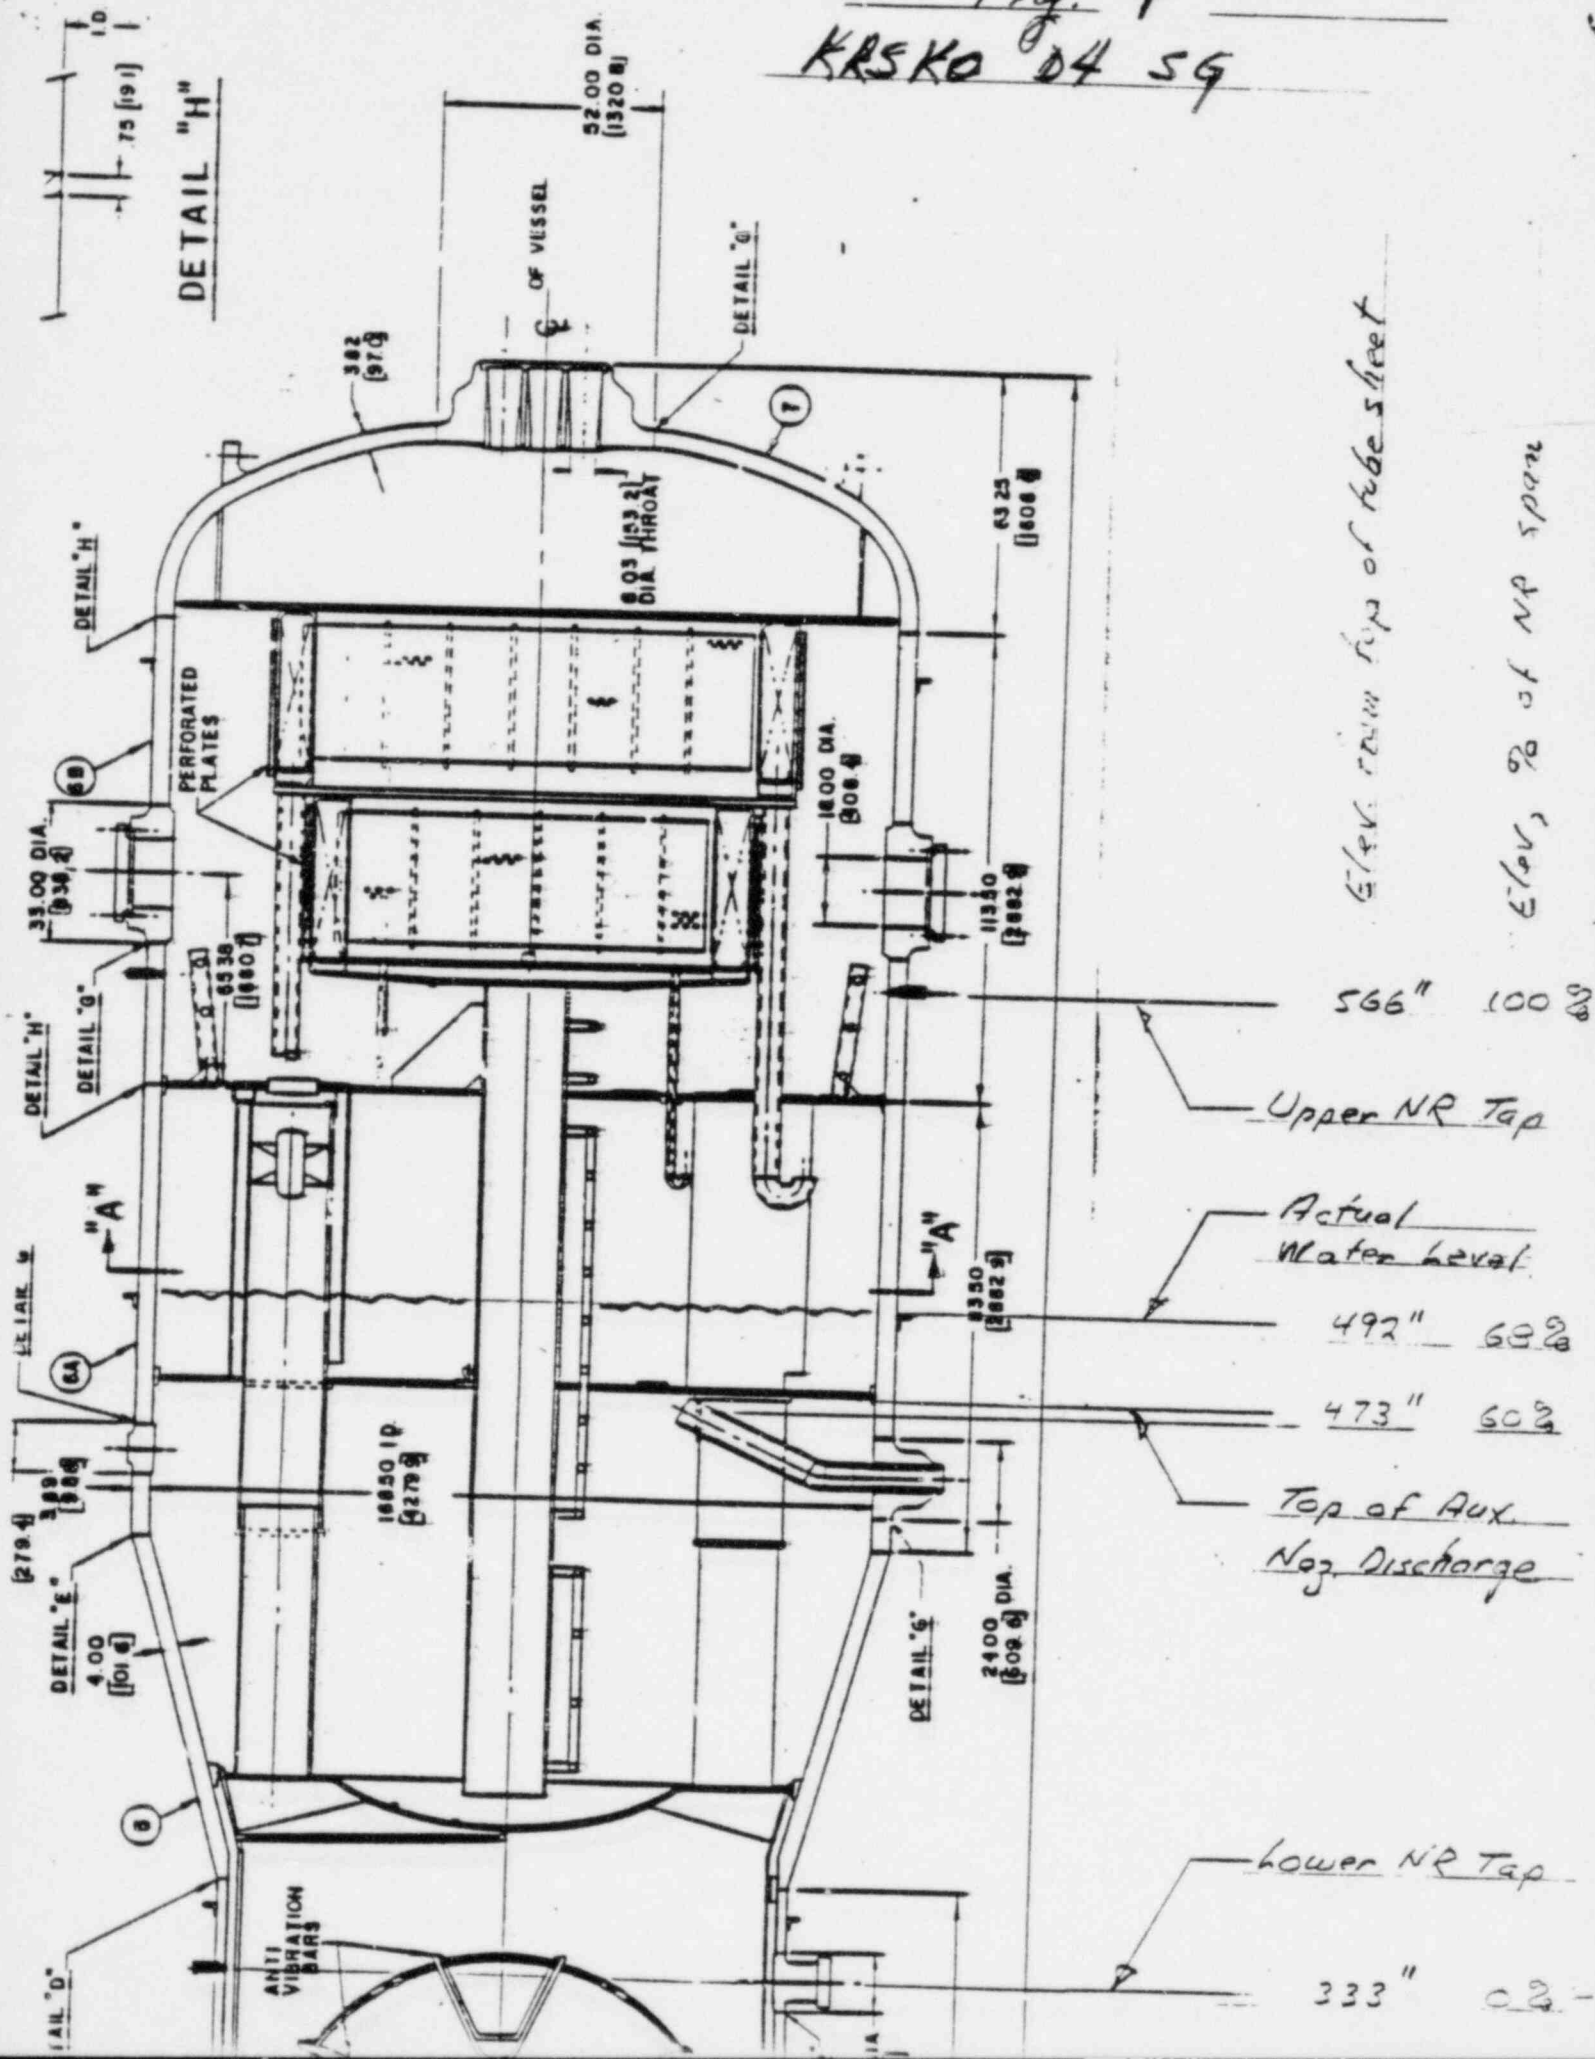
Fig. 4
KRSKO 04 59

The internals of the KRSKO Model D4 steam generator are shown in Figures 4 and 5. Figure 4 for the upper shell shows the auxiliary nozzle and internal extension. Also indicated is the actual water level for 100 percent power.

Also with respect to plant operation, the customer was instructed to maintain the steam generator water level above the top of the auxiliary feedwater discharge pipe inside the steam generator as much as possible. With the discharge pipe covered, only hot water and not steam could leak back into the bypass and AFS piping, thus greatly reducing the potential for waterhammer.
