SUBJECT: BOARD NOTIFICATION - CONTROL ROD DRIVE GUIDE TUBE SUPPORT
PIN FAILURES AT WESTINGHOUSE PLANTS
(Board Notification No. 82-81)

CONTROL ROD DRIVE GUIDE TUBE SUPPORT PIN FAILURES AT W PLANTS

IE INFORMATION NOTICE NO. 82-29: CONTROL ROD DRIVE (CRD) GUIDE TUBE SUPPORT
PIN FAILURES AT WESTINGHOUSE PWRs

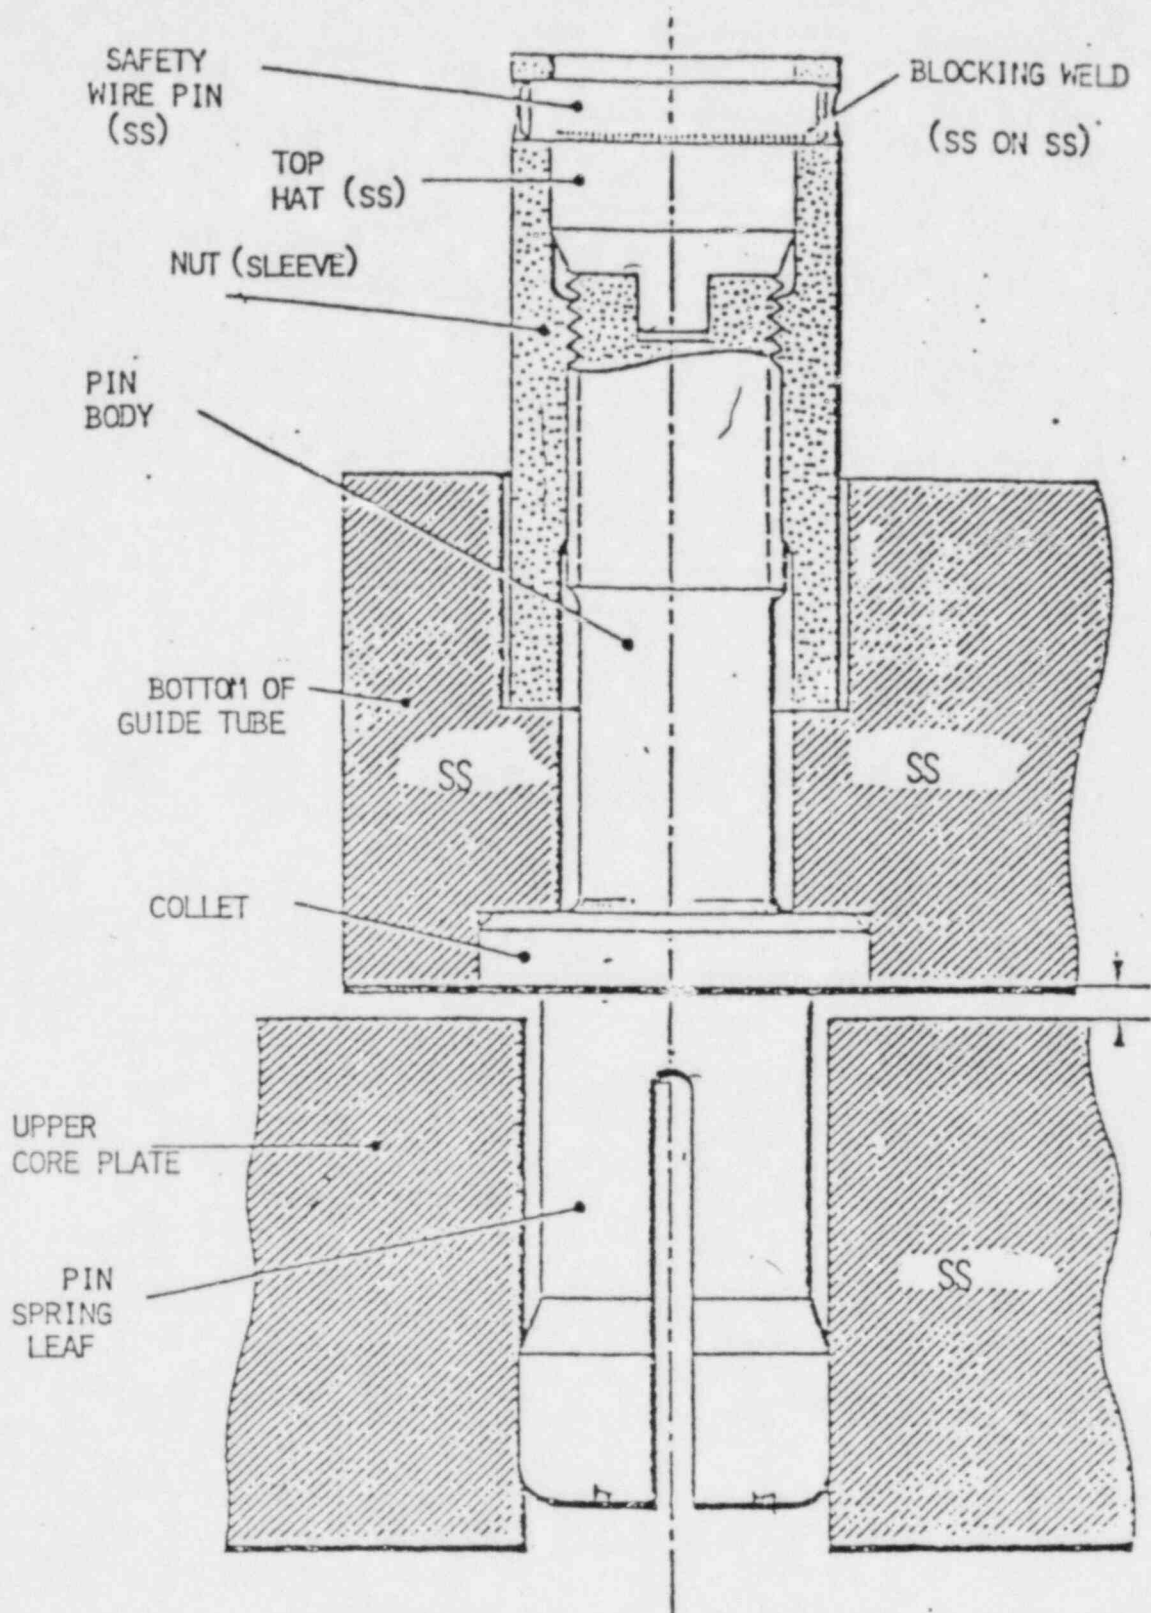
PIN ASSEMBLY
(INCONEL)

Prior to May of this year, at which time a guide tube pin failed at North Anna 1, these failures had occurred only at foreign reactors (Japan and France). The pins are used to align the bottom of the CRD guide tube assembly into the top of the upper core plate. Two support pins are bolted into the bottom plate of each lower guide tube, and are inserted into the top of the upper core plate in a manner that provides lateral support while accommodating thermal expansion of the guide tube relative to the core plate (see attached pin assembly diagram). The pins are about 3½ inches long and have a diameter of 0.507 or 0.537 inch (depending on reactor design). The pin assembly includes (1) a bolt section

to which a nut (sleeve) is threaded to anchor the pin to the guide tube, (2) a collet that rests against the guide tube, and (3) a leaf spring section with the leaf shaped somewhat like a clothespin. The material is Inconel X-750, which, depending on the manufacturer and the fabrication date, has been solution heat treated and age hardened at various temperatures and for various times. For example, the solution heat treatment temperatures and times ranged from 1625°F to 2100°F and from ½ hour to 24 hours; age hardening temperatures and times ranged from 1148°F to 1544°F and from 8 hours to 20 hours, respectively.

The first failures were detected in early 1978 at Mihama Unit 3 in Japan, at which time the top portion of a support pin with the shank and lock nut engaged was found in a steam generator. Subsequent ultrasonic testing (UT) showed a possibility of cracks in 103 out of 105 pins at the bolt to collet transition region of the pin. Seven of the Mitsubishi-supplied pins were then removed and inspected, confirming the UT results. All pins were subsequently replaced and UT inspection was conducted at other Japanese plants. In all, there have been at least eight support pin failures where a pin has actually broken. These occurred with both Westinghouse and Mitsubishi-supplied pins.

Westinghouse's analysis indicated that the failures are caused by stress corrosion cracking (SCC) of pins that are solution heat treated at less than 1800°F after which they are age hardened, and then highly stressed (60,000 psi nominal on the shank and 130,000 psi on the leaf spring section of the pin). The solution heat treatment of the North Anna 1 support pin was 1625°F for 1 hour followed by an age hardening treatment. The torque on the nut was 210 ft-lb. Westinghouse now recommends that the pins be solution heat treated at 2000°F for 1 hour and age hardened at 1300°F for 20 hours to minimize the SCC problem. Westinghouse also recommends that the torque on the lock nut be reduced to 130 to 140 ft-lb.
