November 10, 1982  
Fort St. Vrain  
Unit No. 1  
P-82515

REPORTABLE OCCURRENCE 82-042  
ISSUE 0

FORT ST. VRAIN NUCLEAR GENERATING STATION  
PUBLIC SERVICE COMPANY OF COLORADO  
16805 WELD COUNTY ROAD 19 1/2  
PLATTEVILLE, COLORADO 80651-9298

REPORT NO. 50-267/82-042/03-L-0

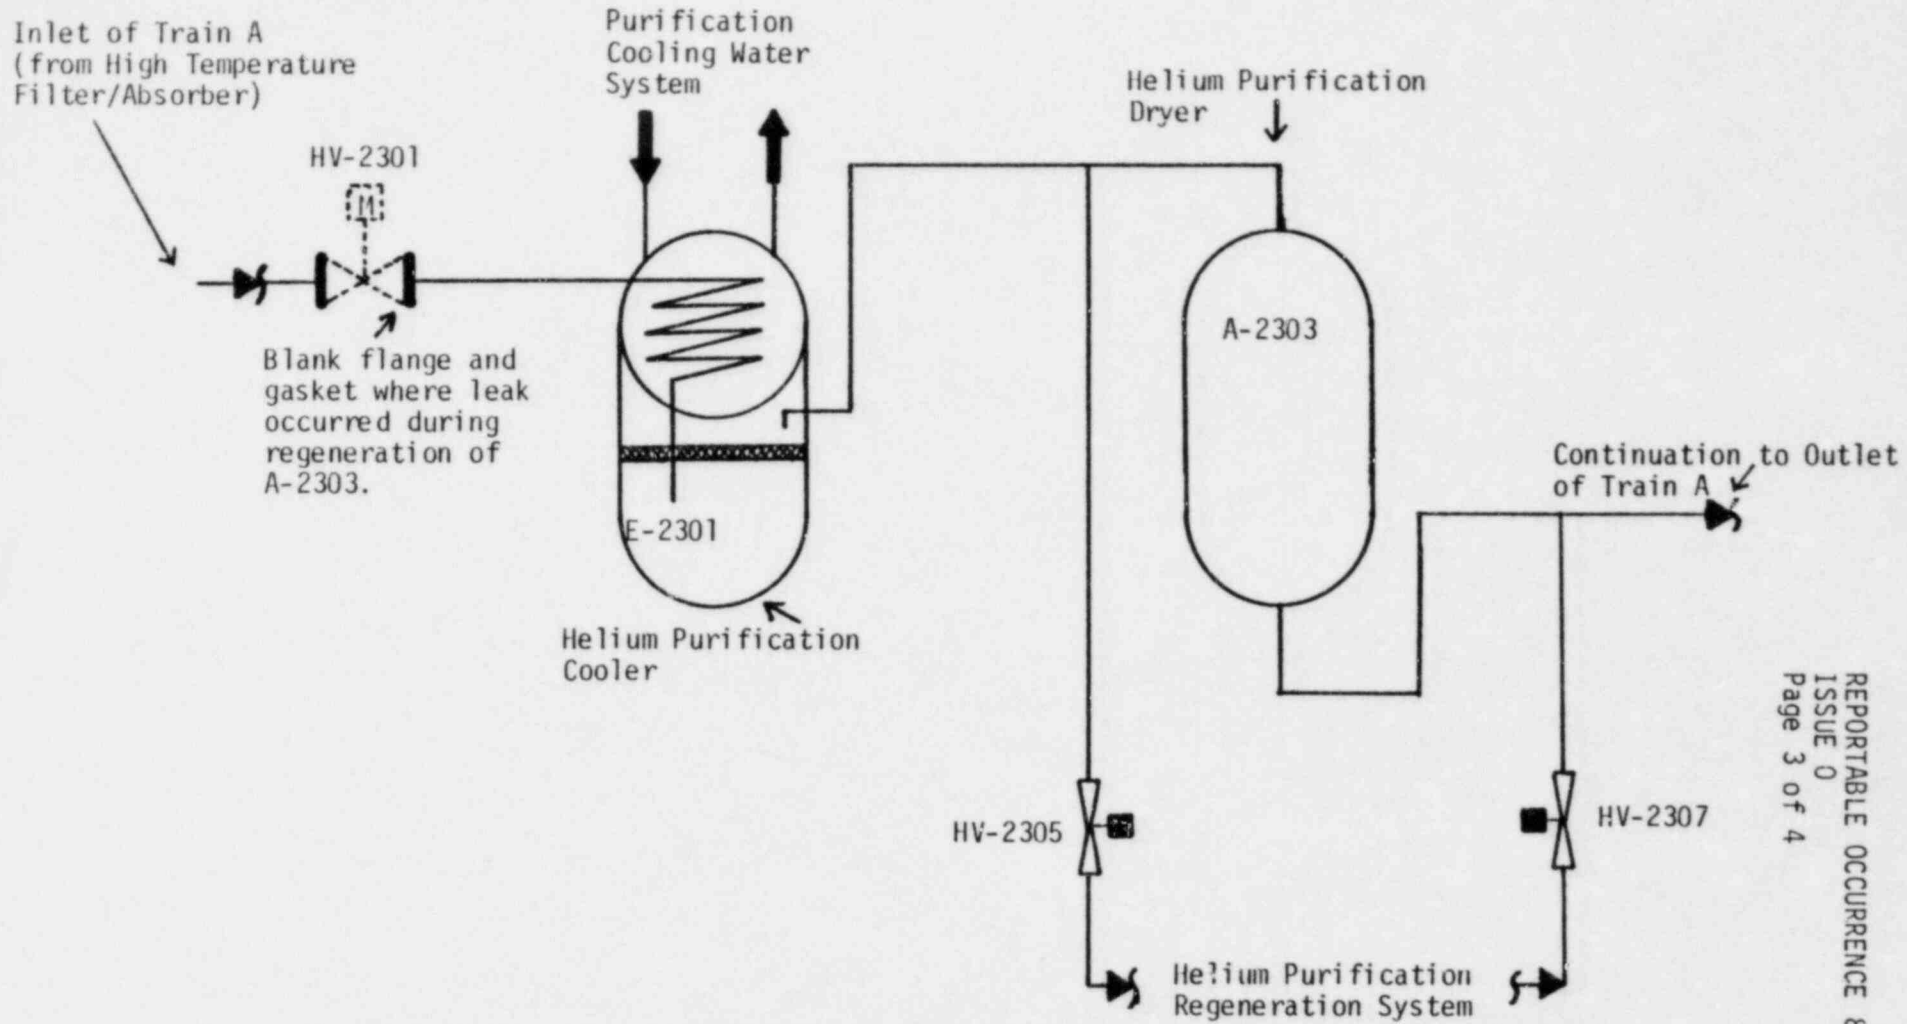
Figure 1: Simplified Section of Helium Purification System  
-Train A-

Upon investigation of the source of airborne gaseous activity, it was found that the blank flange (on the purification side of where HV-2301 was removed) had a leaking seal (See Figure 1). The source of activity was the helium being used to regenerate that purification train's dryer. During dryer regeneration, that particular flange was subjected to approximately 88 psig pressure.

The seal between a blank flange and the purification train "A", where HV-2301 was removed, failed. This failure allowed helium being used to regenerate the train's dryer to escape to the Reactor Building. The associated activity was then exhausted via the filtered Reactor Building exhaust stack to the atmosphere.

When accessible, a new seal was installed on the blank flange which was found to be leaking. The associated secondary cover was replaced on the well where HV-2301 is normally located, until the valve could be re-installed in the system.
