UNITED STATES
NUCLEAR REGULATORY COMMISSION

SUBJECT: SCHMUCKER, PAUL, NOHR & ASSOCIATES - NRC INSPECTION REPORT
030-34421/2019-002, NOTICE OF VIOLATION AND EXERCISE OF
ENFORCEMENT DISCRETION

Report: 2019-002

Schmucker, Paul, Nohr & Associates, Inc. NRC Inspection Report 030-34421/2019-002

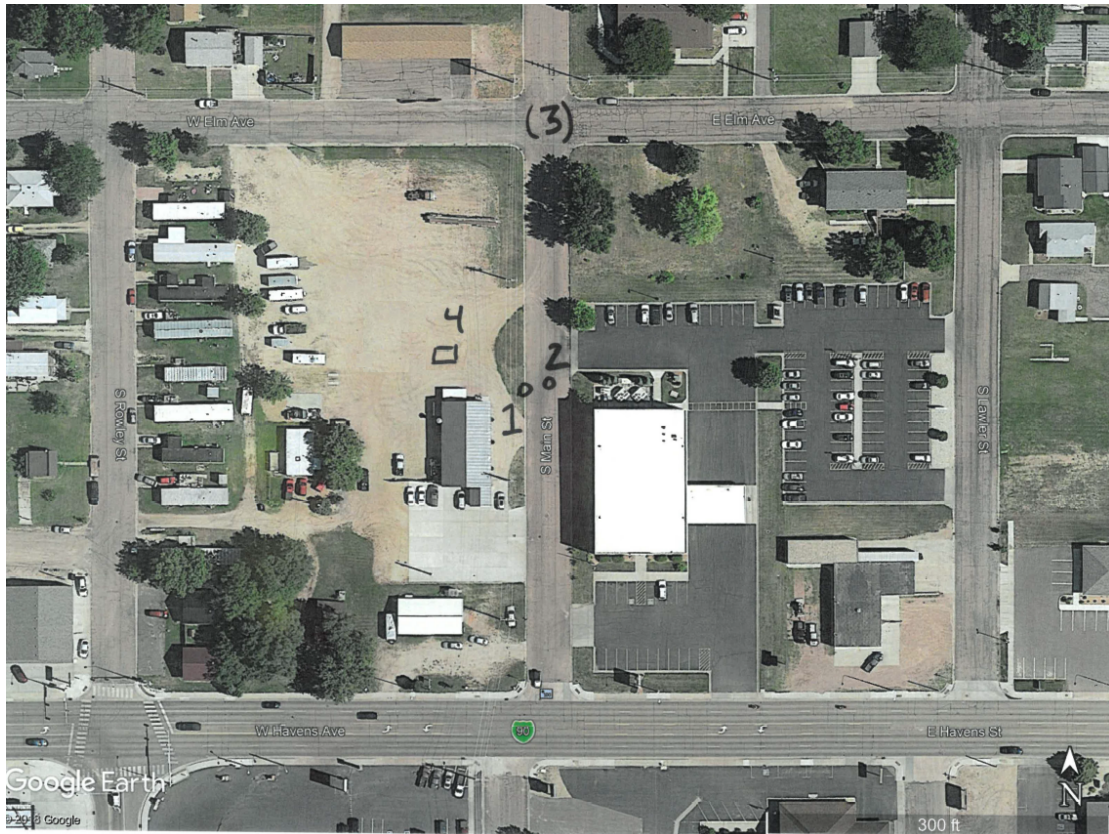
Figure 1 – Google Earth image showing the approximate locations involved during the gauge event. The north-south road is South Main Street, with West Havens Avenue running east-west to the South, and West Elm Avenue running east-west to the North. The labeled locations are: (1) the location of the gauge when damaged; (2) the location of the gauge user when the gauge was damaged; (3) the location of most ancillary personnel and construction equipment; and (4) the location of the supervisor's truck and where the gauge body was provided with a field repair.

The gauge user had begun their fourth density test at approximately the location labeled as (1) in Figure 1. While this test was ongoing, the gauge user moved to roughly the middle of the road (labeled (2) in Figure 1) to begin preparing the ground for the fifth density test, which involved creating a hole of sufficient depth and width to allow the cesium-137 source rod free-movement into the roadbed. While this was occurring, the gauge user stated that most of the construction equipment and personnel were approximately half a block to the north at the intersection of South Main Street and West Elm Avenue, labeled in Figure 1 as location (3).

The supervisor put the cesium source rod on the ground (within the cordoned off area) and moved the remaining gauge body to the supervisor's pickup truck, which was located approximately at the location labeled as (4) in Figure 1. At this time, the gauge user and supervisor agreed that no personnel or equipment was trafficking the area around the damaged gauge.

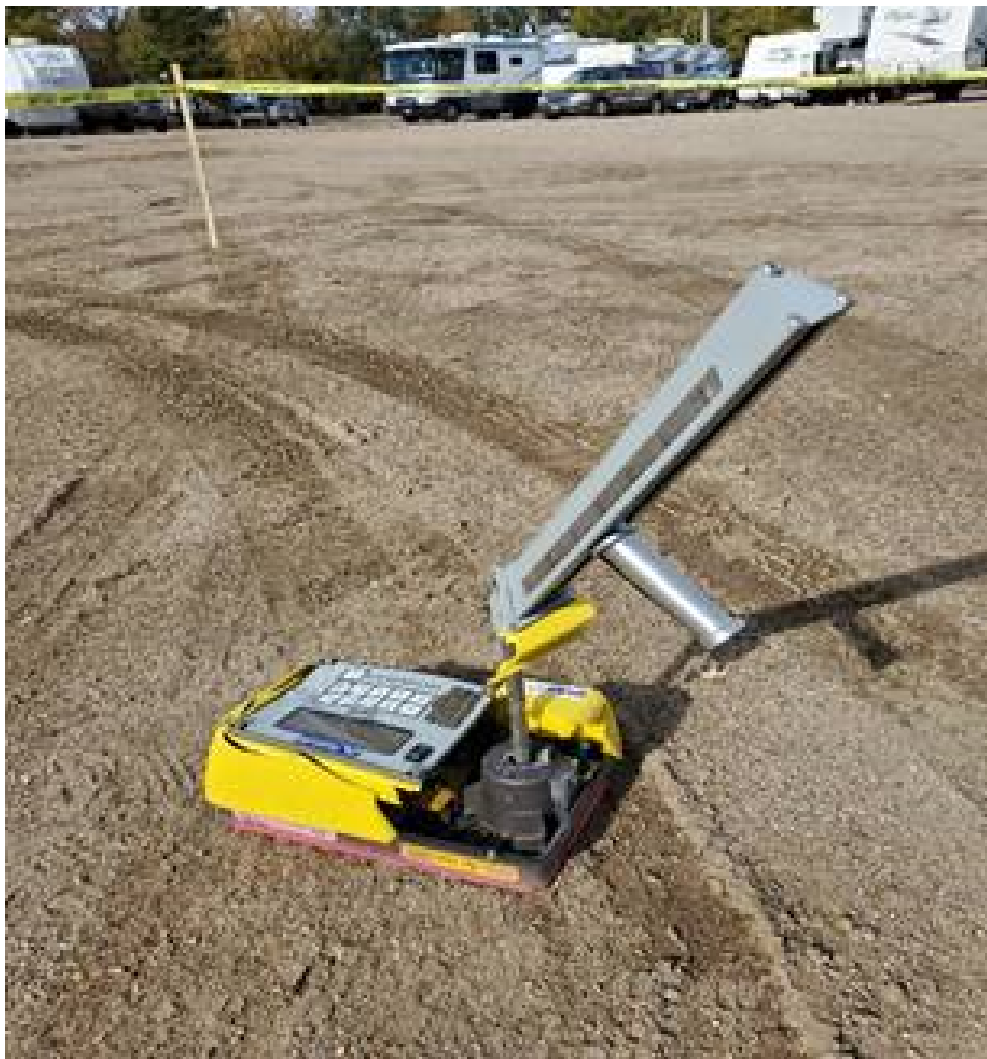
At approximately 8:56 a.m., local time, on October 26, 2019, the gauge user heard the sharp cracking sound of the portable gauge as it was run over by a wheeled skid-steer. The skid-steer had traversed down to the location of the gauge to begin moving a pile of material northward, and in its first trip backed over the portable gauge.

Figure 2 – The damaged Troxler Model 3430, S/N 73136. Visible in the picture are the boundaries put up by the gauge user following the damaging of the gauge and the skid-steer tire tracks. The gray and angled portion of the gauge is the index rod, and the cesium-137 source rod is the vertical portion beneath the index rod, with the bottom portion within the shielded block.

The gauge user noted that the cesium-137 source rod, which had been extended for the density test, was flush to the ground (not extended). As best can be determined, the skid-steer, in running over the portable gauge, had caused part of the gauge to lift sufficient to raise the cesium-137 source rod above the ground level, and when the skid-steer moved off the gauge the gauge returned to level ground, which caused the cesium-137 source rod to retract to a flush position to the ground.

The gauge user erected a boundary tape (visible in Figure 2) at approximately fifteen feet from the portable gauge in all directions and contacted the office supervisor, in accordance to the licensee's emergency procedures. The supervisor called the radiation safety officer for the NRC license on the way to the incident, and arrived on the scene of the event at approximately 9:40 a.m.

sliding block immediately returned to the closed and shielded position. The supervisor used a power saw to remove the non-radioactive index rod (shown above in Figure 2), with the goal of allowing the gauge body to fit within the transportation case. Satisfied with the field repair, the supervisor returned and secured the bottom plate to the gauge body and brought the gauge body back to the cordoned off area.

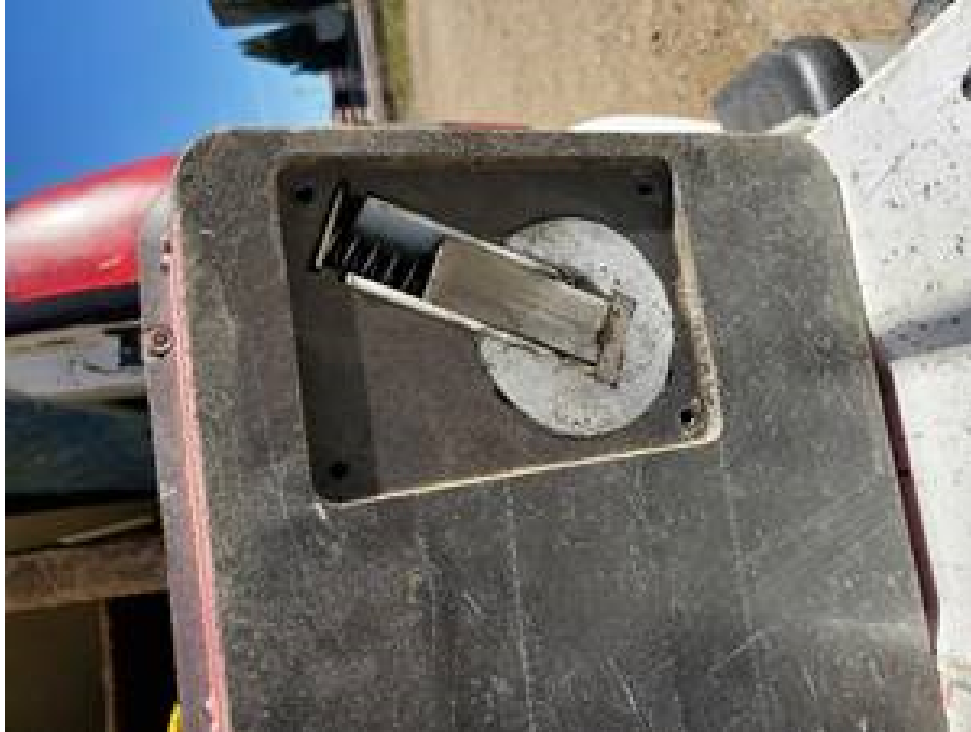
The supervisor approached the damaged portable gauge with the survey meter and tilted the gauge to assess the damage to the underside of the gauge. The supervisor observed that the sliding block, a spring-loaded shield that lessens the radiation levels out the bottom of the portable gauge (see Figure 3), had not returned to the closed and shielded position. On the gauge's return to the ground, the cesium-137 source rod slipped out the top of the gauge body while being held by the supervisor by the opposite end as the cesium source.

The supervisor, in accordance with the Troxler User Manual, removed the screws that secure the bottom plate to the gauge body and pulled the plate away from the sliding block (see Figure 3 below). The supervisor observed that, with the plate removed, the

Figure 3 – The bottom of the Troxler Model 3430, with the bottom plate removed to show the sliding block. In this figure, the sliding block is in the fully closed and shielded position.

The supervisor then took the cesium-137 source rod, by the non-source end, and slid the source rod back through the top of the gauge body into the shielded position. The supervisor then used adhesive tape to secure the cesium source rod to prevent free-movement and placed the gauge within the transportation case. Secured within the transportation case, the supervisor took additional radiation surveys on-contact with the transportation case's surface and at one meter to establish the radiation levels were at or below those provided in the Troxler User Manual, Appendix A, and thus adequate for transportation back to the licensee's Mitchell, South Dakota office.
