NUREG-0090
Vol. 5, No. 2

Report to Congress on Abnormal Occurrences

April - June 1982

**U.S. Nuclear Regulatory
Commission**

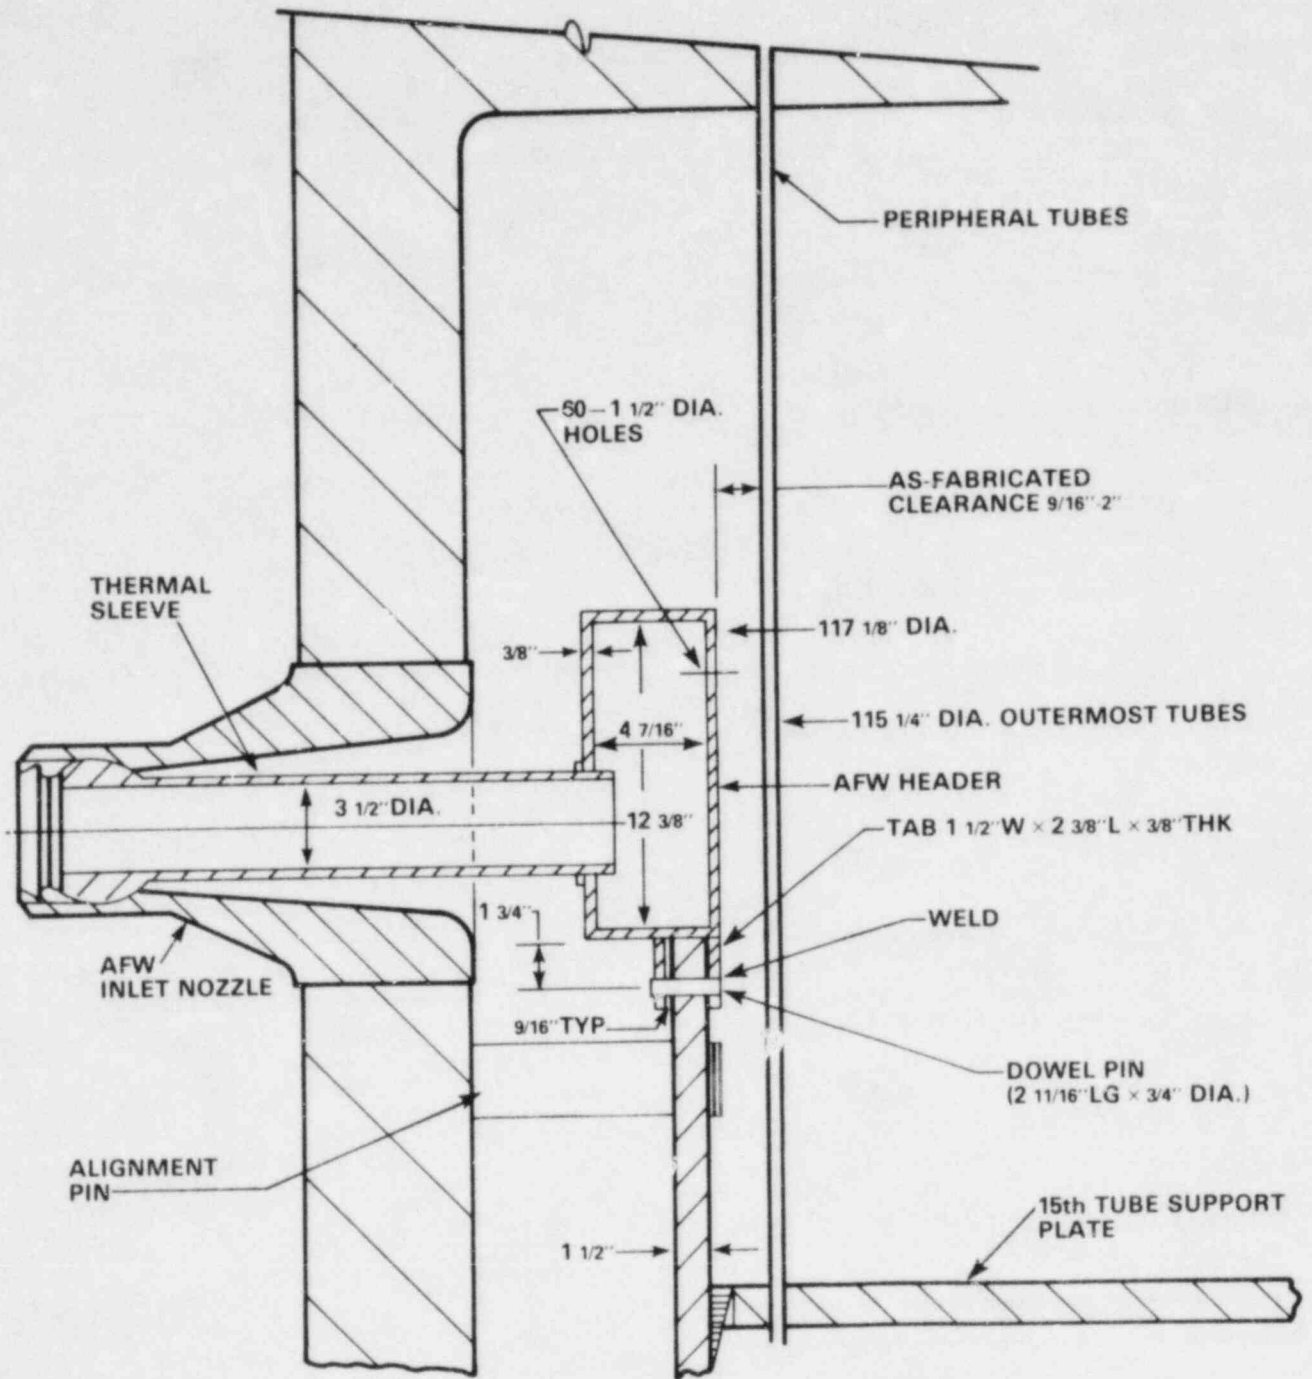
Figure 1. Internal AFW Header Design (Longitudinal Section) for Davis - Besse Unit 1

The internal AFW header design is described as follows (Ref. B-12); Figure 1 shows a longitudinal section of the design for Davis-Besse Unit 1 (Rancho Seco Unit 1 and Oconee Unit 3 designs are similar). The internal AFW header is a rectangularly shaped torus fabricated of welded plate segments. The header is positioned on the upper end of the upper vertical cylindrical baffle (upper shroud). The header also serves as a continuation of the upper shroud to separate the tube bundle from the steam annulus. The header is positioned and retained by eight sets of inner and outer brackets welded to the bottom of the header and match drilled through the shroud. A dowel pin passes through each set of brackets and is welded to the inner bracket (see Fig. 1).

A visual inspection of the internal header at Davis-Besse Unit 1, followed by a 360° remote video inspection, showed that the outer wall (shellside) of the header was distorted inward (concave) as much as 4-1/2 inches. In addition, the inner vertical wall was noted to be bent inward in some locations. In one S/G, the thermal sleeve was disengaged from the inlet hole of the header and was offset from the center of that opening. It was also noted that certain header support brackets were bent, the bottom ligament torn out or were broken off, and that there was evidence of wear and/or distress on dowel pins and brackets. Dowel pins were missing at the majority of the eight bracket locations in each of the S/Gs. All brackets and all but one dowel pin have been located and retrieved.

It has been concluded that the most likely cause was rapid condensation-induced high pressure differential. Stress calculations performed by the licensees concluded that a pressure differential in excess of 200 psi is required to cause collapse of the internal headers. The design of the internal AFW header was such that during operation of the plant, prior to AFW actuation, the header would be filled with steam. When AFW was actuated, there would be a sufficient flow of subcooled water which would result in a rapid condensation of trapped steam, with attendant depressurization, inside the header. It is also concluded that the rapid flooding of the header with cold AFW when the steam generator was at operating conditions produced high thermal stress which could contribute to the distortion. S/G tube damage occurred due to interactions of the header, brackets, and dowel pins with the tubes.

The apparent cause of the above problems was a design deficiency in plants which utilize the internal AFW header design.

AFW header with six injection nozzles (eight at Davis-Besse) to provide AFW flow, similar to the AFW ring header design which exists at five other B&W plants; (3) removal of loose parts that can be located (those that cannot be found must be shown to not pose a safety-related problem); and (4) the use of surveillance programs to assure no degradation of the systems and components involved. The NRC has completed safety evaluations for the restart of Rancho Seco Unit 1 and Davis-Besse Unit 1 (Refs. B-13, B-14) and will complete a safety evaluation for the restart of Oconee Unit 3.
