August 5, 1981

MEMORANDUM FOR: R. H. Vollmer, Director
Division of Engineering

FROM: J. Halapatz
Materials Engineering Branch

SUBJECT: DIFFERING PROFESSIONAL OPINION RELATED GENERICALLY TO
SENSITIZATION OF BWR STAINLESS STEEL WELDMENTS

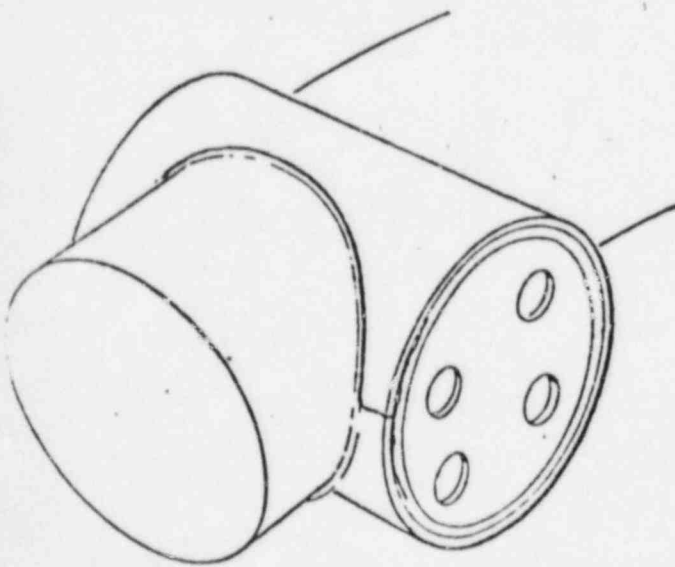
Millstone 1 - Apr 73

A planned shutdown and inspection (as part of the salt water intrusion recovery surveillance program, see VI.C.3) revealed new cracking in 2 of the 4 new FW spargers (see II.11). Subsequent exams disclosed that the 3rd and 4th spargers had PT crack indications. This 2nd set of spargers, No.2 design, replaced the originally installed which was found to be severely cracked. Based on the analysis which followed the chloride intrusion incident, it was concluded that the cracks in the spargers had occurred prior to the chloride transient as a result of high cycle fatigue following a condition of inadequate cold preload. The failure of the 2nd set of spargers, in the absence of chloride, substantiated the conclusion regarding the initial failure. However, it raised questions concerning the completeness of the definition of sparger operating conditions used as a basis for the Millstone design.

Underwater TV revealed that both the NW and NE spargers were cracked in the junction box and front plate. Subsequent close-up examination (in vessel) revealed loose jack bolt/vessel contact, loose end bracket pins, and changes in sparger proximity to the vessel wall on all but the SE sparger. Tests indicated that only the SE sparger had maintained the cold as-installed preload (~6000 lb). The SE sparger is the entry point for clean up system return flow. While the SW, NW, and NE spargers showed a resistance to movement, none exhibited any significant preload.

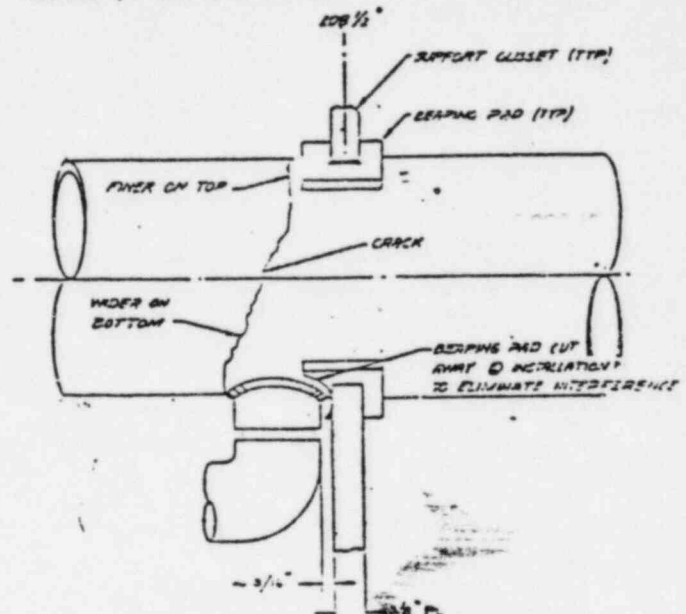
Oyster Creek - Oct 78 - refueling

While performing ISI inside the reactor vessel, an indication was discovered on the core spray sparger for System II. The core spray sparger consisted of 3 1/2 in. schedule 40 type 304 SS pipe formed in 2 semi-circles held in place with brackets attached to the core shroud. Nozzles were welded into the bottom of the pipe about every 5 in. to direct the flow of water directly on the fuel bundles in a pre-established pattern. The circumferential crack (see figure) was $\sim 1/32$ in. wide at its widest point and extended $\sim 200^\circ$ around the sparger. It was located at an azimuth location of 208° in the reactor vessel. This was $\sim 58^\circ$ from the inlet and 32° from the end of the sparger arm. The crack was through the wall, as determined by pneumatic testing, and was smaller inside the pipe than on the outside. The crack appeared to have initiated close to one of the spray nozzles and was adjacent to one of the support brackets. Because of the design of the sparger and the mounting brackets, it was concluded that the sparger would have been held in place if called upon for operation even if the crack had propagated completely around the pipe circumference before it was discovered.

The most probable cause of the crack was due to local cold work of the sparger and stresses imposed during installation and fitting of the sparger within the shroud. Fitting the pipe into position during installation could have resulted in stresses large enough to propagate a stress corrosion crack.

The upper core spray sparger repair consisted of the addition of a bracket assembly to provide axial support to the core spray piping in the vicinity of the crack. No attempt would be made to seal the crack. The bracket assembly was constructed of Type 304 solution annealed SS and was held in place by four 3/4 in. bolts that were pre-loaded and locked in place by Class A type locking caps. The bracket assembly was fitted around the existing spray nozzles on both sides of the crack to provide axial support to the core spray sparge in the event the existing

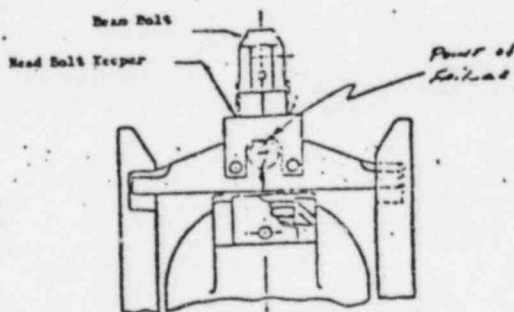
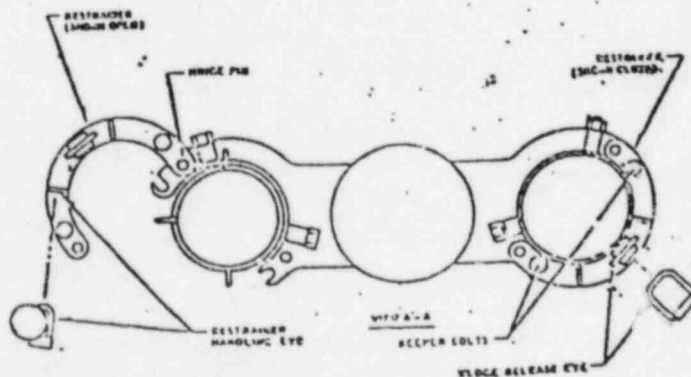
View B
Jet Pump Beam Details

At Dresden 3, alarms were received in the control room. Observed changes in plant parameters indicated that a jet pump had failed. Shutdown was initiated to bring the Unit to cold shutdown within 24 hr as per Tech Specs. The changes were 1) generator output decrease from 539 to 511 MWe, 2) core thermal decrease, 3) core flow increase from 97.6 to 104.7 x 10⁶ lb/hr, 4) core plate dp decrease from 16.1 to 13.8 psid, and 5) "B" recirc loop flow increase from 49 to 54 x 10³ gpm while "A" loop flow remained at 49 x 10³ gpm. It was then determined that jet pump No 13 had failed.

Following vessel head removal and defueling, TV camera and VT of the jet pumps and vessel annulus revealed the hold-down beam assembly of the suspect jet pump had broken across its ligament sections at the mean diameter of the bolt thread area. Failure of the beam assembly resulted in pump decoupling at the diffuser connection. Subsequent in situ UT of all other jet pump hold-down beams, using a special UT technique developed by GE revealed ultrasonic indications of cracking at the same location in 6 of the remaining 19 beams examined. A sketch of the typical jet pump assembly is shown in Figs. The indications ranged from 6 to ~ 20 mils. The beams were machined from stock Inconel X-750 material. (hmi)

At Quad Cities 2, a UT was performed on all jet pump hold-down beam assemblies. A wide-crack indication along the upper machined surface near the beam bolt on jet pump No 16 was discovered. It was estimated in excess of 100 mils in depth and in the same location as found at Dresden.
