**Washington Public Power Supply System**

January 28, 1983  
G02-83-80

Subject: NUCLEAR PROJECT NO. 2  
10CFR50.55(e) REPORTABLE CONDITIONS #22, #29, #37, #43, #49,  
#50, #53, #54, #60, #64, #82 AND #102; DEFICIENCIES IN  
ELECTRICAL SEPARATION

OPERATION OF STANDBY GAS TREATMENT SYSTEM DAMPER  
10CFR50.55(e) CONDITION #49  
INTERIM REPORT

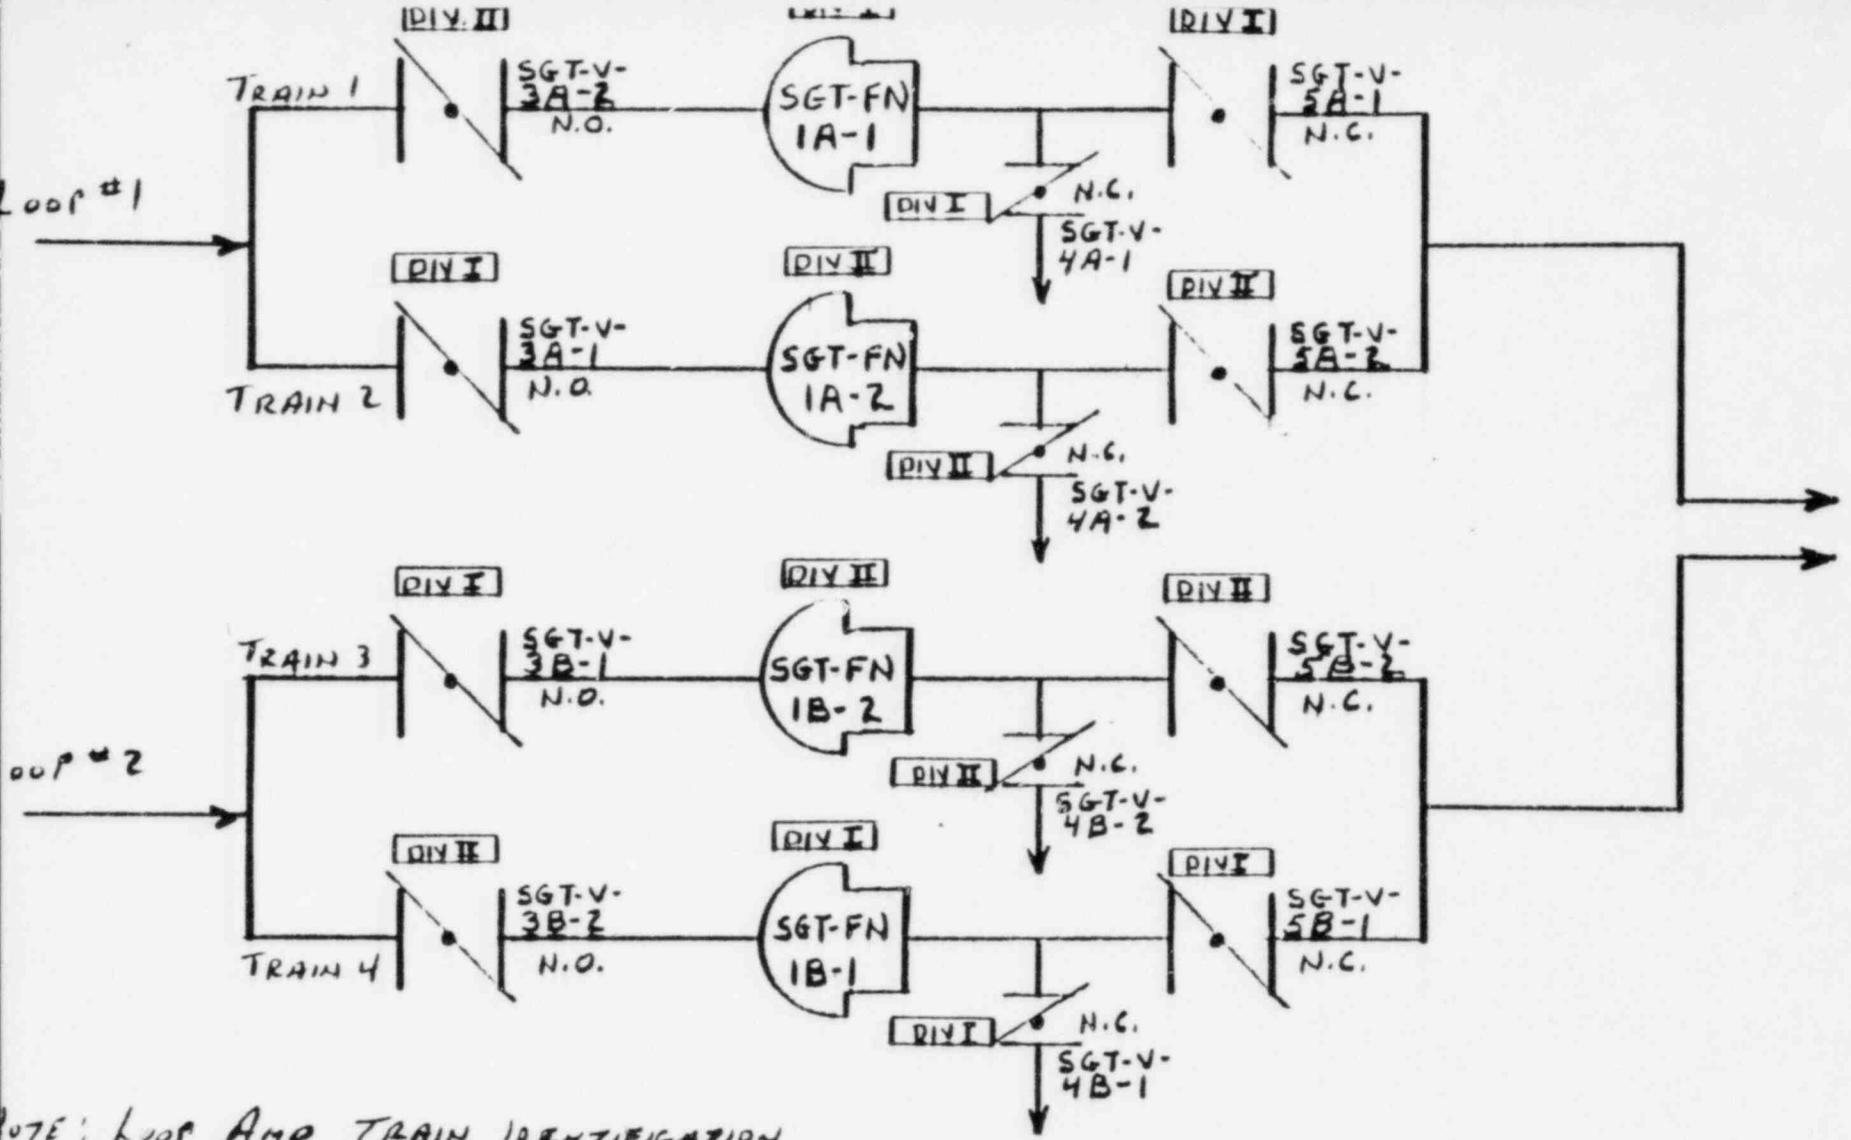
Flow Diagram

As shown on the attached flow diagram there exists electrically operated dampers to control the mode of operation of each train (e.g., isolation, recirculation or exhaust). Also depicted on the attached diagram is the source of emergency power for each motor operated damper and fan.

It is contended that due to the system design which provides two redundant divisions of dampers in each fan train, a possible loss of both Standby Gas Treatment System loops from a single event is possible and that separation problems exist in each fan and heater area (i.e., all four dampers within either division, if closed, would render the system inoperable).

Since all compatible division damper control circuits (for all four fan trains) are routed together, the worst case single failure will be a fault which could generate a localized fire and cause both SGTS trains to become inoperative.

The Architect Engineer, in conjunction with Supply System Project engineers is evaluating the damper control circuits for corrective action.
