SUBJECT: DOCKET NO. 50-333
LICENSEE EVENT REPORT: 90-025-01
Service Water Check Valves

TITLE (4) **Five Service Water to Emergency Service Water Swing Check Valves Fail to Close During Testing Due to Corrosion and Silt Accumulation in Hinge**

Figure 1 to
 LER 90-025-01
 Docket No. 50-333

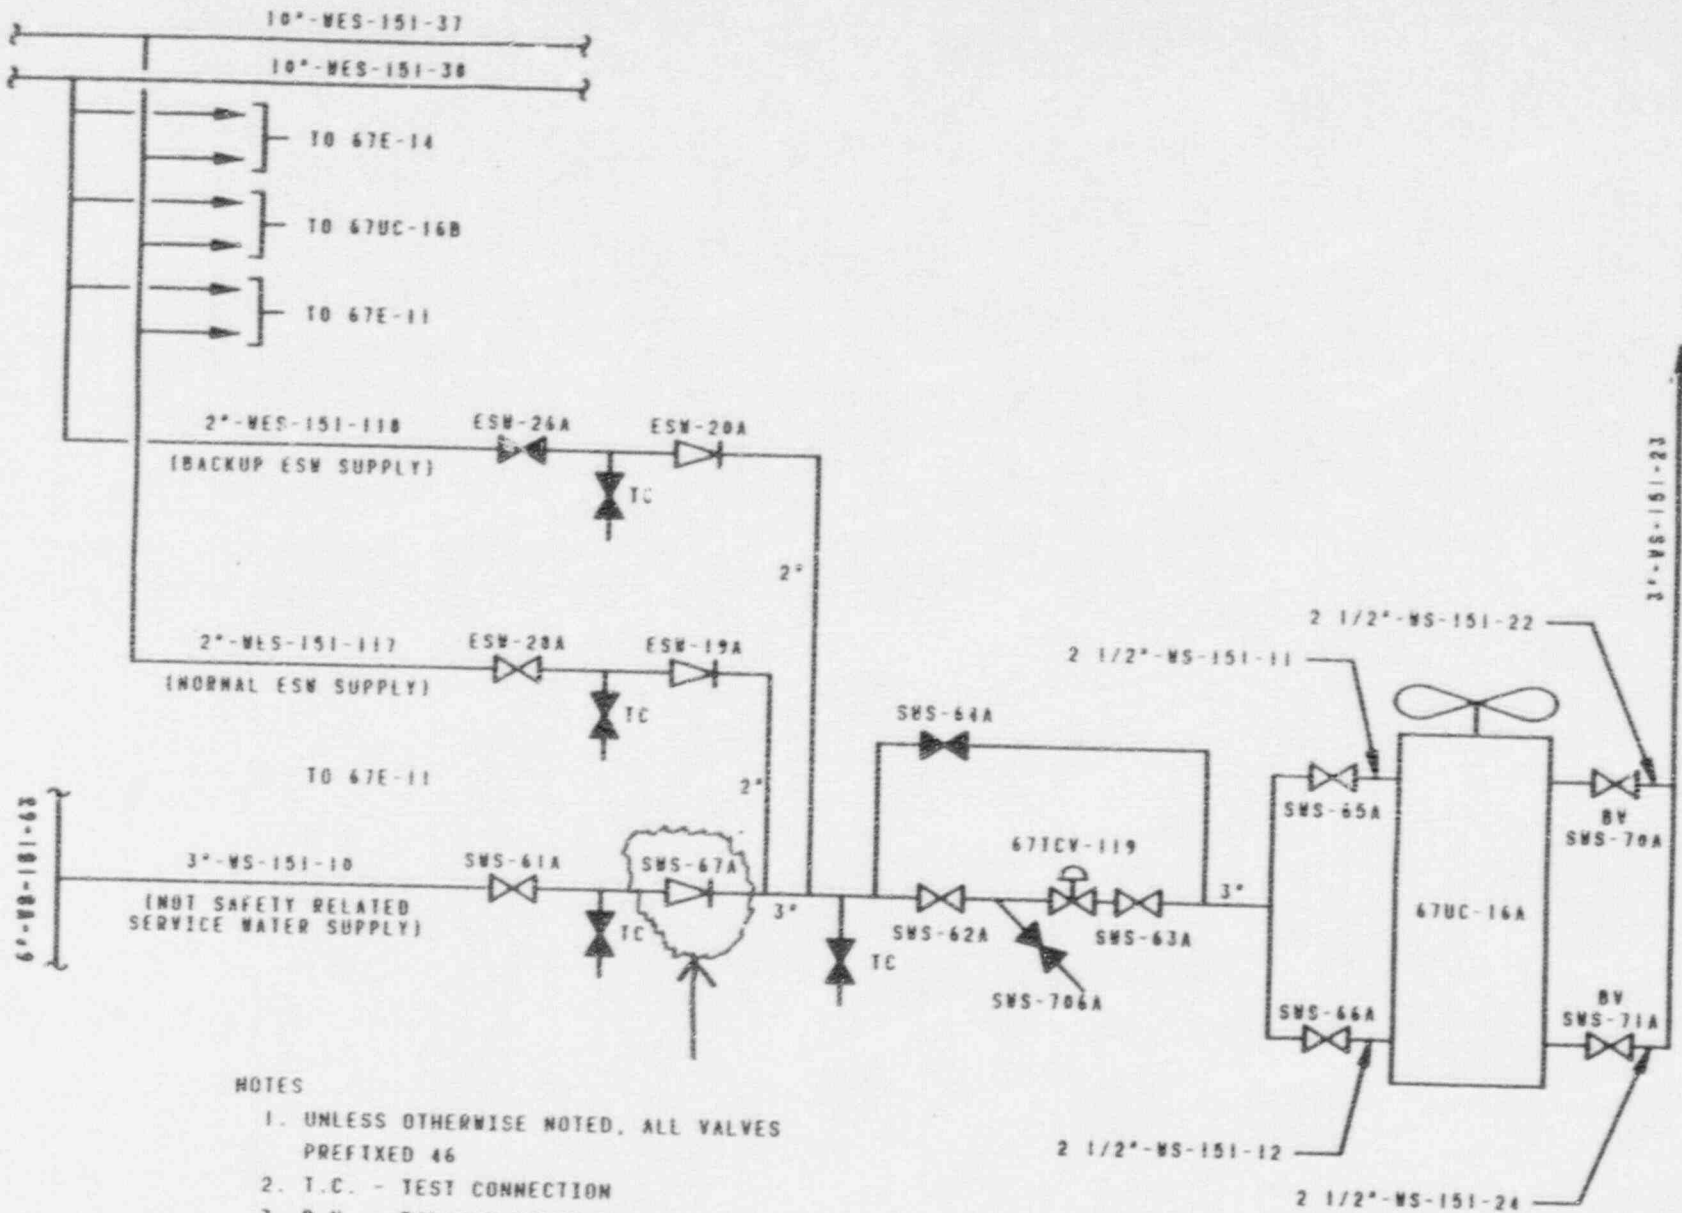
ELECTRIC BAY UNIT COOLERS
67UC-16A

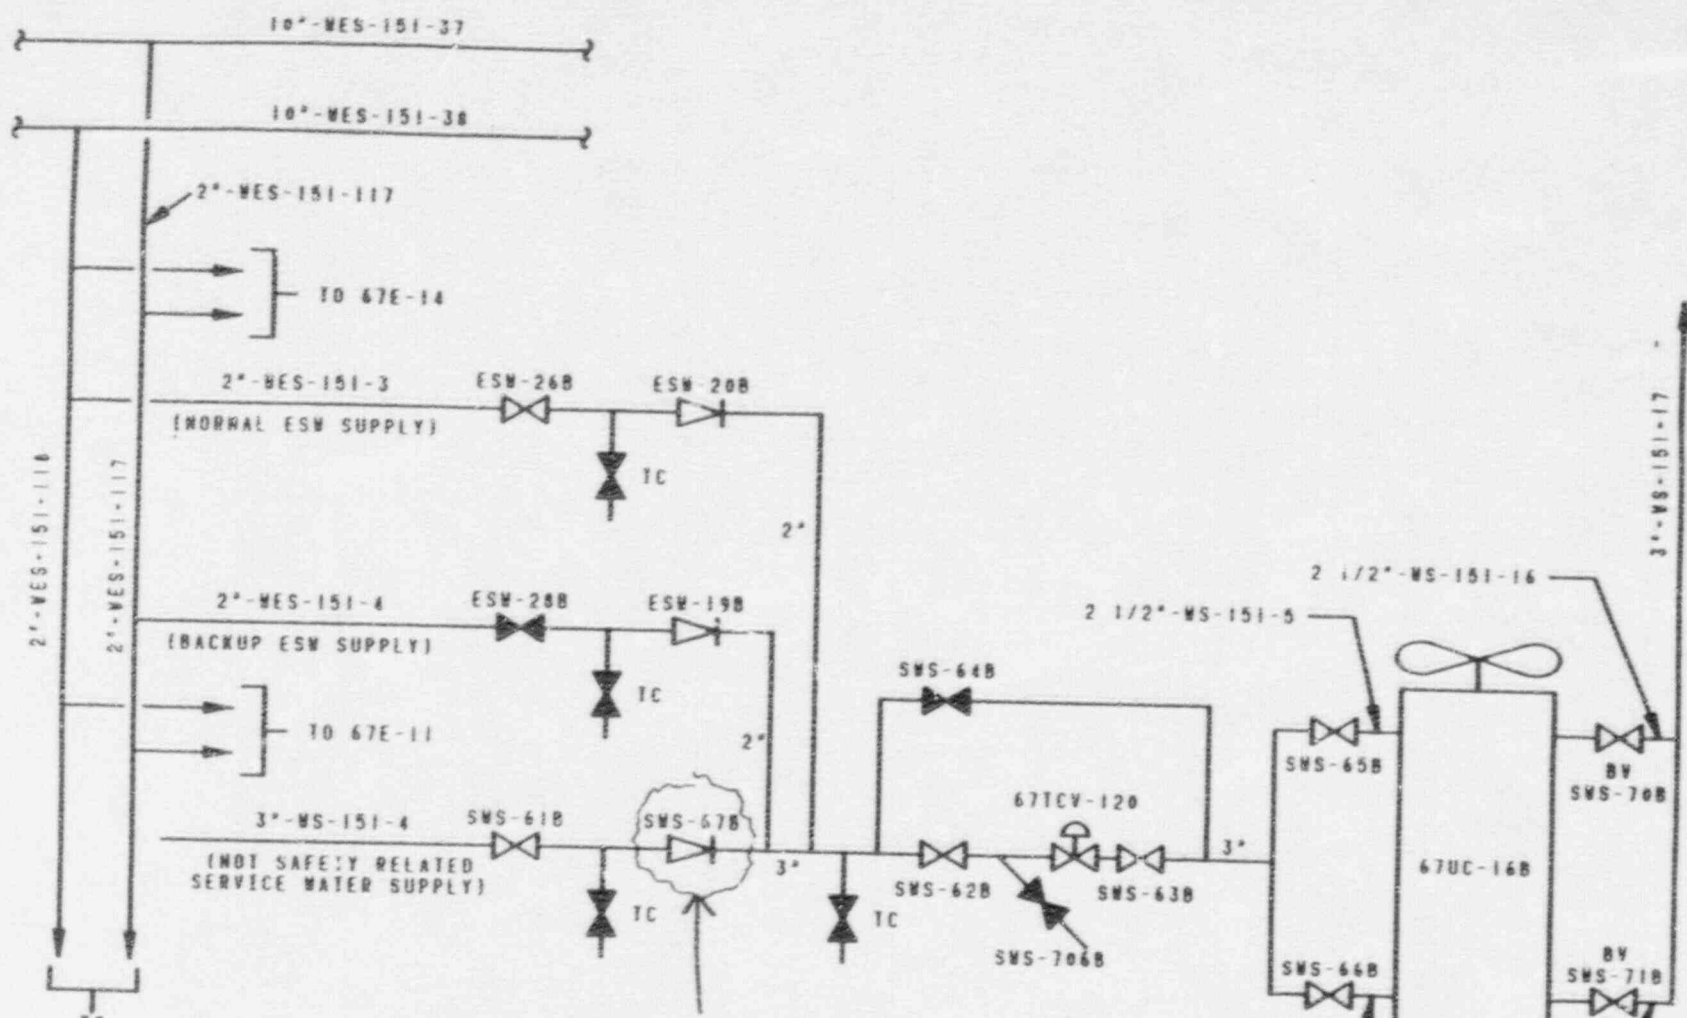
Figure 2 to
 LER 90-025-01
 Docket No. 50-333

ELECTRIC BAY UNIT COOLERS
67UC-16B

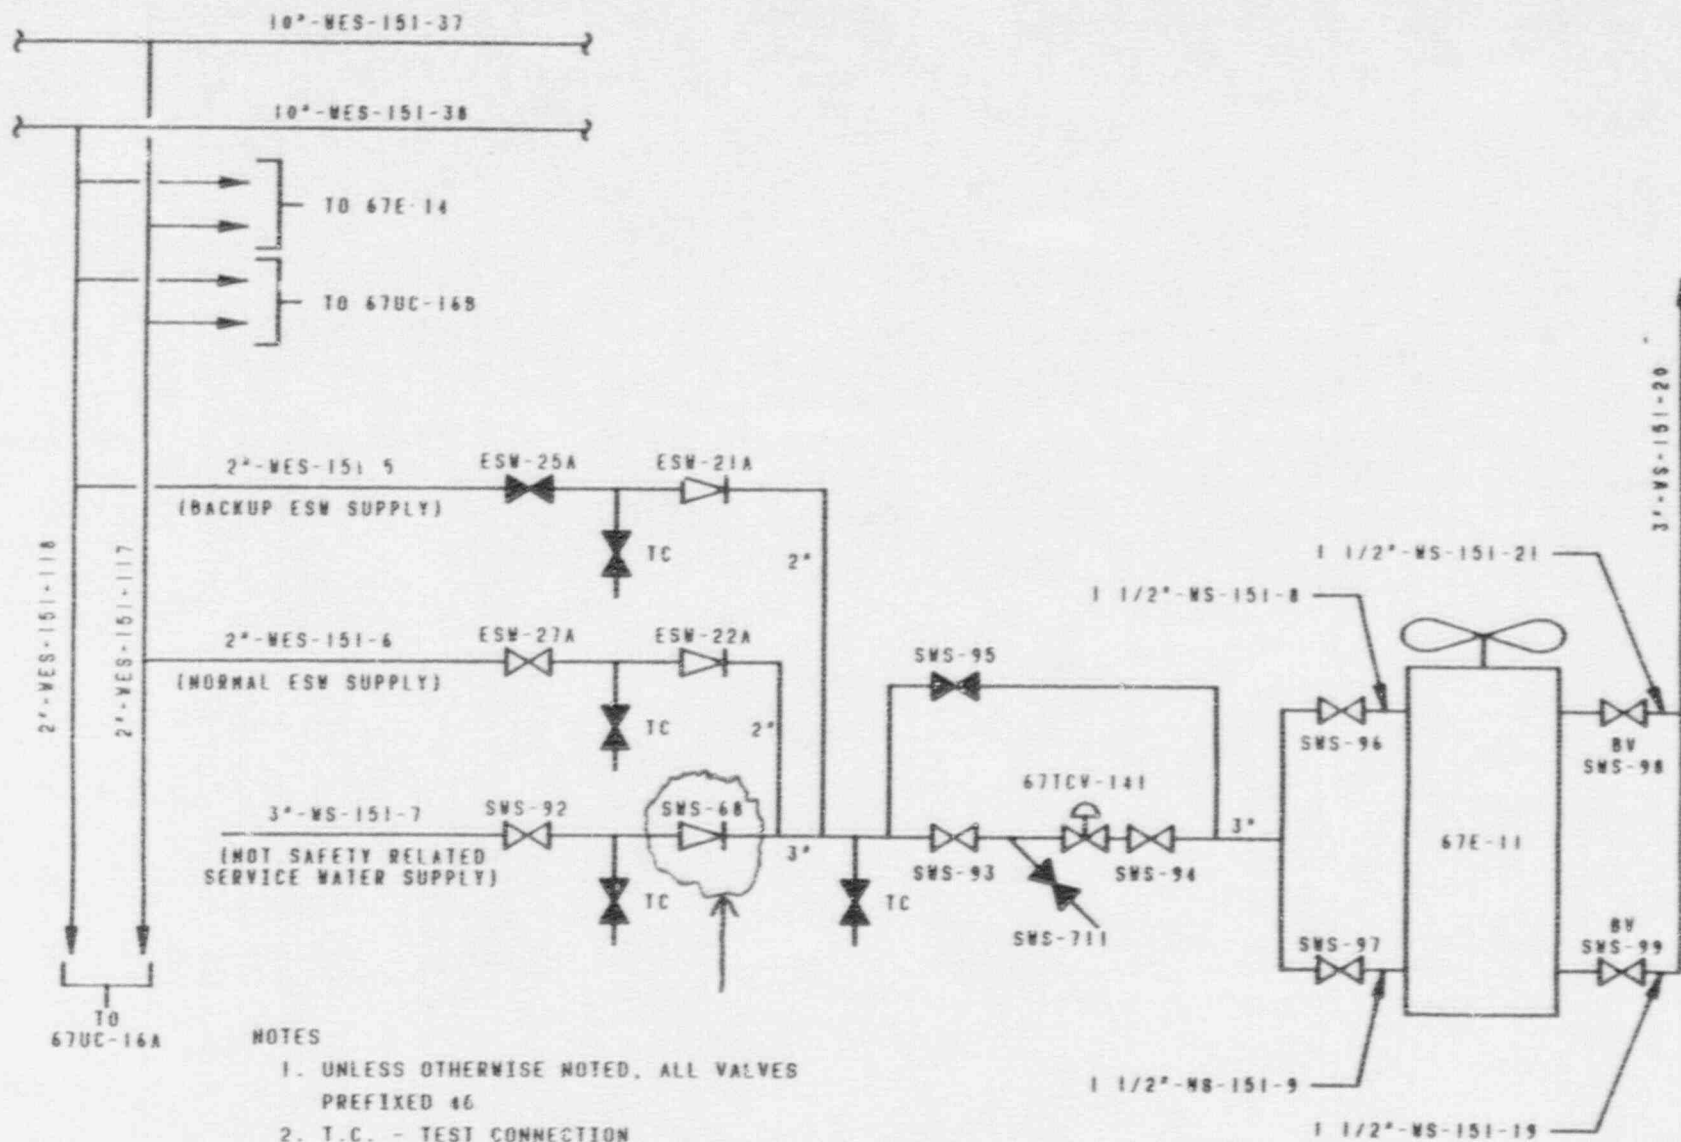
Figure 3 to
 LER 90-025-01
 Docket No. 50-333

CABLE TUNNEL/SWITCHGEAR ROOM COOLER

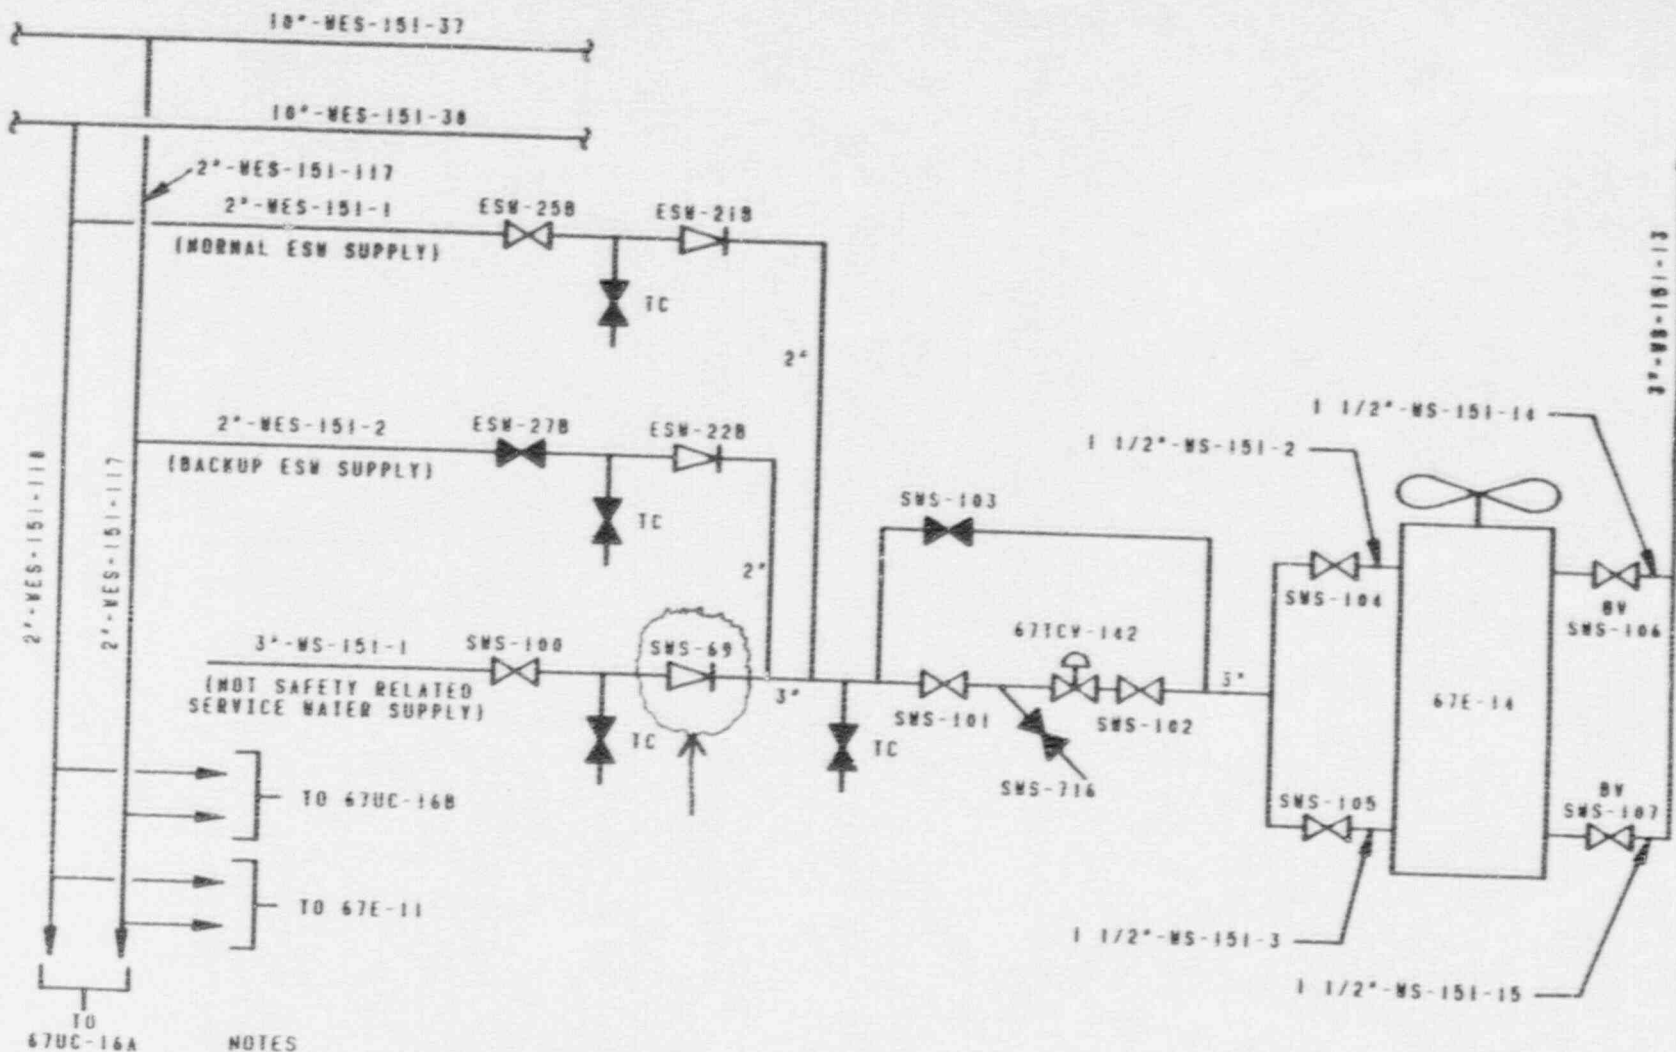
Figure 4 to
 LER 90-025-01
 Docket No. 50-333

CABLE TUNNEL/SWITCHGEAR ROOM COOLER

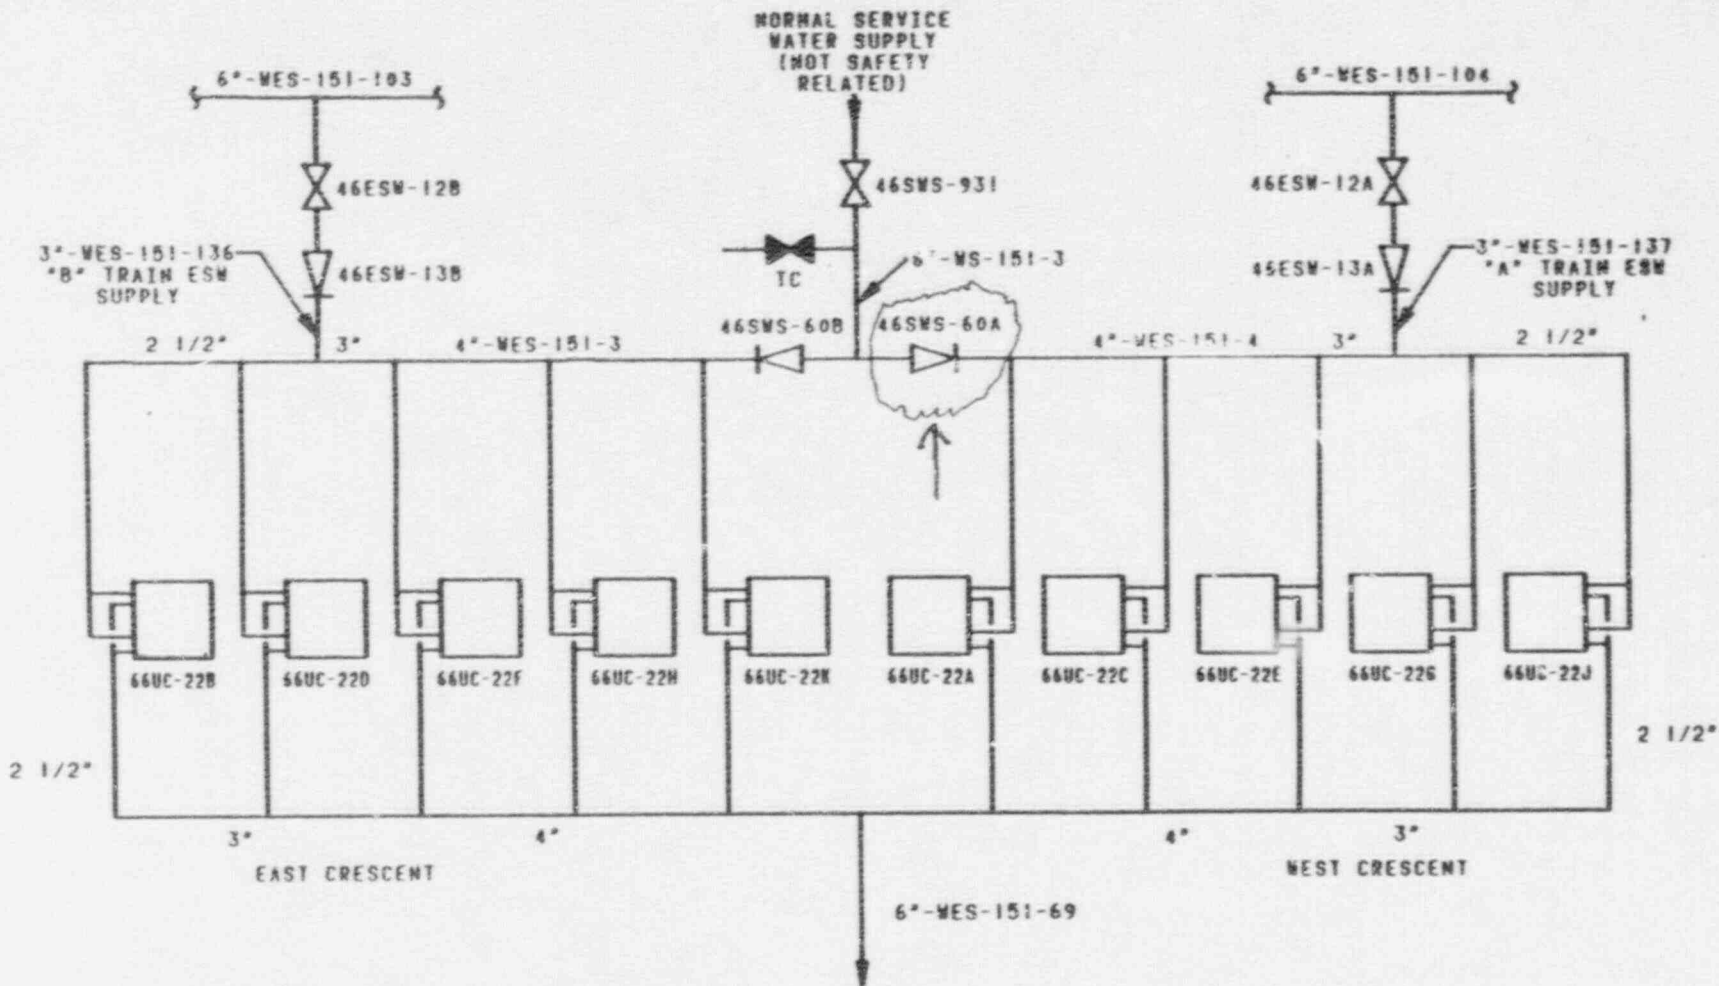
Figure 5 to
 LER 90-025-01
 Docket No. 50-333

The crescent area unit cooler heat exchangers provide cooling for portions of the emergency core cooling system (ECCS) [BJ, BM, BN, BO] equipment located in the reactor building west crescent (Safety Division 1) (see Figure 5).

(1 per division). The 4-inch header contains the 4-inch swing check valve (46SWS-60A) which initially failed to close under test conditions. Downstream of this valve the header has five tee connections into 2-1/2-inch supply lines to each cooler. The ESW supply also ties into the same header downstream of the failed check valve. Upon initiation of the ESW, the service water check valve 46SWS-60A is designed to close to prevent diversion of ESW from the unit coolers.

CRESCENT UNIT COOLERS
