***TRANSAMERICA DELAVAL, INC.
EMERGENCY DIESEL GENERATORS
OWNERS GROUP***

***Generic Topical Report
TDI-EDG-001-A***

***Basis for Modification to Inspection Requirements For
Transamerica Delaval, Inc., Emergency Diesel Generators***

Approved by the U.S. Nuclear Regulatory Commission March 17, 1994

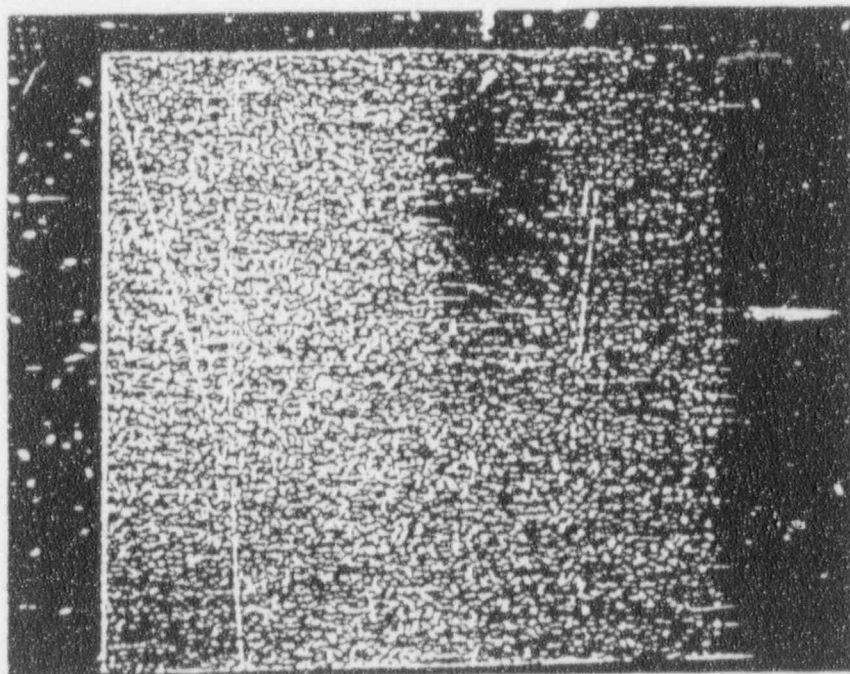
Figure 1. Macro Etched Sample A. 6X. Heavy Keller's Etch.
ID is to the right.

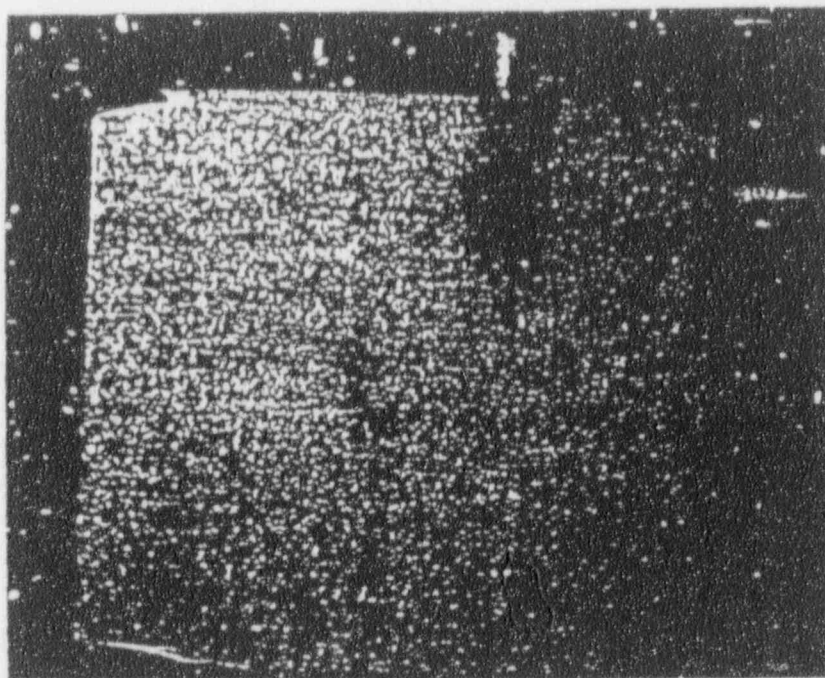
Figure 2. Macro Etched Sample B. 6X. Heavy Keller's Etch.
ID is to the right.

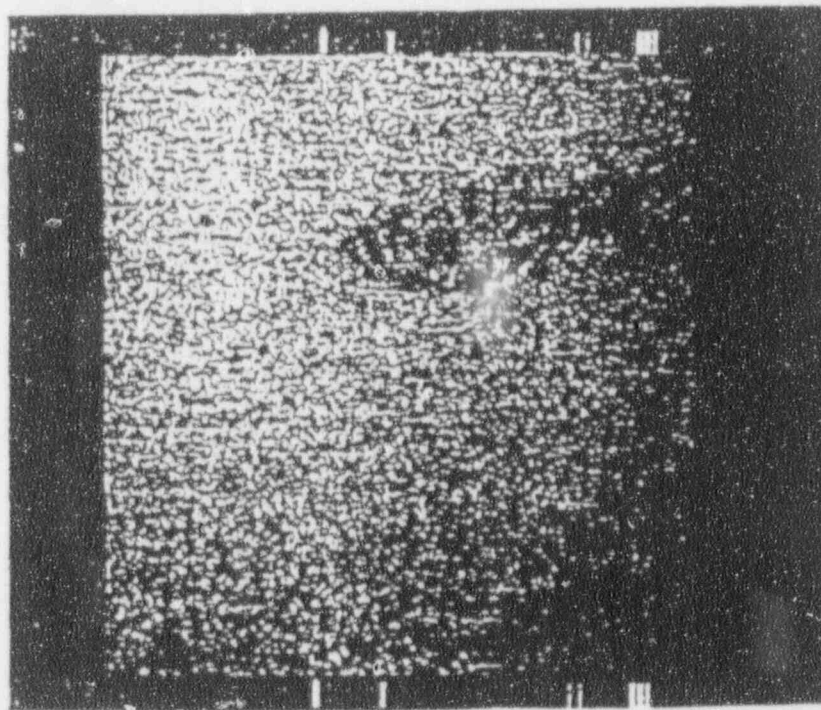
Figure 3. Macro Etched Sample C. 6X. Heavy Keller's Etch.
ID is to the top.

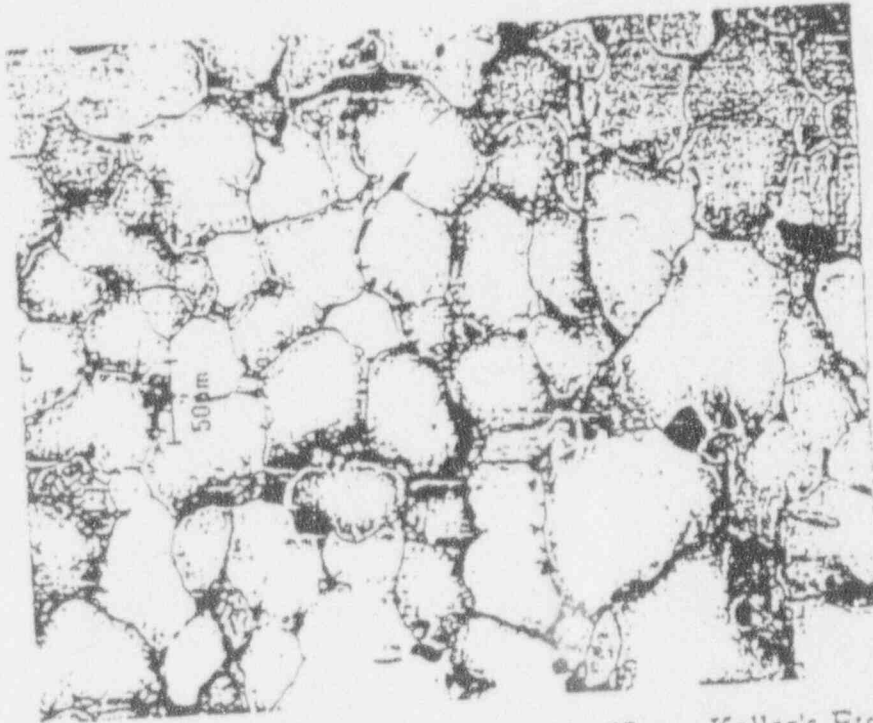
Figure 4. Equiaxed grain area. 200X. Heavy Keller's Etch.

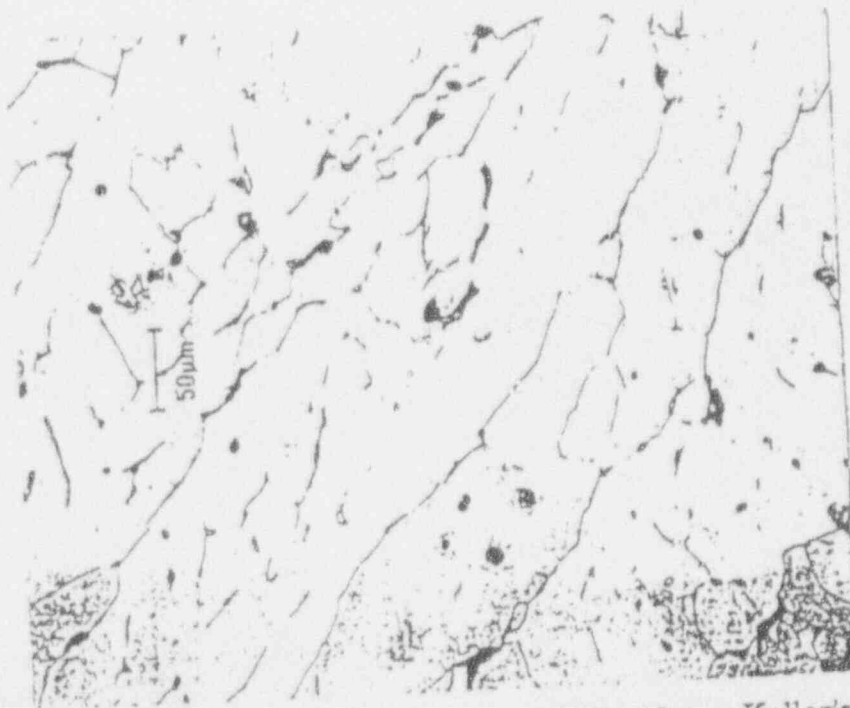
Figure 5. Columnar grain structure. 200X. Heavy Keller's Etch.

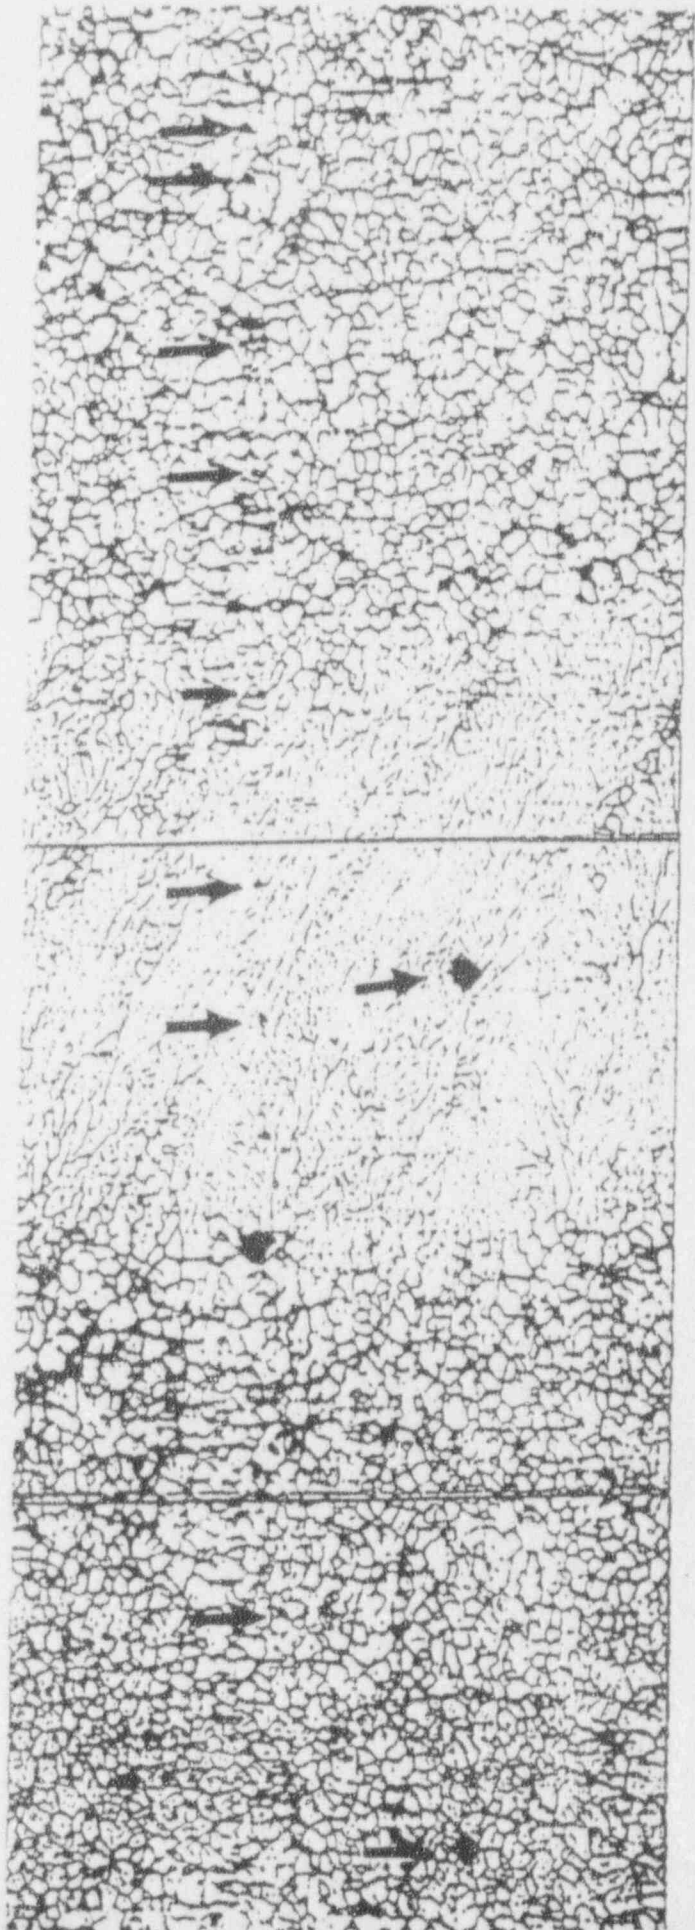
Figure 6. Panoramic view
through the columnar area
Showing the hardness test
indentations. 38X.
Heavy Keller's Etch.

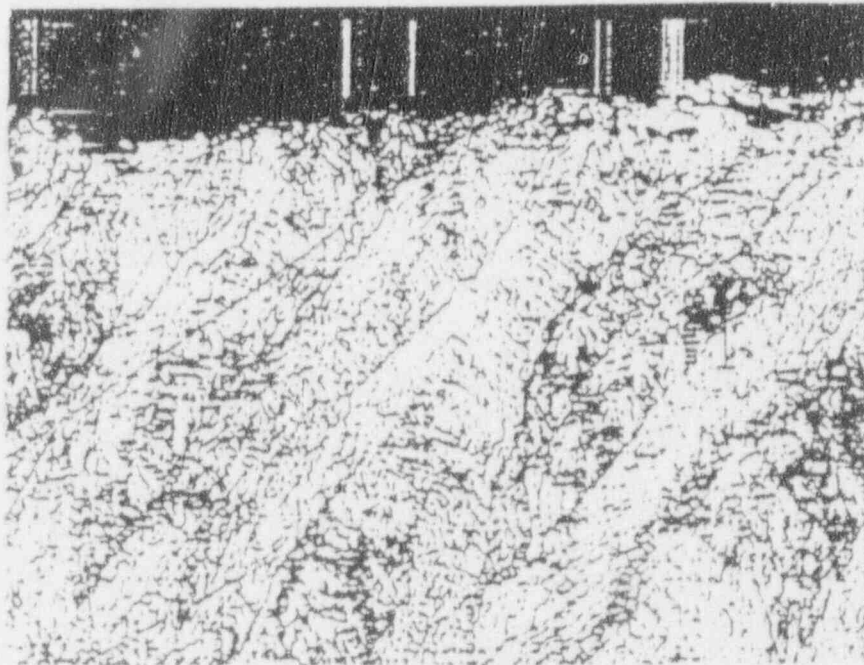
Figure 7. Cross section through surface of unmachined casting. Note similarity to center area of Figure 6.
50X. Heavy Keller's Etch.

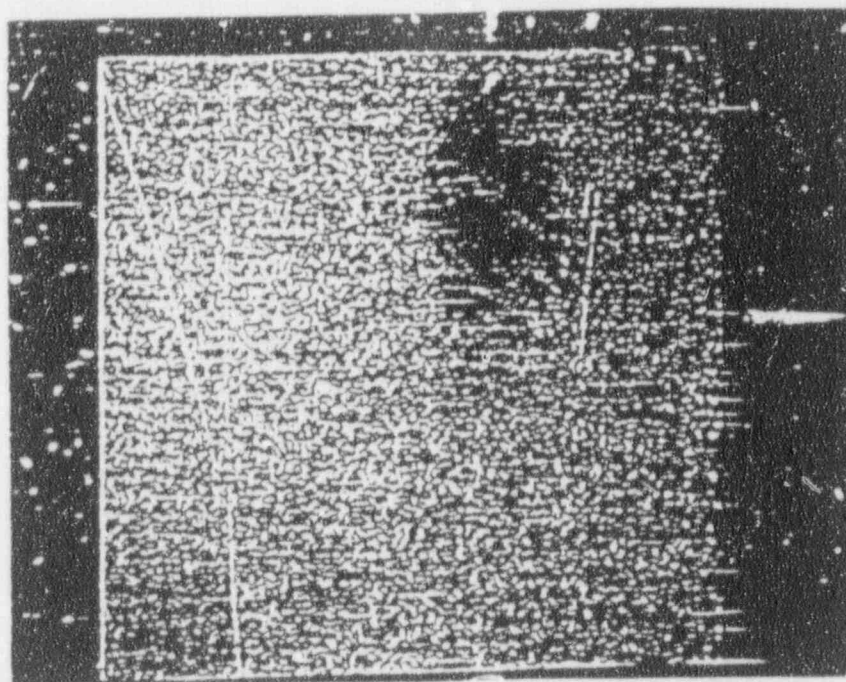
Figure 1. Macro Etched Sample A. 6X. Heavy Keller's Etch.
ID is to the right.

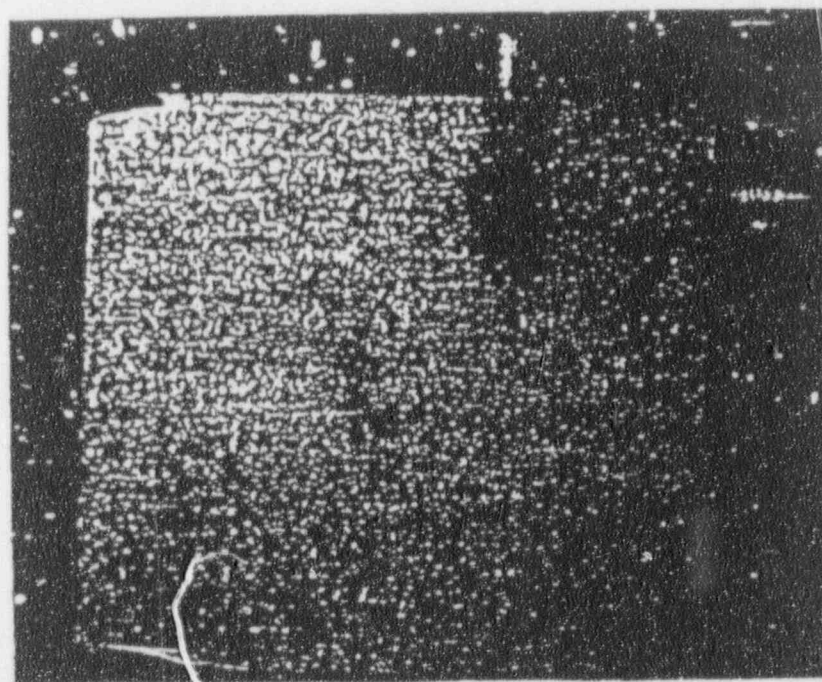
Figure 2. Macro Etched Sample B. 6X. Heavy Keller's Etch.

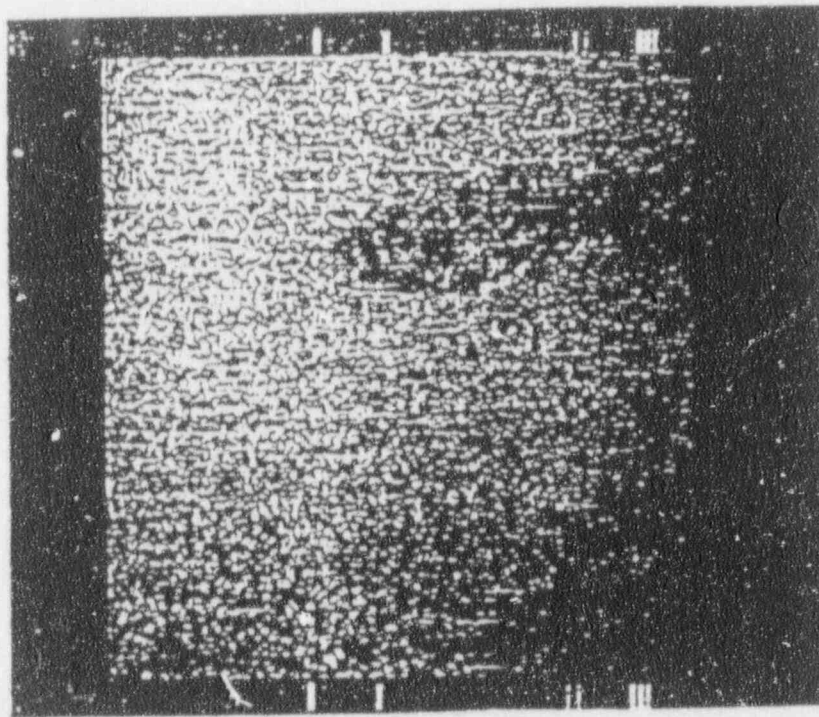
Figure 3. Macro Etched Sample C. 6X. Heavy Keller's Etch.
ID is to the top.

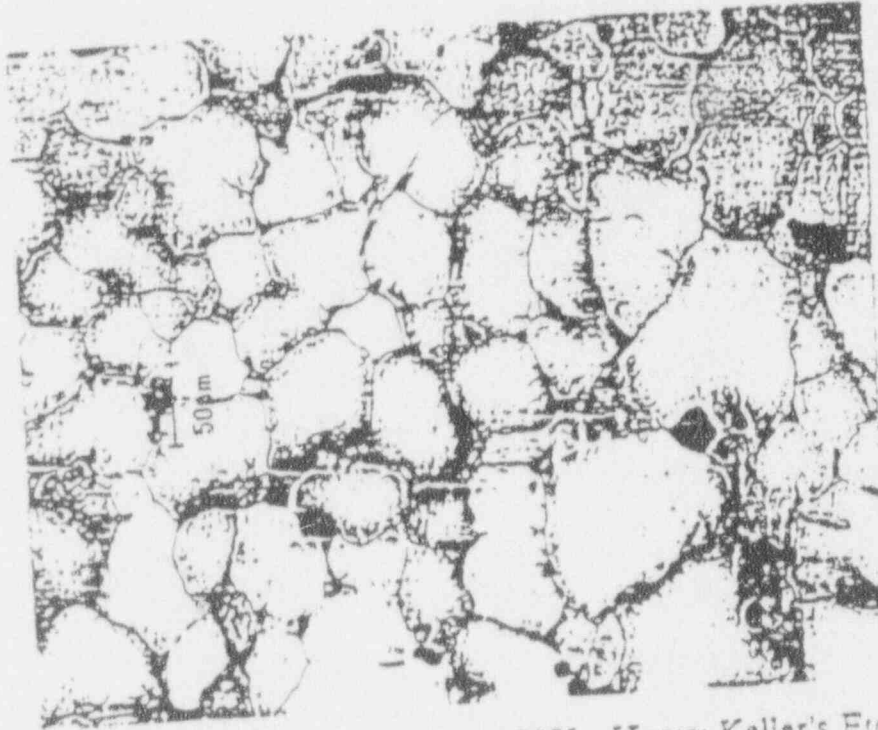
Figure 4. Equiaxed grain area. 200X. Heavy Keller's Etch.

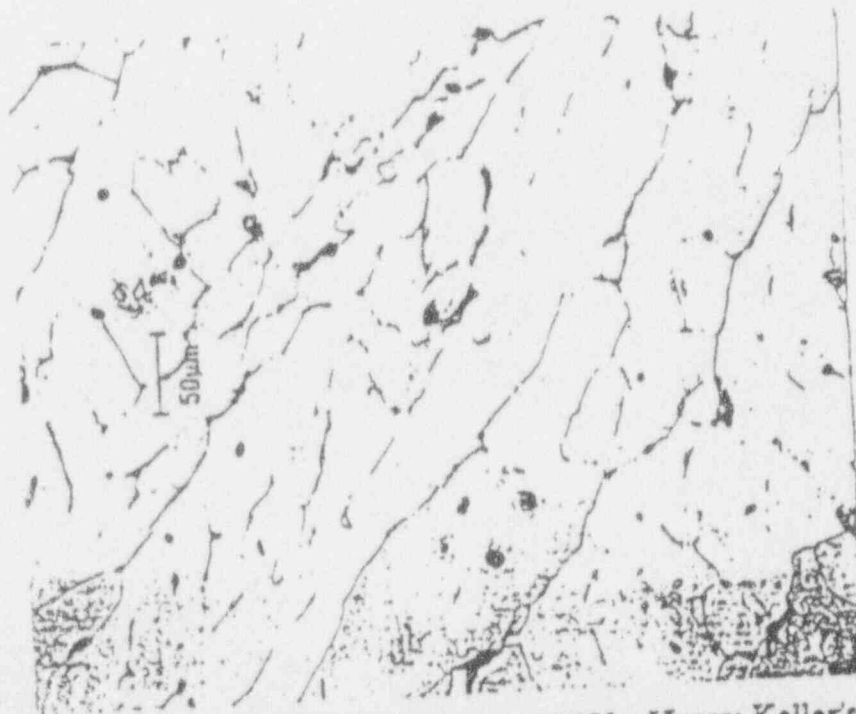
Figure 5. Columnar grain structure. 200X. Heavy Keller's Etch.

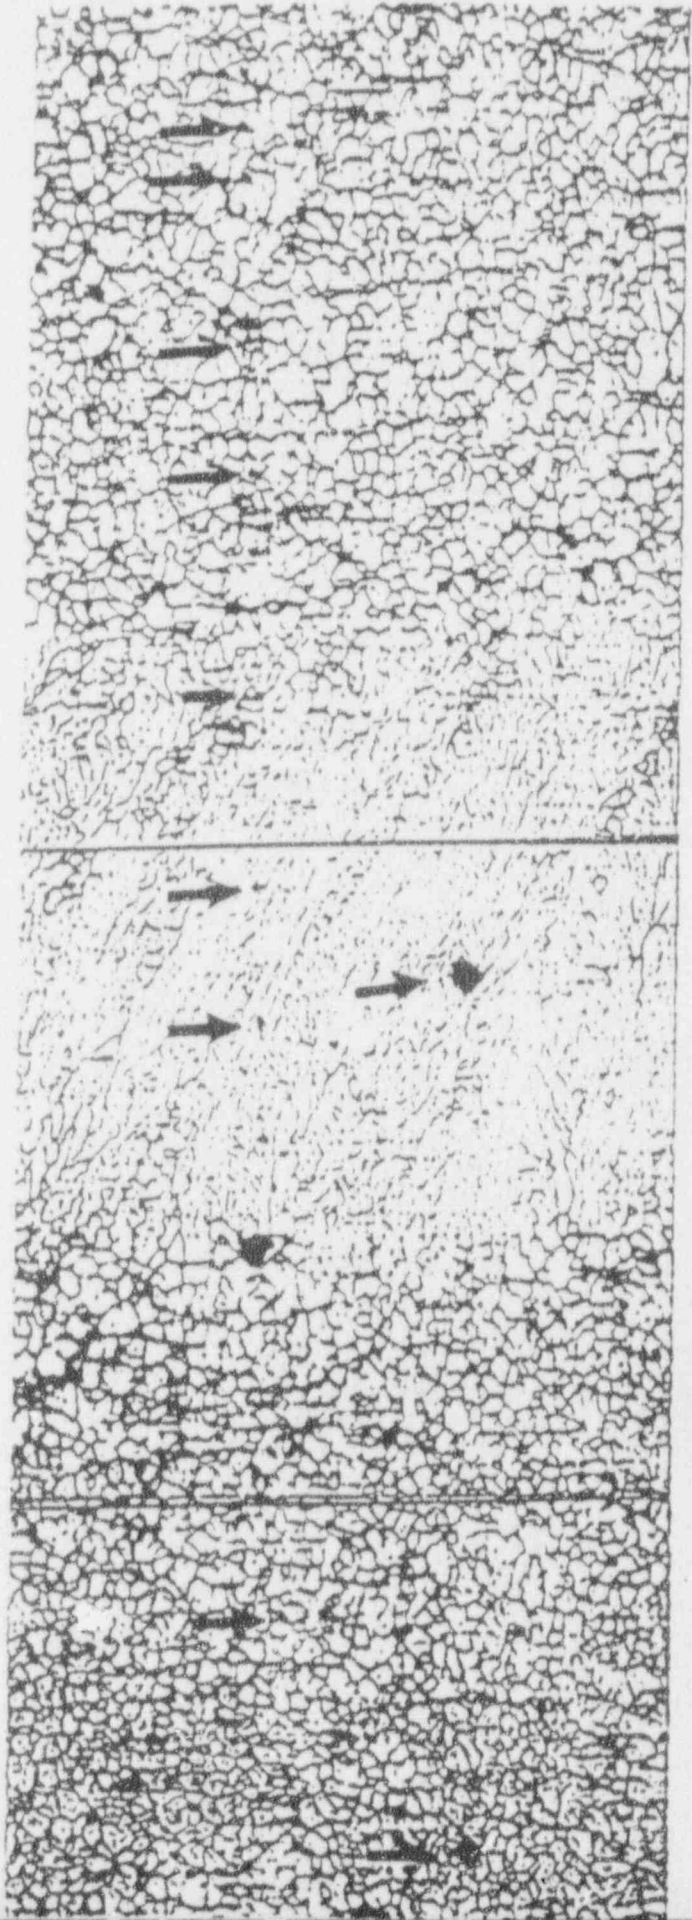
Figure 6. Panoramic view
through the columnar area
Showing the hardness test
indentations. 38X.
Heavy Keller's Etch.

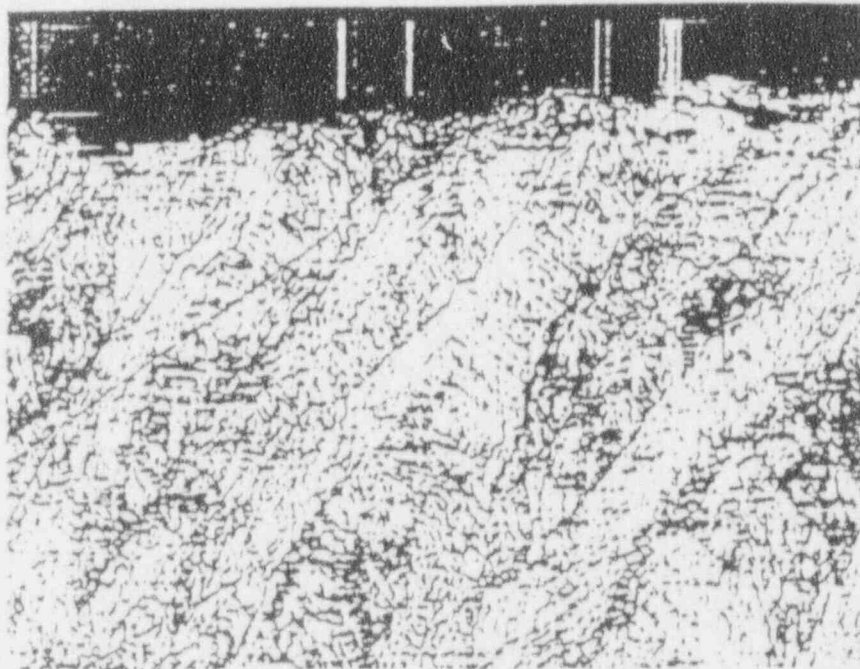
Figure 7. Cross section through surface of unmachined casting. Note similarity to center area of Figure 6.
50X. Heavy Keller's Etch.
