U.S. House of Representatives
Subcommittee on Oversight and Investigations
of the
Committee on Energy and Commerce
Washington, DC 20515-6116

March 21, 1994

TITLE (4)
Automatic Reactor Shutdown Following Failure of the Main Turbine

SUBJECT: FERMII 2 CATASTROPHIC
TURBINE-GENERATOR FAILURE

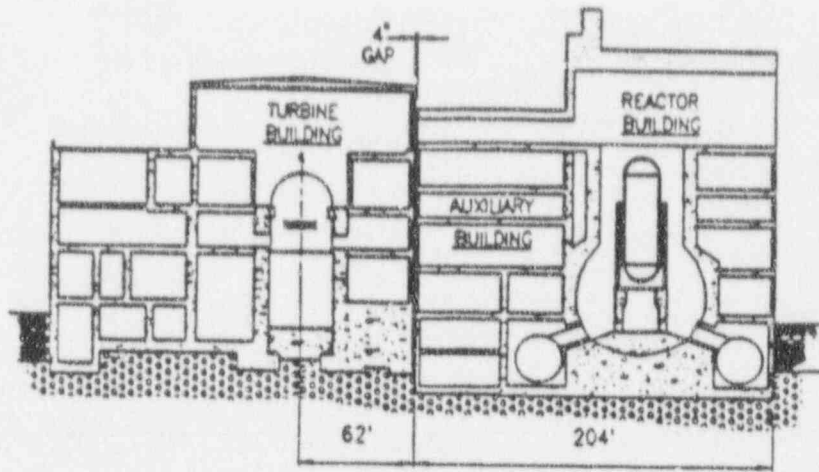
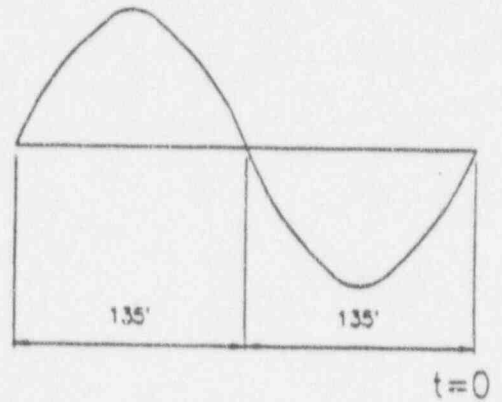
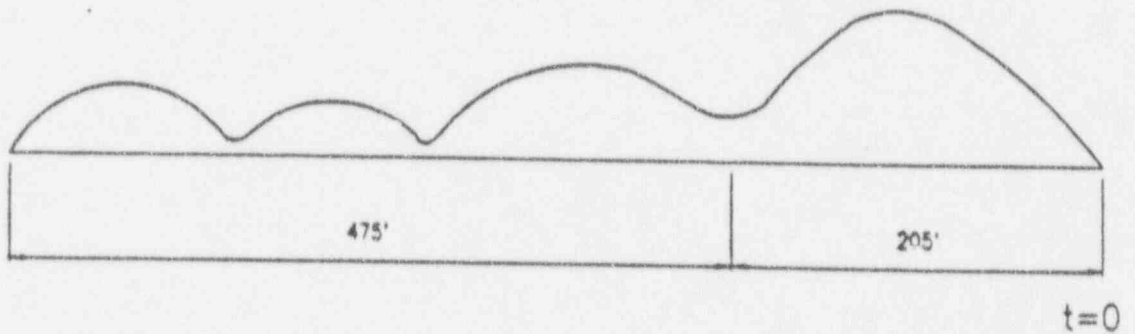
Figure 4.0.1

The shock wave length resulting from the turbine event at Fermi 2 was small compared to the building, and therefore produced local high accelerations, but the short duration, low energy, and small deformations associated with these high frequency accelerations did not compromise the structural integrity of the Reactor/Auxiliary building or the equipment therein.

**Schematic Representation of Shock impulse Wave Length
Compared to Building Dimension**

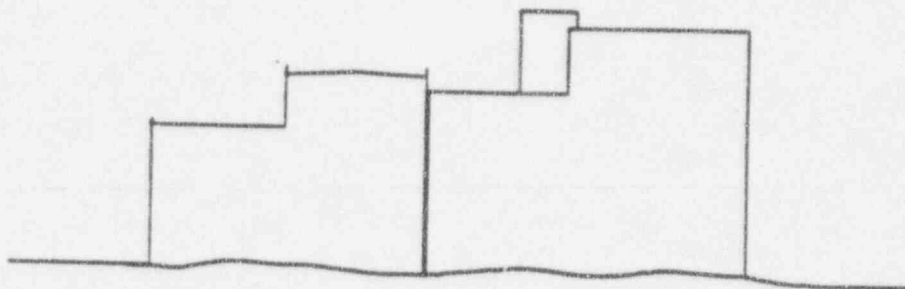
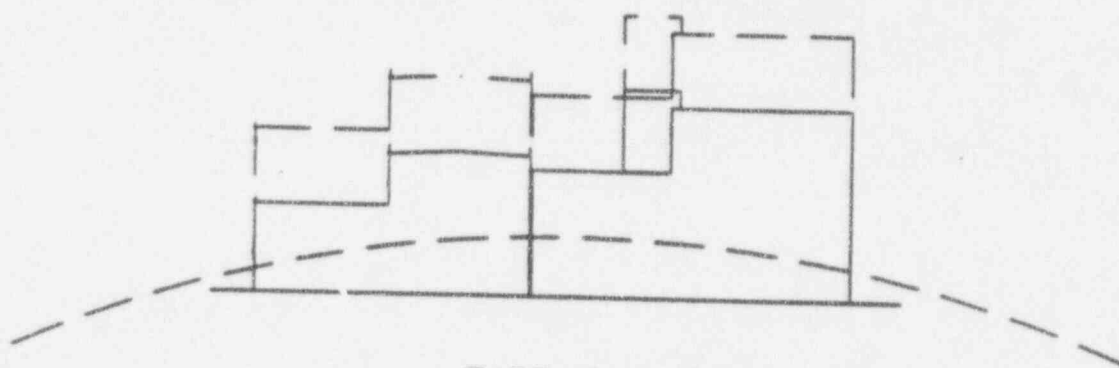
Schematic Representation of Impulse Tremor Versus
Earthquake Wave - Vertical Direction
